Saipan Watershed Assessment 2020

<p>Site ID: AS102</p>	<p>Watershed: Achugao South</p>
<p>Crew: EH</p>	<p>Date/Time: 01/19/2020 8:33 PM</p>
<p>Project Type:</p> <ul style="list-style-type: none"> • Drainage Infrastr., Maint. & Repair

2020 SAIPAN WATERSHED FIELD NOTES

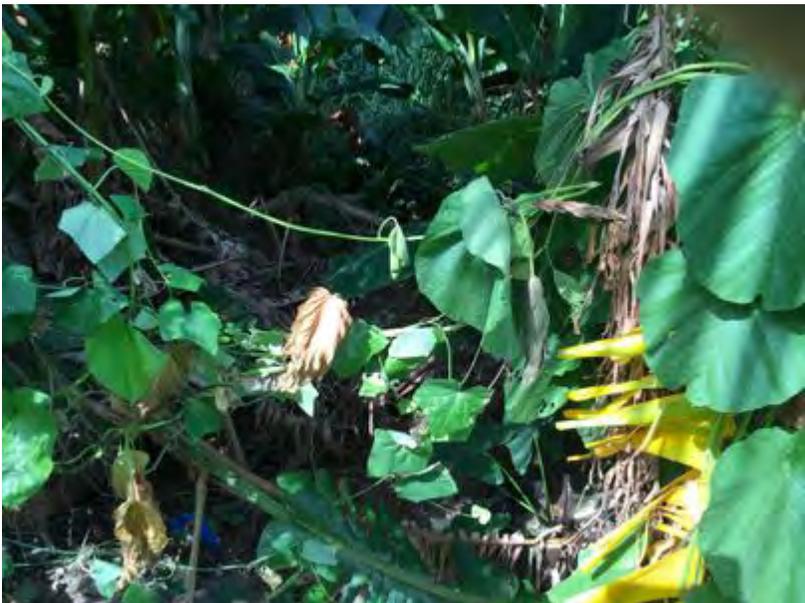
<p>Enforcement Needed: Yes</p>	
<p>Severity Rating: 2</p>	
<p>Implementation Priority: It's OK (Med)</p>	
<p>Descriptions of Existing Conditions: Ditch on uphill side of road, crosses road in 90 deg culvert to headwall.</p>	
<p>Description of Proposed Opportunity: Maintenance: clean. Repair trash rack, increase swale and pipe size. Reduce angles of 90 degree turn, add sediment forebay.</p>	
<p>Challenges/Constraints: Main road, limited space, developed</p>	
<p>Additional Notes:</p>	
<p>Site Photo</p>

<p>Site Overview Caption: Outfall toward wetland</p>

Additional Photo Caption: Headwall on downstream end

Ditch crosses road via 90° culvert.
Headwall on downstream end.
Lots of trash.

At minimum - clean.
Install trash rack, increase swale & pipe size. Add sediment forebay.
Possibly change angle of culvert?

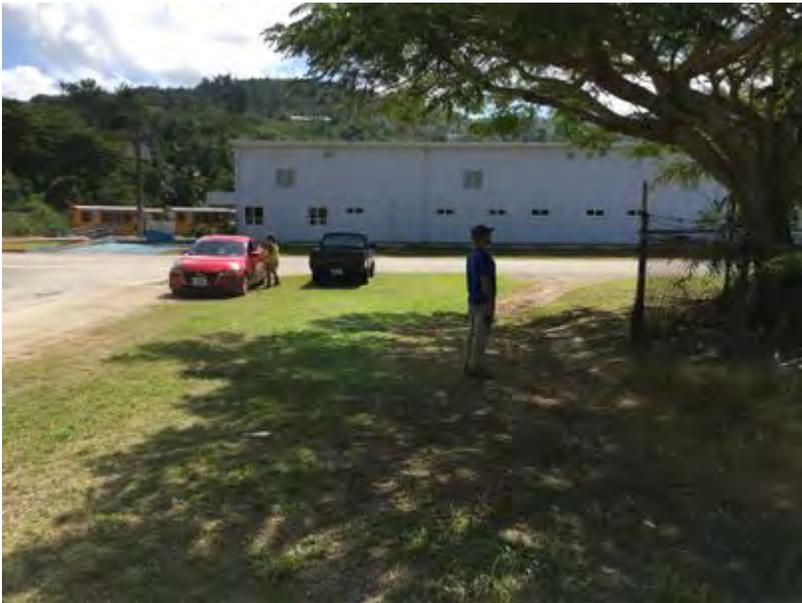
<p>Enforcement Needed: No</p>	
<p>Severity Rating: 2</p>	
<p>Implementation Priority: Love it! (High)</p>	
<p>Descriptions of Existing Conditions: Catch basin & inlet to dry swale. Flow goes through culvert to drainage ditch with standing water (recently cleared by DPW Roads & Grounds).</p>	
<p>Description of Proposed Opportunity: Install a sediment forebay at inlet to wet swale for enhanced water quality treatment and reduced maintenance. Possibility for educational signage.</p>	
<p>Challenges/Constraints: Industrial area. Road with catch basin may be redone. Land ownership/future use could be an issue. Side slope stabilization could be difficult in steep ditch.</p>	
<p>Additional Notes: Recently excavated drainage ditch</p>

<p>Site Overview Caption: Swale area</p>

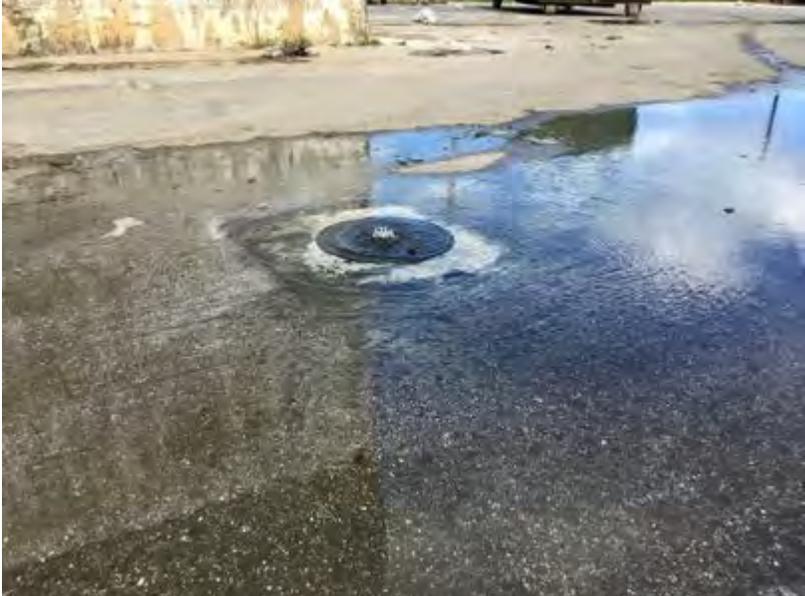
<p>Enforcement Needed: Yes</p>	
<p>Severity Rating: 5 (Severe)</p>	
<p>Implementation Priority: Love it! (High)</p>	
<p>Descriptions of Existing Conditions: Municipal transfer station. Two leaking water main bubbling up in road, picking up trash and dumpster juice. Discharging to historic wetland. May be for fire suppressant.</p>	
<p>Description of Proposed Opportunity: Fix water line leaks.</p>	
<p>Challenges/Constraints:</p>	
<p>Additional Notes:</p>	
<p>Site Photo</p>

<p>Site Overview Caption: Water bubbling up.</p>

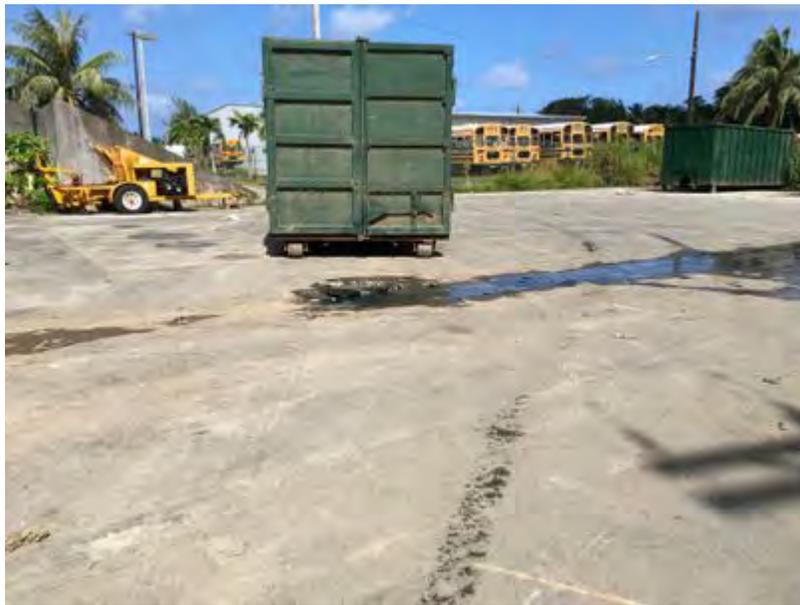
Additional Photo Caption: Another leaking main or pipe

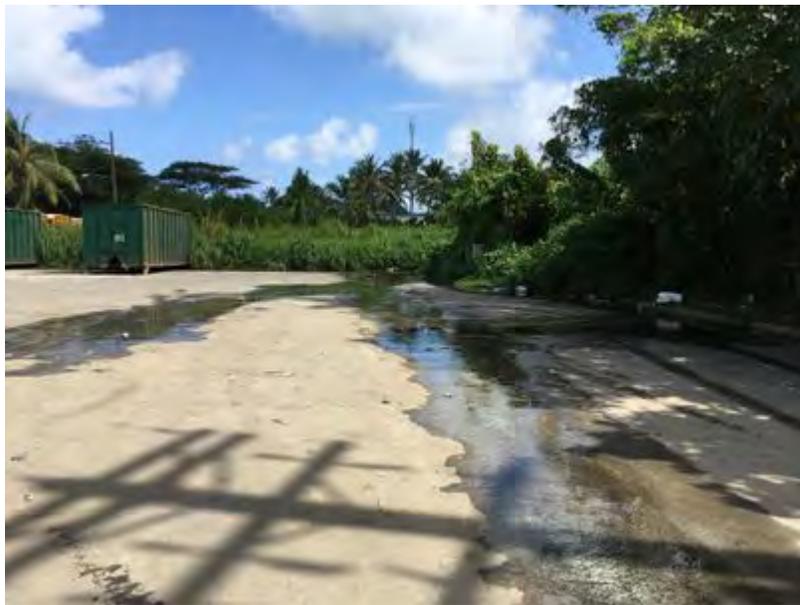
Additional Photo Caption: Runoff from the leaks, wetland is to the right.

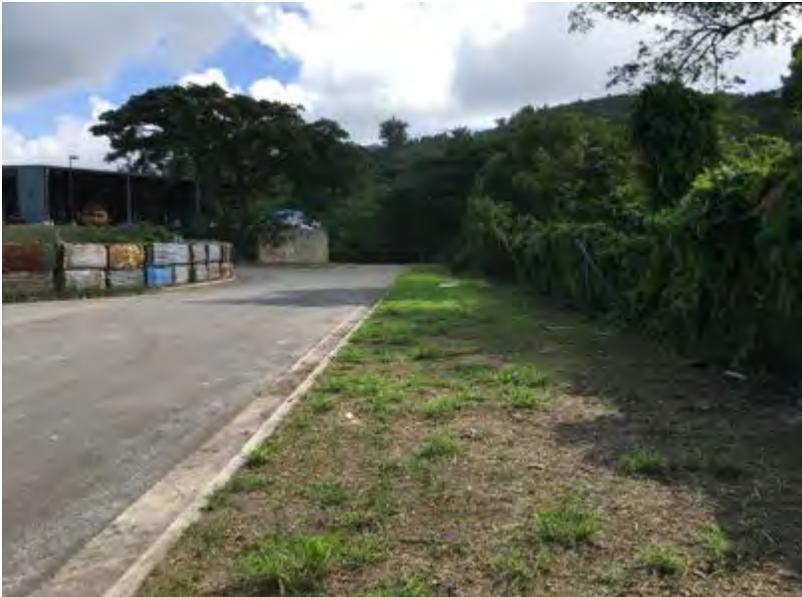
<p>Enforcement Needed: No</p>	
<p>Severity Rating: 5 (Severe)</p>	
<p>Implementation Priority: Love it! (High)</p>	
<p>Descriptions of Existing Conditions: Transfer station drainage network clogged. Unclear where runoff is discharged.</p>	
<p>Description of Proposed Opportunity: Build swale along landscape strip between wetland, fence, and roadway.</p>	
<p>Challenges/Constraints: Transfer station, maintenance, pollutants, large tree.</p>	
<p>Additional Notes:</p>	
<p>Site Photo</p>

<p>Site Overview Caption: Proposed swale location.</p>

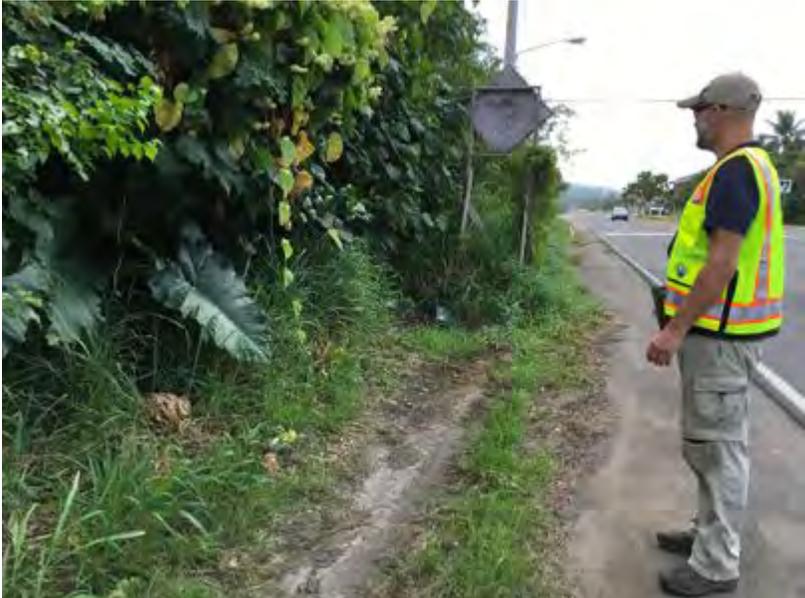
<p>USGS The National Map: National Boun... Powered by Esri</p>
<p>Enforcement Needed: Yes</p>	
<p>Severity Rating: 3</p>	
<p>Implementation Priority: It's OK (Med)</p>	
<p>Descriptions of Existing Conditions: Concrete road swale. Clogged with sediment</p>	
<p>Description of Proposed Opportunity: Clean and remove sediment.</p>	
<p>Challenges/Constraints:</p>	
<p>Additional Notes:</p>	
<p>Site Photo</p>

<p>Site Overview Caption: Swale clogged with sediment (flowing toward sign)</p>

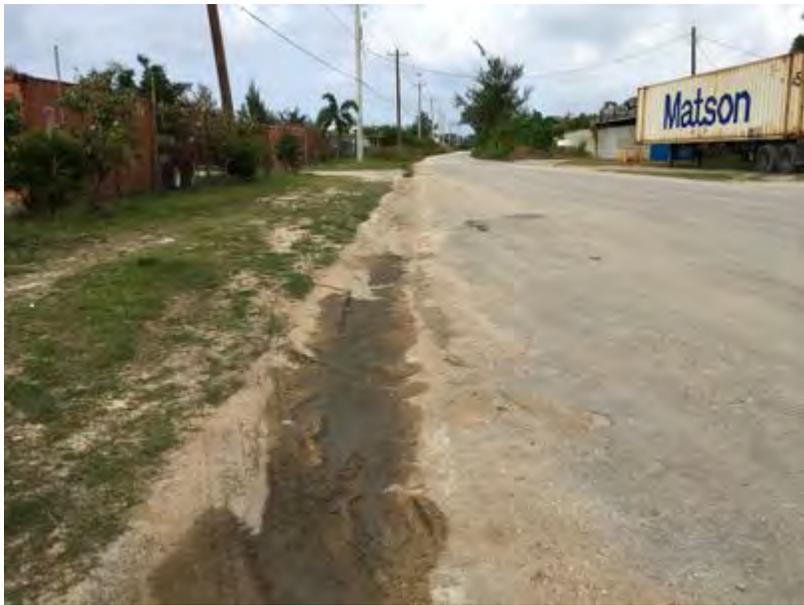
<p>Enforcement Needed: No</p>	
<p>Severity Rating: 5 (Severe)</p>	
<p>Implementation Priority: Love it! (High)</p>	
<p>Descriptions of Existing Conditions: Concrete swale along side of road. Collapsed culvert. Old tidal gate (WWII era?)</p>	
<p>Description of Proposed Opportunity: Formalize inlet and add sediment forebay. For industrial businesses nearby-- implement individual BMPs to control sediment. Replace culvert & restore side slopes. (also see AS168)</p>	
<p>Challenges/Constraints: Access to down gradient/outfall area is difficult. Abutting private property.</p>	
<p>Additional Notes:</p>	
<p>Site Photo</p>

<p>Site Overview Caption: Large amount of sediment accumulation in channel</p>

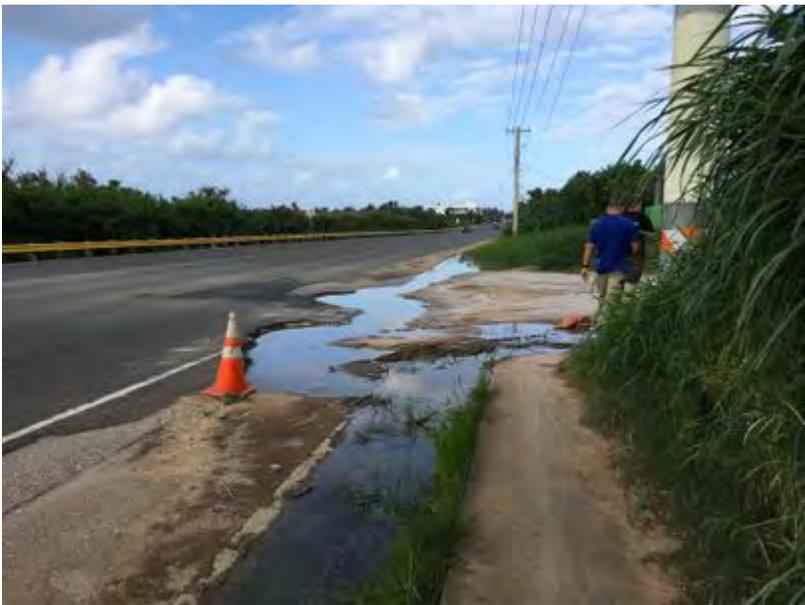
<p>Enforcement Needed: Yes</p>	
<p>Severity Rating: 5 (Severe)</p>	
<p>Implementation Priority: Love it! (High)</p>	
<p>Descriptions of Existing Conditions: Agatan Stream has base flow and has been rerouted as part of development. Stream runs freely across the road and then along gutter line. Constant flow to another gut. (Also see AS134)</p>	
<p>Description of Proposed Opportunity: PRIORITY PROJECT. Restore and reestablish stream to remove water and erosion of road gutter line. Fix culvert (AS133).</p>	
<p>Challenges/Constraints: Middle Road and property access.</p>	
<p>Additional Notes:</p>	
<p>Site Photo</p>

<p>Site Overview Caption: Looking north along middle road. Driveway on right is to old garment factory.</p>

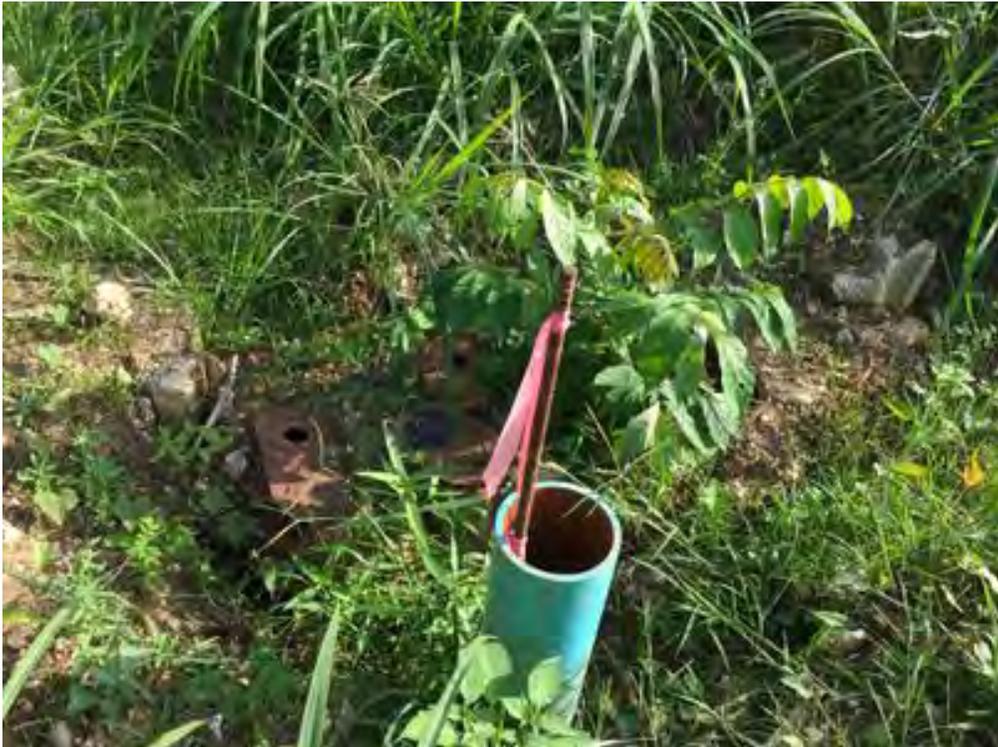
<p>Enforcement Needed: Yes</p>	
<p>Severity Rating: 5 (Severe)</p>	
<p>Implementation Priority: Love it! (High)</p>	
<p>Descriptions of Existing Conditions: Clogged culvert. Part of AS132 restoration.</p>	
<p>Description of Proposed Opportunity: Stream restoration along Middle Road and culvert restoration.</p>	
<p>Challenges/Constraints:</p>	
<p>Additional Notes:</p>	
<p>Site Photo</p>

<p>Site Overview Caption: Clogged culvert and drainage infrastructure.</p>

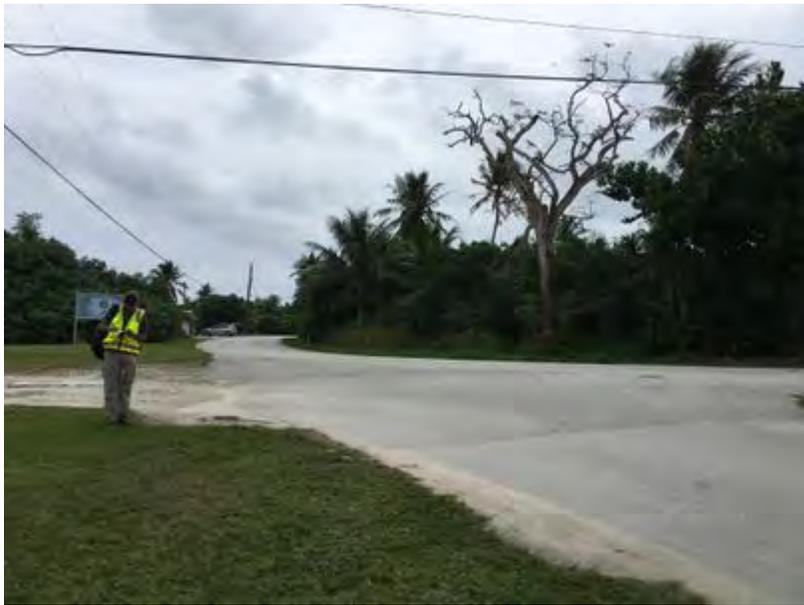
<p>Enforcement Needed: No</p>	
<p>Severity Rating: 3</p>	
<p>Implementation Priority: Love it! (High)</p>	
<p>Descriptions of Existing Conditions: Paved roads drain to unpaved dirt road in park. Road runoff appears to pond and scour.</p>	
<p>Description of Proposed Opportunity: Add waterbar or cross drain to direct runoff from Tanapag Ave (paved) to forebay and bio/rain garden in park. May have to be a wet swale. Education opportunity in park.</p>	
<p>Challenges/Constraints: Overflow-- where would that go? Maintenance could be difficult. Should be careful to not change/damage park. Very flat paved roads could make getting the water into swale difficult.</p>

<p>Site Overview Caption: Tanapag Ave (to right) and Santa Remedios Drive (bottom right to top) and park to left.</p>

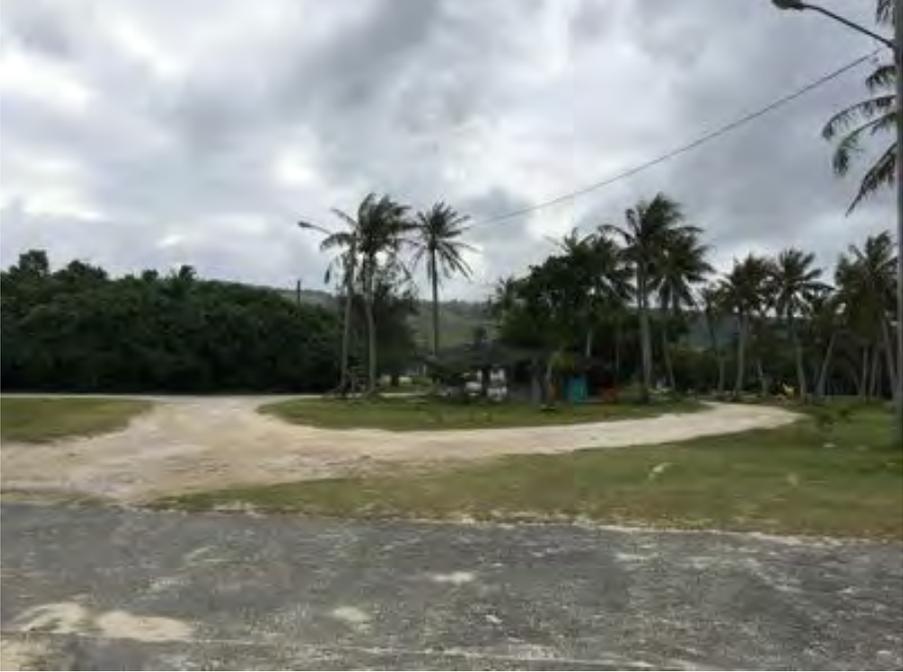
<p>Enforcement Needed: No</p>	
<p>Severity Rating: 2</p>	
<p>Implementation Priority: Not that important (Low)</p>	
<p>Descriptions of Existing Conditions: Park with boat ramp and several roads with unorganized vehicular traffic. Dirt roads causing minor erosion and sedimentation. Overall park is in good condition except lots of trash.</p>	
<p>Description of Proposed Opportunity: Eliminate some roads by reorganizing circulation and re-vegetating former roads. Add signage for litter.</p>	
<p>Challenges/Constraints: None-- complete as part of a larger improvement project of the entire park.</p>	
<p>Additional Notes:</p>	
<p>Site Photo</p>

<p>Site Overview Caption: Roads within the park.</p>

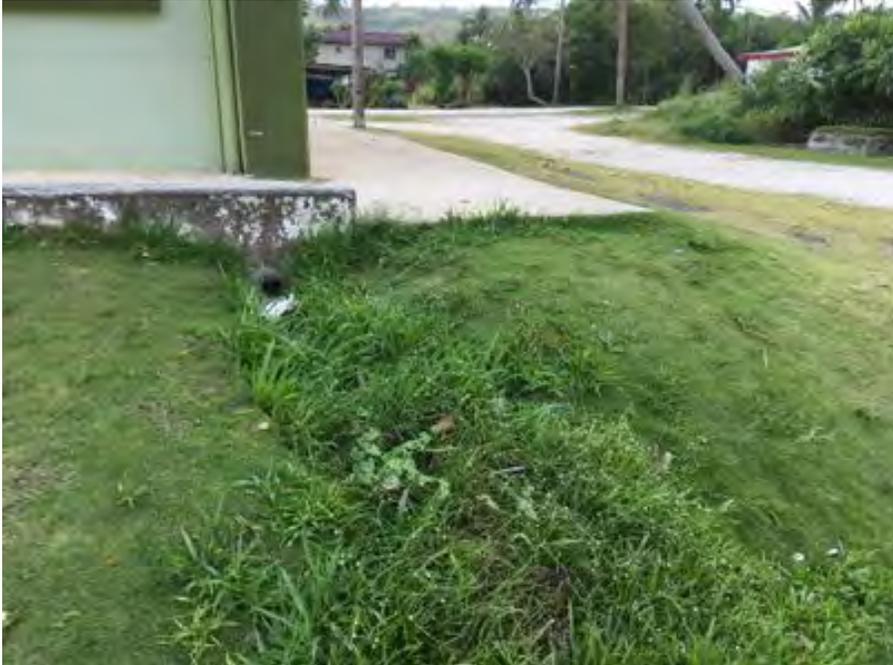
<p>Enforcement Needed: No</p>	
<p>Severity Rating: 2</p>	
<p>Implementation Priority: Love it! (High)</p>	
<p>Descriptions of Existing Conditions: Roof runoff discharges directly to park through downpipes.</p>	
<p>Description of Proposed Opportunity: Rain garden to capture runoff from building roof, eliminate nearby dirt access road. (See AS138)</p>	
<p>Challenges/Constraints:</p>	
<p>Additional Notes:</p>	
<p>Site Photo</p>

<p>Site Overview Caption: Downpipe from roof, informal swale discharge.</p>

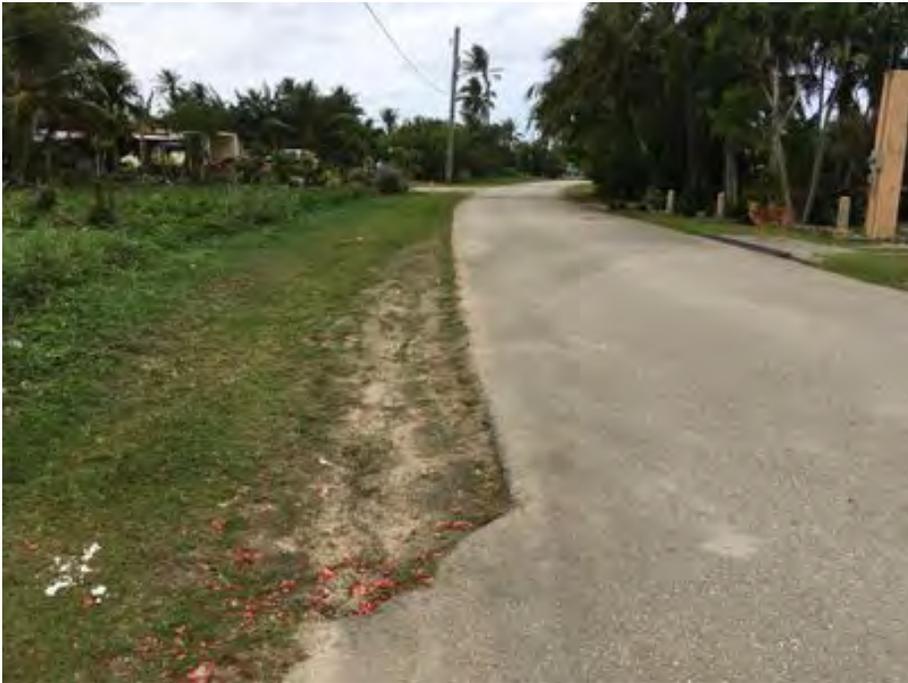
<p>Enforcement Needed: No</p>	
<p>Severity Rating: 1</p>	
<p>Implementation Priority: It's OK (Med)</p>	
<p>Descriptions of Existing Conditions: Paved parking lot drains to swale and weep holes in school wall drain to infiltration trench with pipe overflow. Water from paved swale discharges to lawn w/ erosion and then crosses road.</p>	
<p>Description of Proposed Opportunity: Drainage/vegetated swale along road and tie into infiltration trench overflow near the school yard wall. Possible combination with AS140.</p>	
<p>Challenges/Constraints: Possibly soil?</p>	
<p>Additional Notes:</p>	
<p>Site Photo</p>

<p>Site Overview Caption: Inlet from parking lot by wall, water flows along left side of road and then crosses.</p>

PAVED PARKING LOT TO SWALE ; WOOD HOLES IN SCHOOL WALL LE TO INFILTRATION TRENCH W/ PIG OVERFLOW

TIE IN INFILTRATION TRENCH OVER FLOW

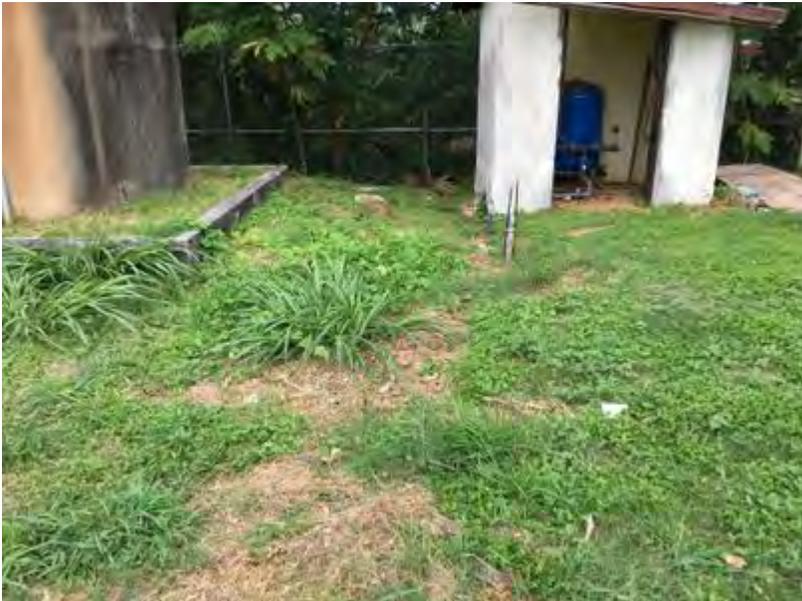
<p>Enforcement Needed: No</p>	
<p>Severity Rating: 2</p>	
<p>Implementation Priority: Not that important (Low)</p>	
<p>Descriptions of Existing Conditions: Informal swale draining runoff from end of dirt road and school yard that discharges off site. Eroded swale. Runoff goes between tanks and pump house.</p>	
<p>Description of Proposed Opportunity: Fix dirt road grades and direct to basin (AS149) on site.</p>	
<p>Challenges/Constraints: Ideally would get this runoff to basin-- may not be possible.</p>	
<p>Additional Notes:</p>	
<p>Site Photo</p>

<p>Site Overview Caption: Runoff goes between tank (left) and pump house (right).</p>

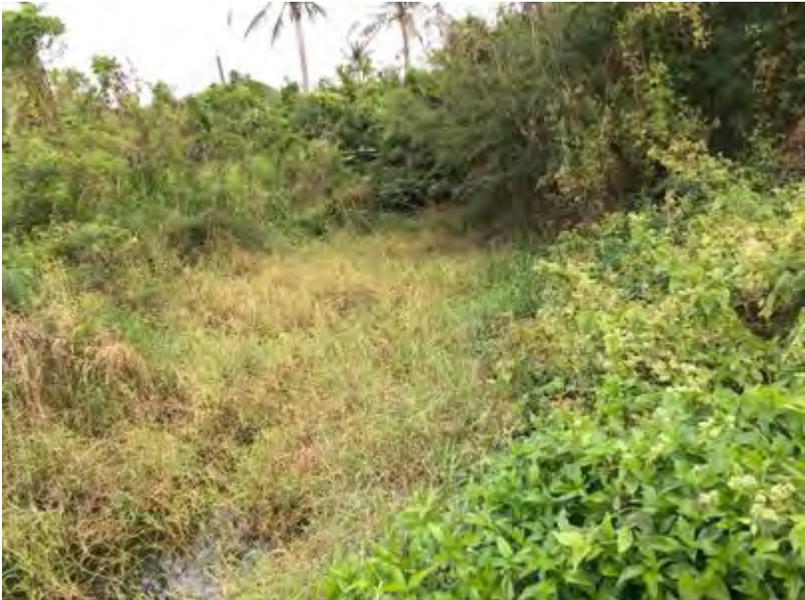
<p>Enforcement Needed: Yes</p>	
<p>Severity Rating: 3</p>	
<p>Implementation Priority: Love it! (High)</p>	
<p>Descriptions of Existing Conditions: Large basin in the NW corner of school site. Takes roof, walkway and field runoff. Vegetation is overgrown and should be cleared/cut and maintained. Standing water observed. Water overtops in the SW corner of basin and contributes to drainage issues at AS142. Basin is 4-6' deep, varies in width; up to 20'.</p>	
<p>Description of Proposed Opportunity: Clean basin. Explore possibility of expanding capacity and address overflow issue?</p>	
<p>Challenges/Constraints: Access-- will disturb school yard field if capacity is expanded.</p>

<p>Site Overview Caption: Upstream</p>

LARGE BASIN IN THE NW CORNER OF SCHOOL SITE TAKED
 ROOF, WALKWAY; FIELD RUNOFF. VEGETATION IS OVERGROWN
 AND SHOULD BE CLEARED/CUT MAINTAINED. STANDING
 WATER OBSERVED.
 WATER OVER TOPS IN THE SW CORNER OF BASIN; CONTRIBUTED
 TO DRAINAGE ISSUES @ SITE AS - ~~141~~ 142

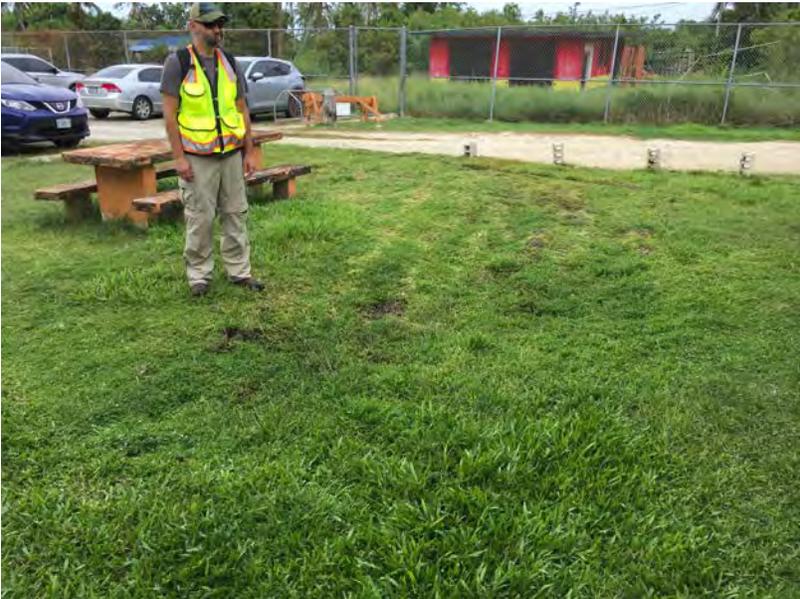
<p>USGS The National Map: National Boun... Powered by Esri</p>
<p>Enforcement Needed: Yes</p>	
<p>Severity Rating: 3</p>	
<p>Implementation Priority: It's OK (Med)</p>	
<p>Descriptions of Existing Conditions: Wet/mushy soils.</p>	
<p>Description of Proposed Opportunity: Determine cause-- leaking pipe? Stormwater? other?</p>	
<p>Challenges/Constraints:</p>	
<p>Additional Notes:</p>	
<p>Site Photo</p>

<p>Site Overview Caption: Mushy soils (see mud and tracks).</p>

+ DETERMINE CAUSE OF WOT SPONGY SOIL

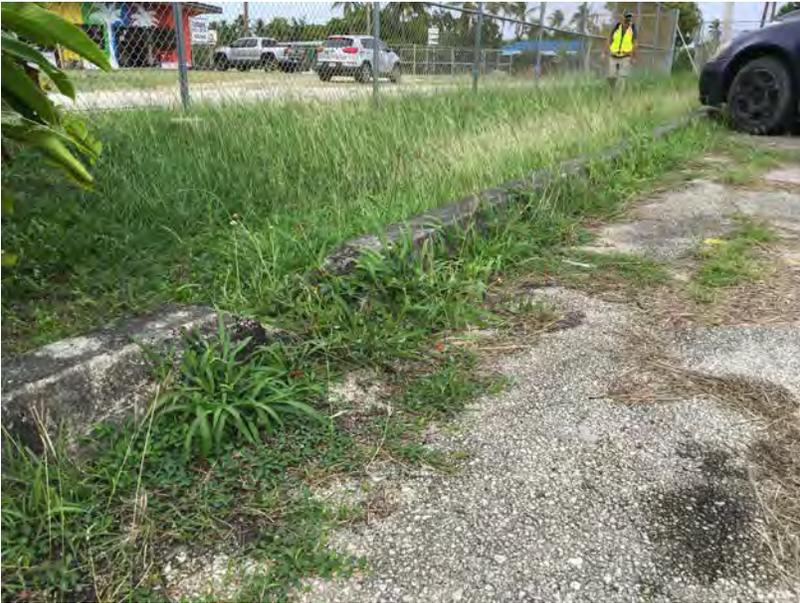
<p>Enforcement Needed: No</p>	
<p>Severity Rating: 2</p>	
<p>Implementation Priority: It's OK (Med)</p>	
<p>Descriptions of Existing Conditions: Parking lot drainage directed to existing swale. Two inlets and one outlet. Inlets clogged- too small. Runoff may not actually be entering swale. Drainage area is parking lot of school and runoff overflow via concrete swales.</p>	
<p>Description of Proposed Opportunity: Add inlets to allow for better drainage/more inflow. Fix existing inverts and outlets to ensure flow. Clean swale and replant.</p>	
<p>Challenges/Constraints: Soils and water table seem to be an issue at the middle school in general. (see AS 152)</p>	
<p>Additional Notes:</p>	
<p>Site Photo</p>

<p>Site Overview Caption: Inlet</p>

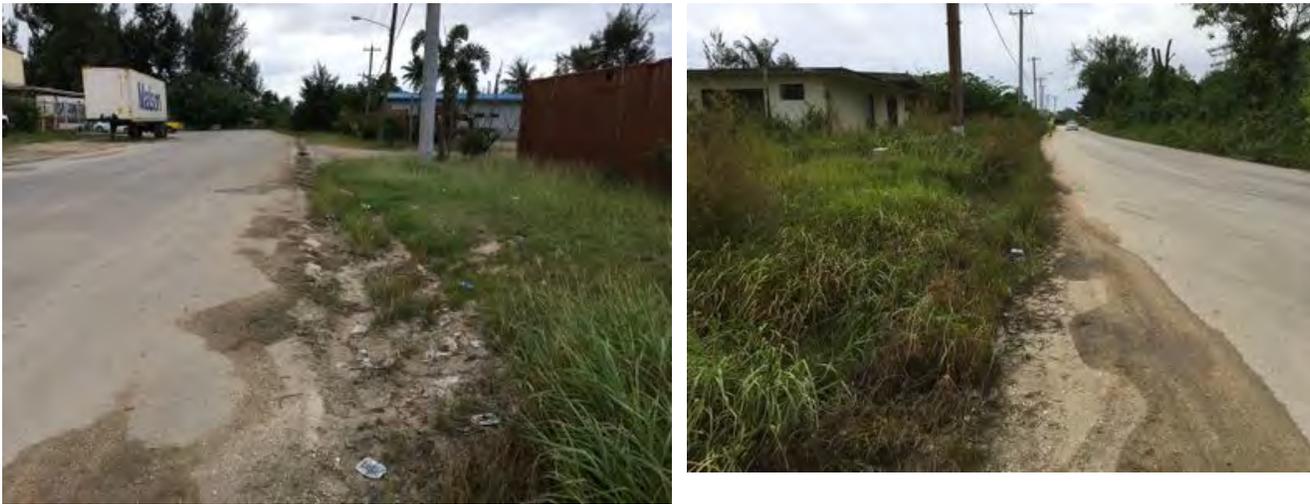
<p>Enforcement Needed: Yes</p>	
<p>Severity Rating: 3</p>	
<p>Implementation Priority: Love it! (High)</p>	
<p>Descriptions of Existing Conditions: Swale full of sediment. Industrial areas don't control their sediment runoff.</p>	
<p>Description of Proposed Opportunity: Clean swale. Require BMPs in contributing industrial area at each site. May be opportunities to install BMPs to control sediment in the ROW.</p>	
<p>Challenges/Constraints: Elimination & reduction of offsite sediment. Frequency of cleaning/controlling source.</p>	
<p>Additional Notes: Do these places have SWPPPs? Could develop a SWPPP for each willing owner.</p>	
<p>Site Photo</p>

<p>Site Overview Caption: (left) South and (right) North</p>

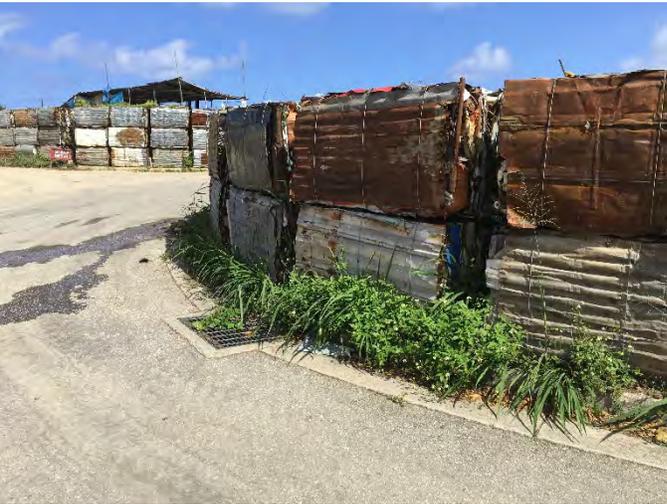
<p>Enforcement Needed: Yes</p>	
<p>Severity Rating: 3</p>	
<p>Implementation Priority: Love it! (High)</p>	
<p>Descriptions of Existing Conditions: Full Catchbasin</p>	
<p>Description of Proposed Opportunity: Clean</p>	
<p>Challenges/Constraints: None</p>	
<p>Additional Notes:</p>	
<p>Site Photo</p>

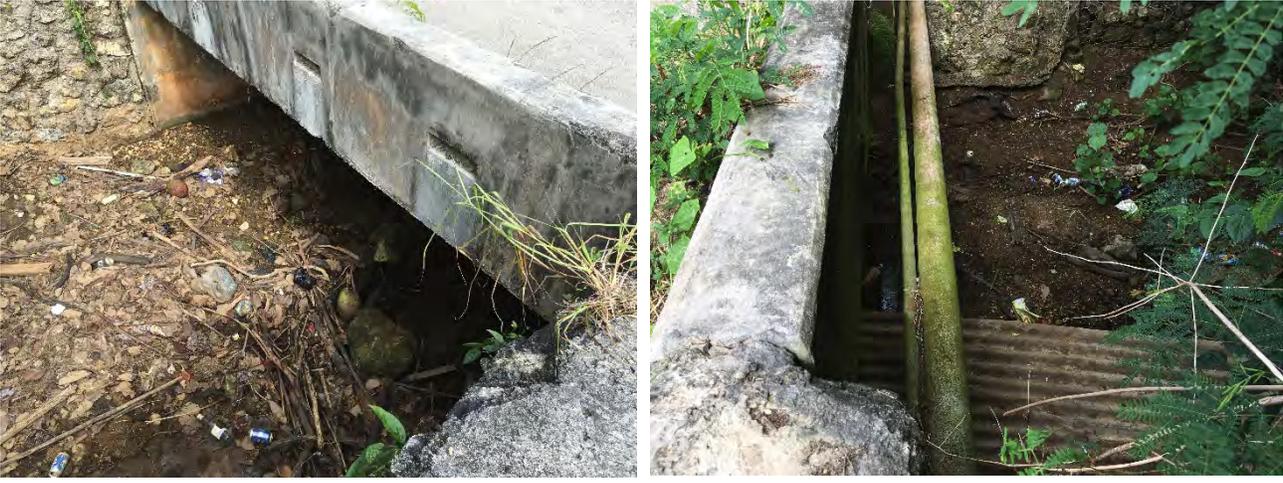
<p>Enforcement Needed: Yes</p>	
<p>Severity Rating: 3</p>	
<p>Implementation Priority: Love it! (High)</p>	
<p>Descriptions of Existing Conditions: Trash in culvert (w/ AS115)</p>	
<p>Description of Proposed Opportunity: Clean and remove debris</p>	
<p>Challenges/Constraints: None</p>	
<p>Additional Notes:</p>	
<p>Site Photo</p>

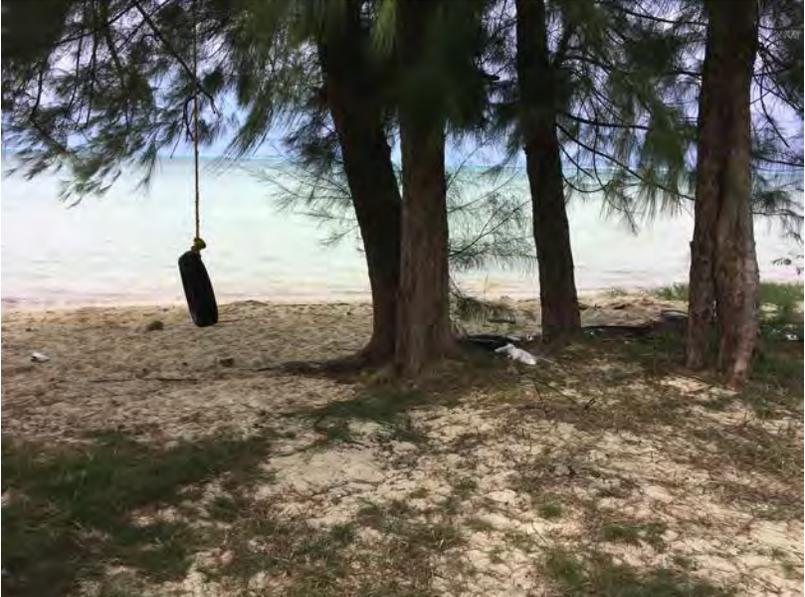
<p>Enforcement Needed: Yes</p>	
<p>Severity Rating: 5 (Severe)</p>	
<p>Implementation Priority: Love it! (High)</p>	
<p>Descriptions of Existing Conditions: Outfall of Dogas stream. LOTS of trash, including human waste (diapers).</p>	
<p>Description of Proposed Opportunity: Remove trash and discourage future dumping (signs, community education). Focus location for MINA.</p>	
<p>Challenges/Constraints: Changing habits.</p>	
<p>Additional Notes:</p>	
<p>Site Photo</p>

<p>Site Overview Caption: Trash on beach.</p>

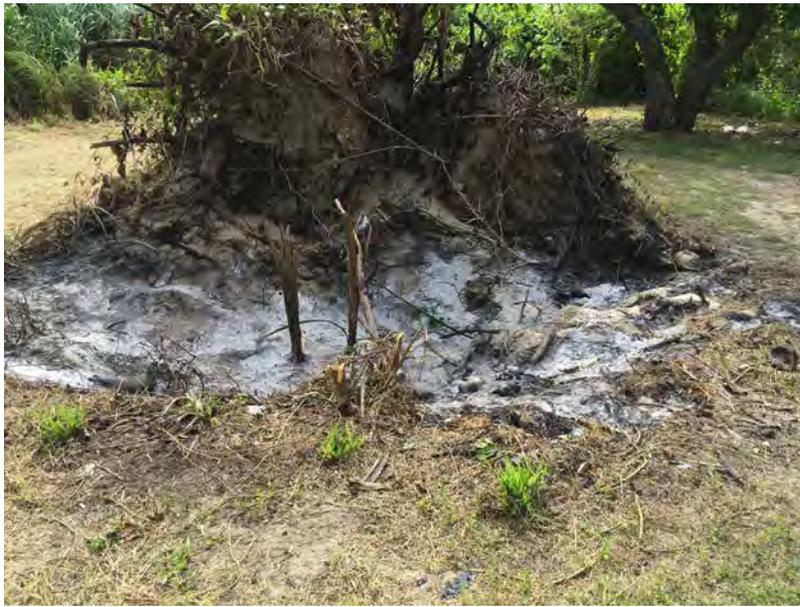
Additional Photo Caption: Burn area.

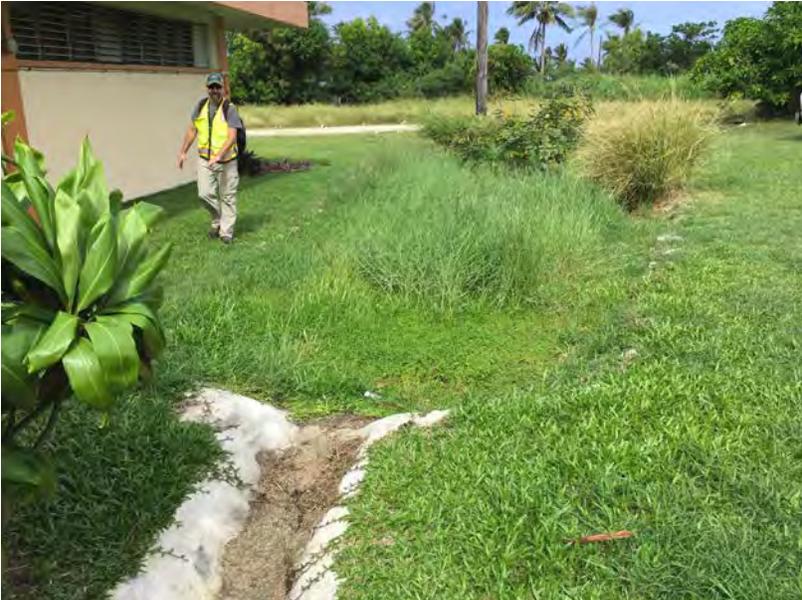
<p>Enforcement Needed: Yes</p>	
<p>Severity Rating: 5 (Severe)</p>	
<p>Implementation Priority: Love it! (High)</p>	
<p>Descriptions of Existing Conditions: Clogged inlet of rain garden at Tanapag Middle School (see AS145). May contribute to flooding of building. Also, rain garden outlet may be at too high an elevation causing backup.</p>	
<p>Description of Proposed Opportunity: Clean inlet. Widen and clean outlet spillway. Maintain positive drainage from outlet to road. Consider replanting with native plants</p>	
<p>Challenges/Constraints: Poor soils and/or high groundwater (poor infiltration nearby).</p>	
<p>Additional Notes:</p>	
<p>Site Photo</p>

<p>Site Overview Caption: Inlet to rain garden.</p>

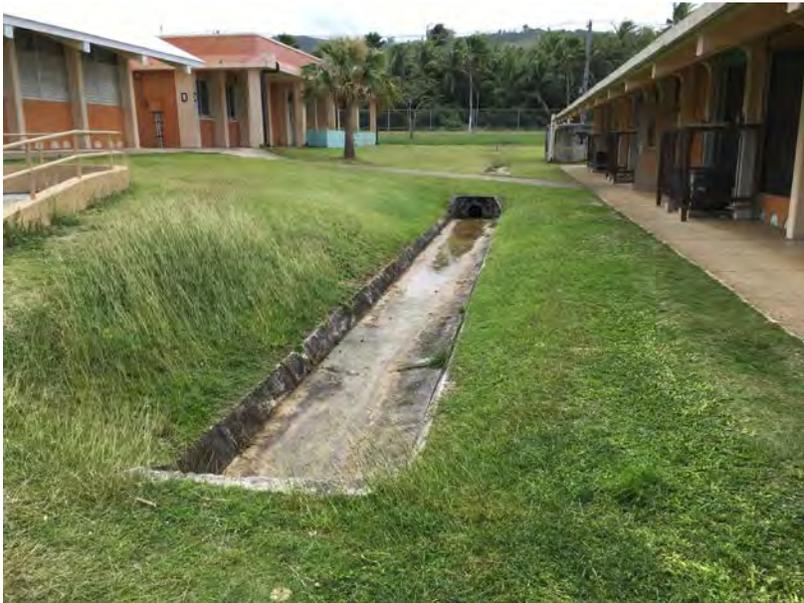
<p>USGS The National Map: National Boun... Powered by Esri</p>
<p>Enforcement Needed: No</p>	
<p>Severity Rating: 3</p>	
<p>Implementation Priority: It's OK (Med)</p>	
<p>Descriptions of Existing Conditions: Existing culvert clogged and unclear where it goes (off school property?).</p>	
<p>Description of Proposed Opportunity: Unclog culvert and consider a stormwater BMP at the downstream inlet.</p>	
<p>Challenges/Constraints:</p>	
<p>Additional Notes:</p>	
<p>Site Photo</p>

<p>Site Overview Caption: Culvert (bottom) with swale draining into it.</p>

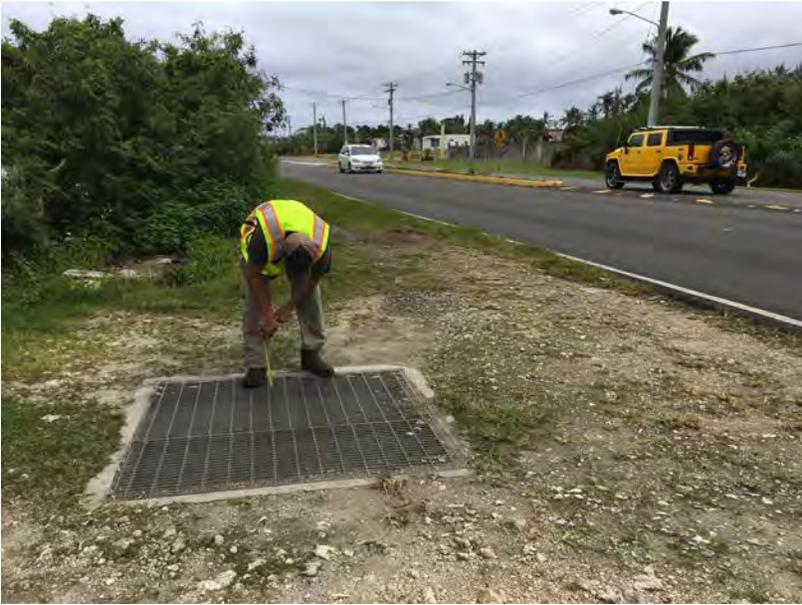
<p>Enforcement Needed: Yes</p>	
<p>Severity Rating: 3</p>	
<p>Implementation Priority: Not that important (Low)</p>	
<p>Descriptions of Existing Conditions: Large catchbasin clogged with sediment.</p>	
<p>Description of Proposed Opportunity: Clean it out.</p>	
<p>Challenges/Constraints: None</p>	
<p>Additional Notes:</p>	
<p>Site Photo</p>

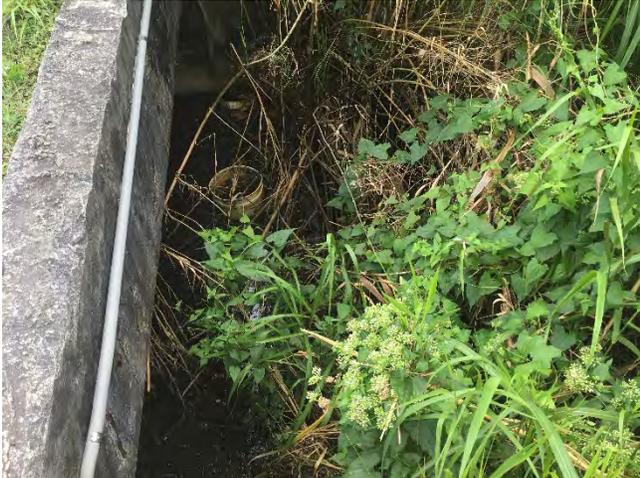
<p>Enforcement Needed: Yes</p>	
<p>Severity Rating: 4</p>	
<p>Implementation Priority: It's OK (Med)</p>	
<p>Descriptions of Existing Conditions: Standing water and trash on open side. Trash and large vegetation on other side of the road/culvert with no standing water.</p>	
<p>Description of Proposed Opportunity: Clean out trash. Remove large vegetation restricting flow.</p>	
<p>Challenges/Constraints:</p>	
<p>Additional Notes:</p>	
<p>Site Photo</p>

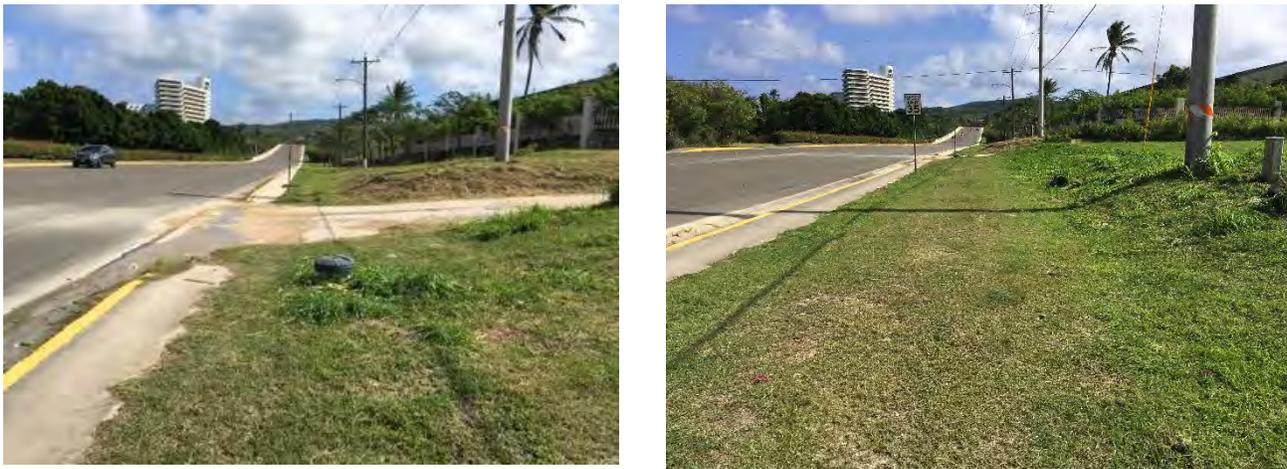
<p>Additional Notes: High visibility, opportunity to provide water quality treatment and reduce sedimentation onto public road. Existing infrastructure in road make overflow connection relatively easy.</p>	
<p>Site Photo</p>

<p>Site Overview Caption: Evidence of sediment tracking onto road from unpaved driveway</p>

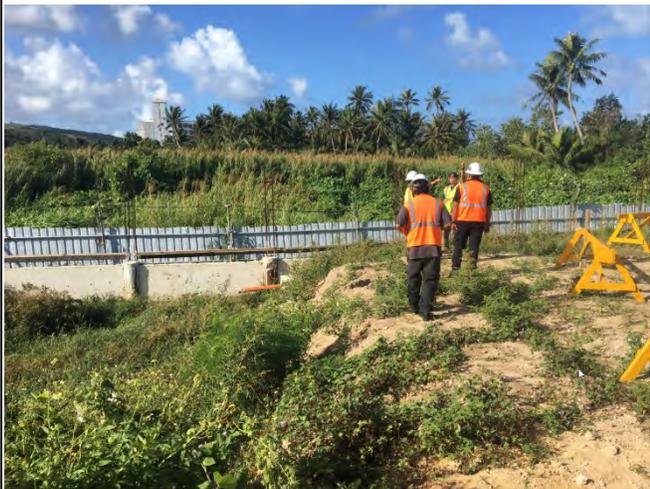
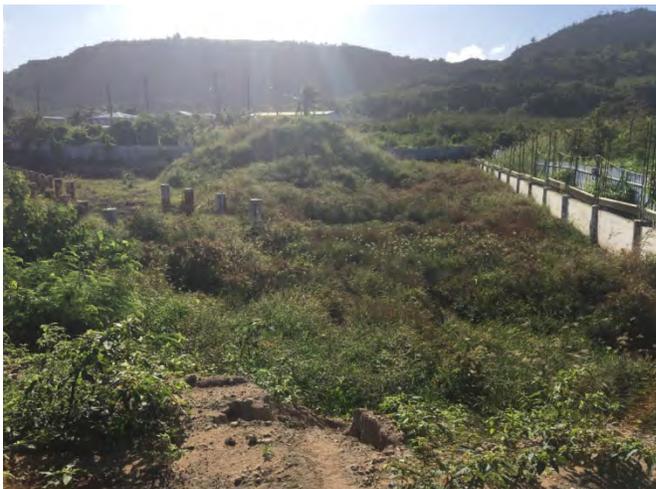
</div>	
<p>Site Overview Caption: Wall constructed to separate section of wetland to be used for stormwater management. Soil stockpiles in wetland area.</p>
