Laolao Bay Watershed Existing Conditions and Opportunities Interim Report

September 2020 DRAFT

CNMI Bureau of Environmental and Coastal Quality
Division of Coastal Resource Management

Horsley Witten Group, Inc.
KOA Consulting, Inc.
Sea Change Consulting

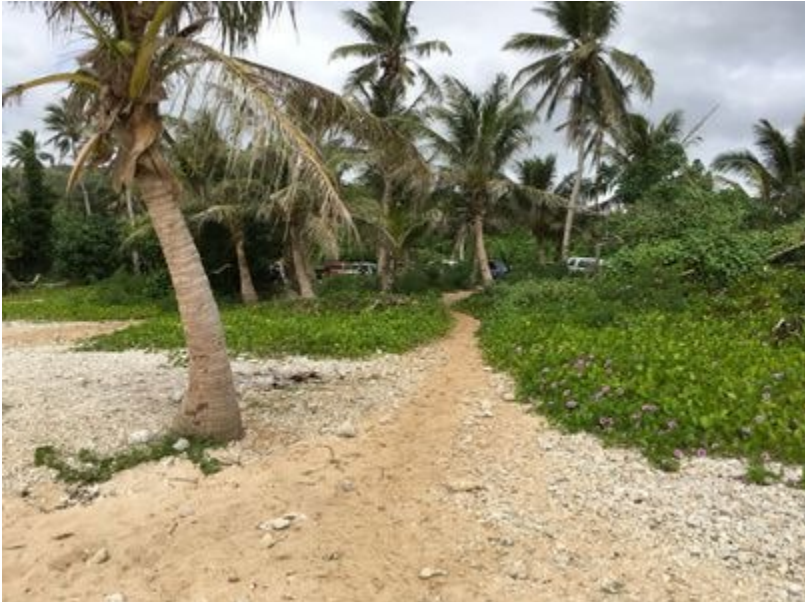
<p>Enforcement Needed: No</p>	
<p>Severity Rating: 3</p>	
<p>Implementation Priority: Love it! (High)</p>	
<p>Descriptions of Existing Conditions: Uncontrolled pedestrian circulation eroding shoreline. Multiple access points to beach.</p>	
<p>Description of Proposed Opportunity: Organize circulation. Limit access points to 2. Stabilize path, add boardwalk? Part of dive site improvement/organization. Educational opportunity with signage etc.</p>	
<p>Challenges/Constraints: Heavy use, storms, hard to change user habits.</p>	
<p>Additional Notes: See previous dive site concept.</p>	
<p>Site Photo</p>

<p>Site Overview Caption: East</p>

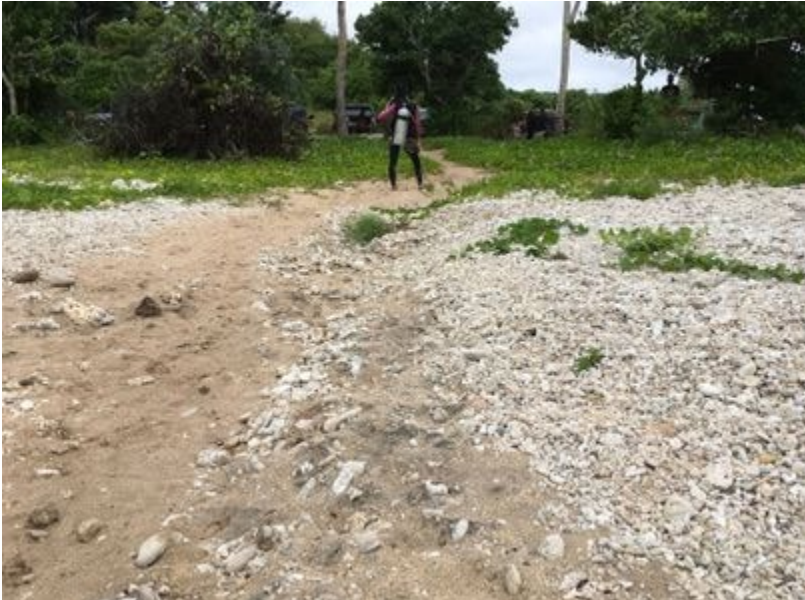
<p>Enforcement Needed: No</p>	
<p>Severity Rating: 4</p>	
<p>Implementation Priority: Love it! (High)</p>	
<p>Descriptions of Existing Conditions: Parking lot runoff eroding shoreline along pedestrian path.</p>	
<p>Description of Proposed Opportunity: Parking lot reorganization. Control drainage. Stabilization and reorganization of circulation. Stabilize path.</p>	
<p>Challenges/Constraints: Heavy use, hard to change user habits.</p>	
<p>Additional Notes: See previous dive site concept and new sketch.</p>	
<p>Site Photo</p>

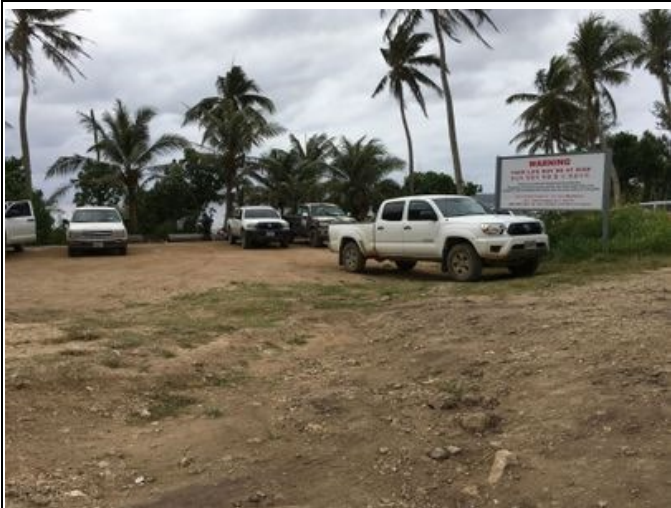
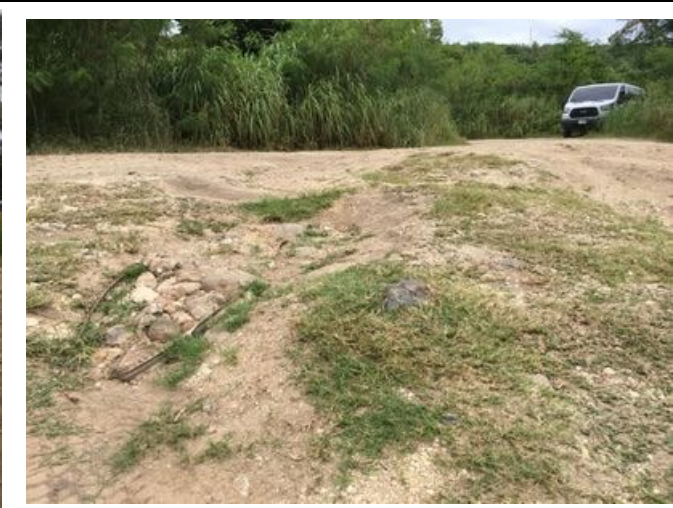
<p>Site ID: LL108</p>	<p>Watershed: Laolao</p>
<p>Crew: EH</p>	<p>Date/Time: 01/21/2020 9:22 PM</p>
<p>Project Type:</p> <ul style="list-style-type: none"> • Drainage Infrastr., Maint. & Repair • Stormwater Retrofit • Unpaved Road Stabilization • Shoreline Stabilization

<p>Enforcement Needed: No</p>	
<p>Severity Rating: 3</p>	
<p>Implementation Priority: Love it! (High)</p>	
<p>Descriptions of Existing Conditions: Runoff from Laolao Bay Rd eroding entrance to parking area and shoreline. Uncontrolled runoff.</p>	
<p>Description of Proposed Opportunity: Intercept runoff before entering dive site. Water bars with stormwater infiltration. Improve drainage along the road.</p>	
<p>Challenges/Constraints: Amount and velocity of runoff. Soils and infiltration capacity may be limited?</p>	
<p>Additional Notes:</p>	
<p>Site Photo</p>

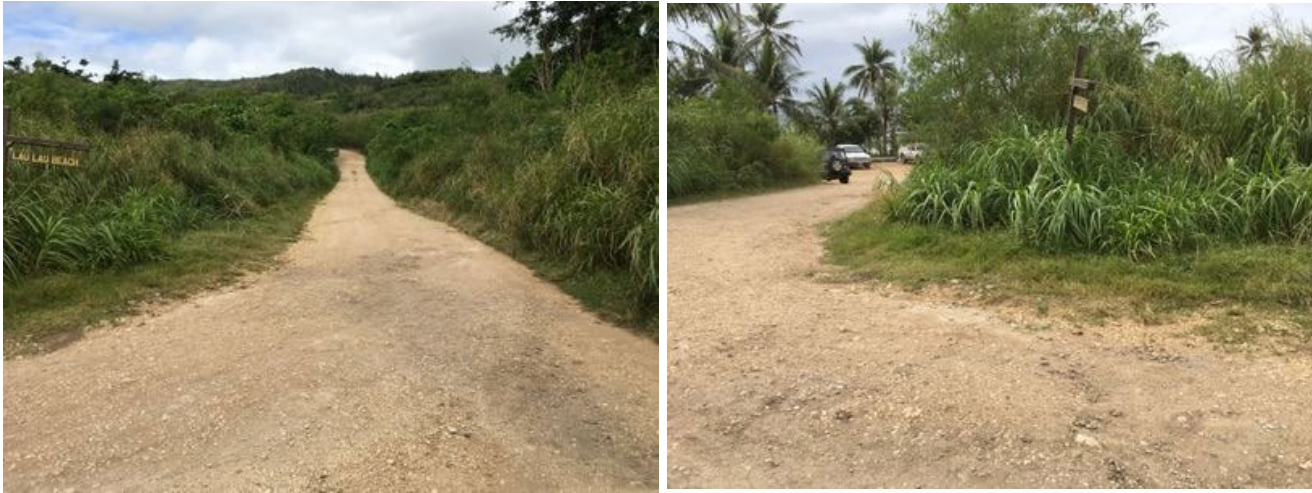
<p>Site ID: LL109</p>	<p>Watershed: Laolao</p>
<p>Crew: EH</p>	<p>Date/Time: 01/21/2020 9:35 PM</p>
<p>Project Type:</p> <ul style="list-style-type: none"> • Stormwater Retrofit • Unpaved Road Stabilization

<p>Enforcement Needed: No</p>	
<p>Severity Rating: 3</p>	
<p>Implementation Priority: Love it! (High)</p>	
<p>Descriptions of Existing Conditions: Entrance to parking. See LL108.</p>	
<p>Description of Proposed Opportunity: See LL108.</p>	
<p>Challenges/Constraints:</p>	
<p>Additional Notes:</p>	
<p>Site Photo</p>

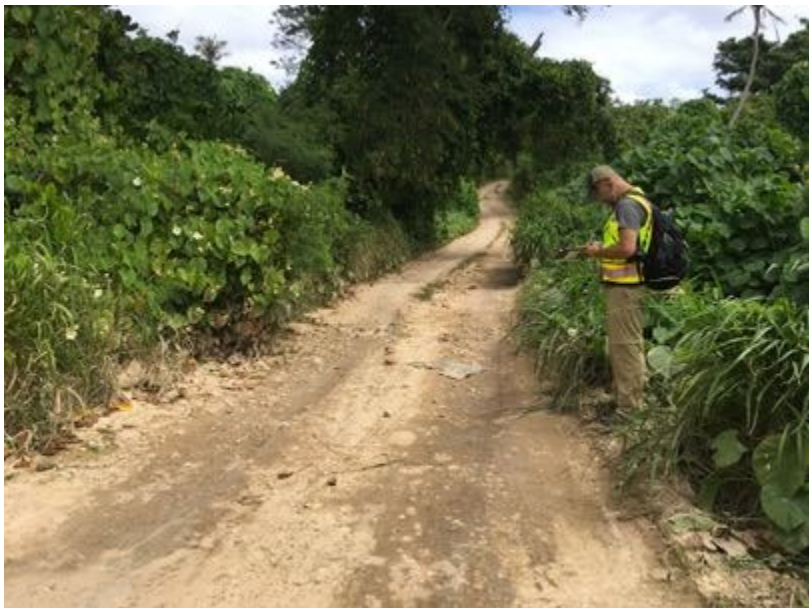
<p>Enforcement Needed: No</p>	
<p>Severity Rating: 4</p>	
<p>Implementation Priority: Love it! (High)</p>	
<p>Descriptions of Existing Conditions: Culvert at road concentrates flow into narrow channel. Road grading is rough mounds and dips.</p>	
<p>Description of Proposed Opportunity: Replace and widen culvert (convert to a large box culvert). Construct broad dip or other diversion at low point to direct road runoff into ditch.</p>	
<p>Challenges/Constraints: Road traffic and frequency of use. Subsurface material? Depth of culvert (very deep from road surface).</p>	
<p>Additional Notes:</p>	
<p>Site Photo</p>

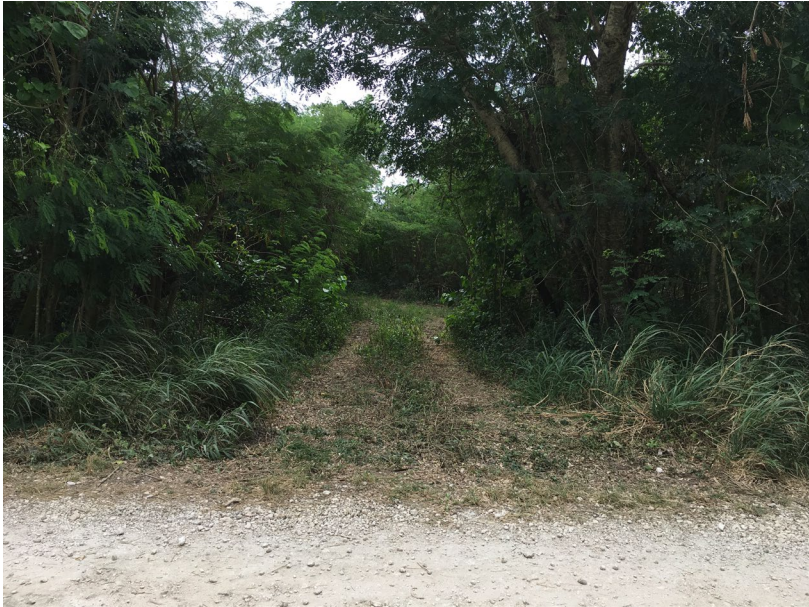
<p>Site ID: LL117</p>	<p>Watershed: Laolao</p>
<p>Crew: EH</p>	<p>Date/Time: 01/21/2020 10:21 PM</p>
<p>Project Type:</p>

<p>Enforcement Needed: No</p>	
<p>Severity Rating: 1</p>	
<p>Implementation Priority: Not that important (Low)</p>	
<p>Descriptions of Existing Conditions: Grass track, possibly to homestead or lookout?</p>	
<p>Description of Proposed Opportunity: Monitor for possible issues.</p>	
<p>Challenges/Constraints:</p>	
<p>Additional Notes:</p>	
<p>Site Photo</p>

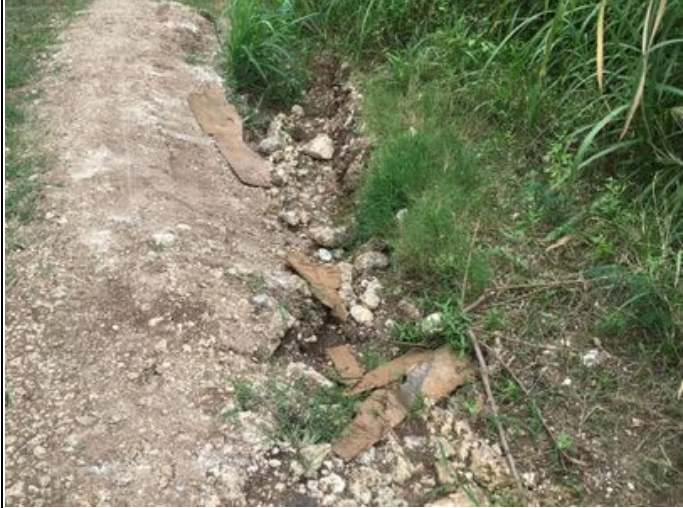
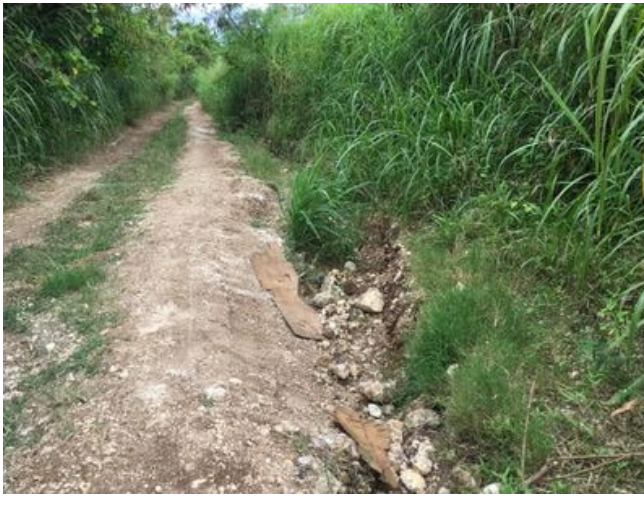
<p>Enforcement Needed: No</p>	
<p>Severity Rating: 5 (Severe)</p>	
<p>Implementation Priority: Love it! (High)</p>	
<p>Descriptions of Existing Conditions: Washout and erosion along Gap Gap Road. See previous conceptual plans</p>	
<p>Description of Proposed Opportunity: See previous plans. Proposed improvements to drainage were confirmed and remain valid.</p>	
<p>Challenges/Constraints: Very steep road, accessibility and long-term maintenance.</p>	
<p>Additional Notes:</p>	
<p>Site Photo</p>	
<div style="display: flex; justify-content: space-around;">

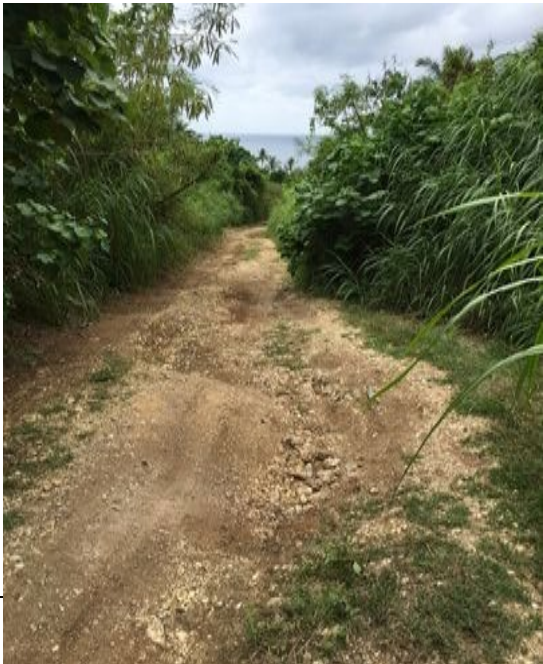
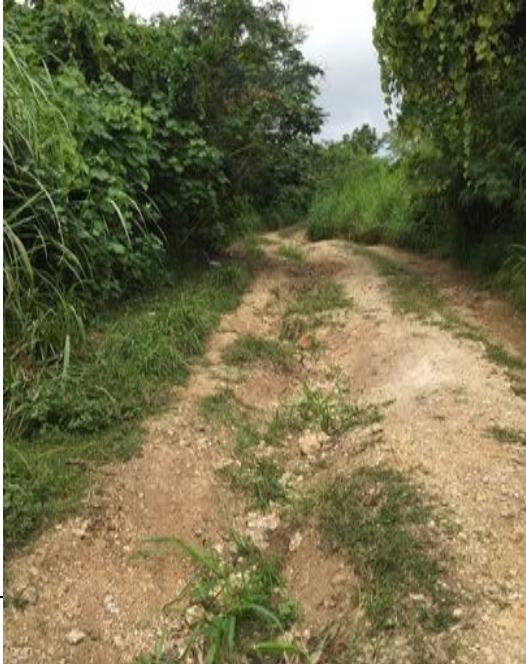
<p>Enforcement Needed: No</p>	
<p>Severity Rating: 5 (Severe)</p>	
<p>Implementation Priority: Love it! (High)</p>	
<p>Descriptions of Existing Conditions: Washout and erosion along Gap Gap Road. See previous conceptual plans</p>	
<p>Description of Proposed Opportunity: See previous plans. Proposed improvements to drainage were confirmed and remain valid.</p>	
<p>Challenges/Constraints: Very steep road, accessibility and long-term maintenance.</p>	
<p>Additional Notes:</p>	
<p>Site Photo</p>

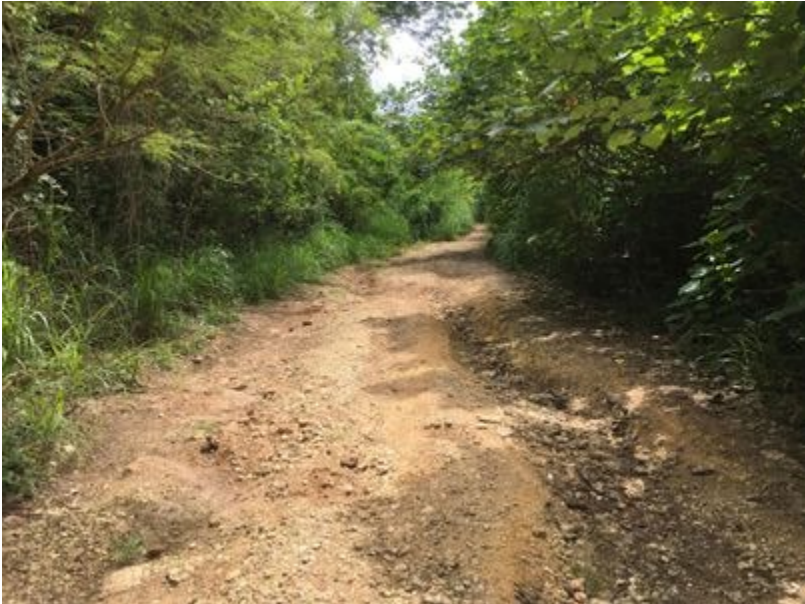
<p>Enforcement Needed: No</p>	
<p>Severity Rating: 5 (Severe)</p>	
<p>Implementation Priority: Love it! (High)</p>	
<p>Descriptions of Existing Conditions: Washout and erosion along Gap Gap Road. See previous conceptual plans</p>	
<p>Description of Proposed Opportunity: See previous plans. Proposed improvements to drainage were confirmed and remain valid.</p>	
<p>Challenges/Constraints: Very steep road, accessibility and long-term maintenance.</p>	
<p>Additional Notes:</p>	
<p>Site Photo</p>

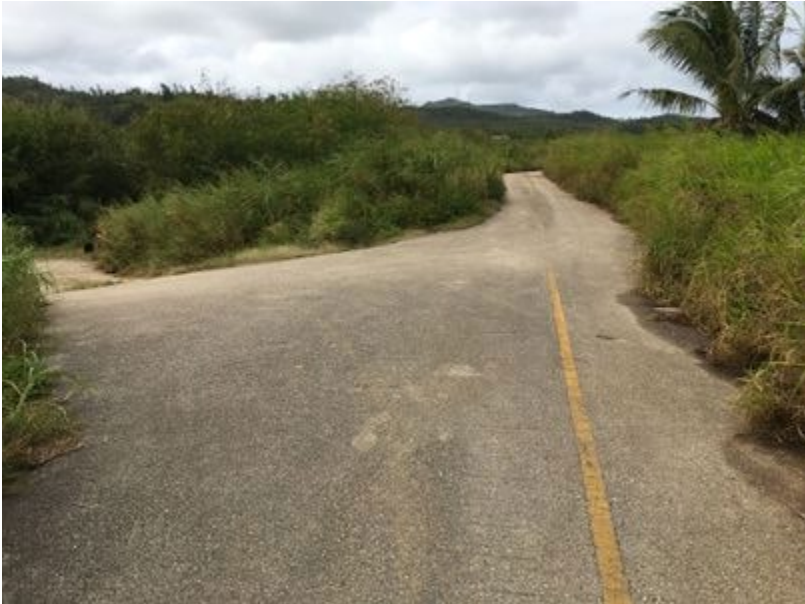
<p>Site ID: LL127</p>	<p>Watershed: Laolao</p>
<p>Crew: BK</p>	<p>Date/Time: 01/21/2020 11:25 PM</p>
<p>Project Type:</p> <ul style="list-style-type: none"> • Drainage Infrastr., Maint. & Repair • Unpaved Road Stabilization

<p>Enforcement Needed: No</p>	
<p>Severity Rating: 4</p>	
<p>Implementation Priority: Love it! (High)</p>	
<p>Descriptions of Existing Conditions: Swales on both side of paved road are filled with vegetation and runoff cannot get into swales. Runoff remains on paved surface and drains down Gap Gap Road.</p>	
<p>Description of Proposed Opportunity: Clean and cut back vegetation & reestablish/clean road swales. Construct broad dip or waterbar (speed bump) at top of Gap Gap Road to keep runoff on pavement/off Gap Gap. Possibly use bioretention, but may</p>	
<p>Challenges/Constraints: Swale maintenance. Has been difficult to get anything implemented at this site, which has been identified several times. Bioretention would have slope/grading changes.</p>

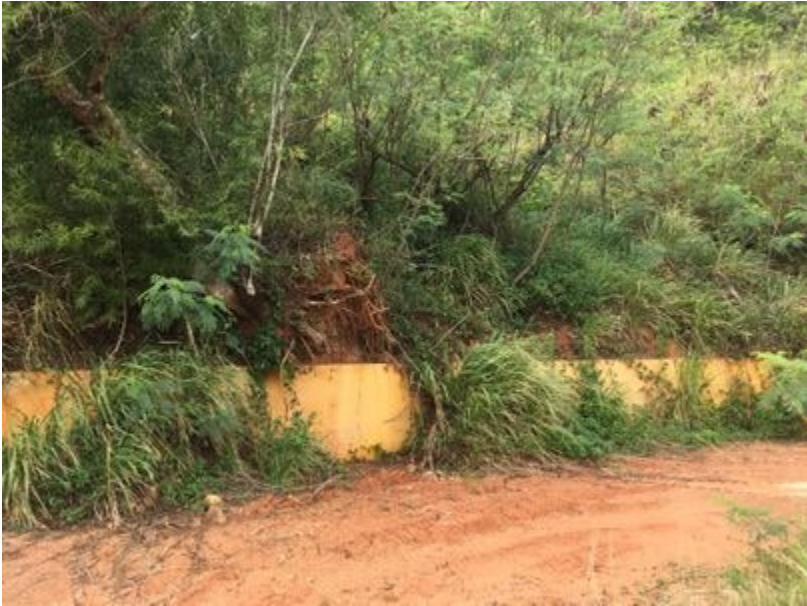
<p>Enforcement Needed: Yes</p>	
<p>Severity Rating: 5 (Severe)</p>	
<p>Implementation Priority: It's OK (Med)</p>	
<p>Descriptions of Existing Conditions: Tree blown down over retaining wall with root destabilization. Excessively steep slope above retaining wall (which appears too short). Bare dirt/mudslide on steep slope. Sediment source to parking lot/rain garden and</p>	
<p>Description of Proposed Opportunity: Clean up sediment and slope. Extend wall and stabilize slope.</p>	
<p>Challenges/Constraints: Very steep slopes. Detention center may be abandoned so may only be feasible if detention center is in use.</p>	
<p>Additional Notes:</p>	
<p>Site Photo</p>

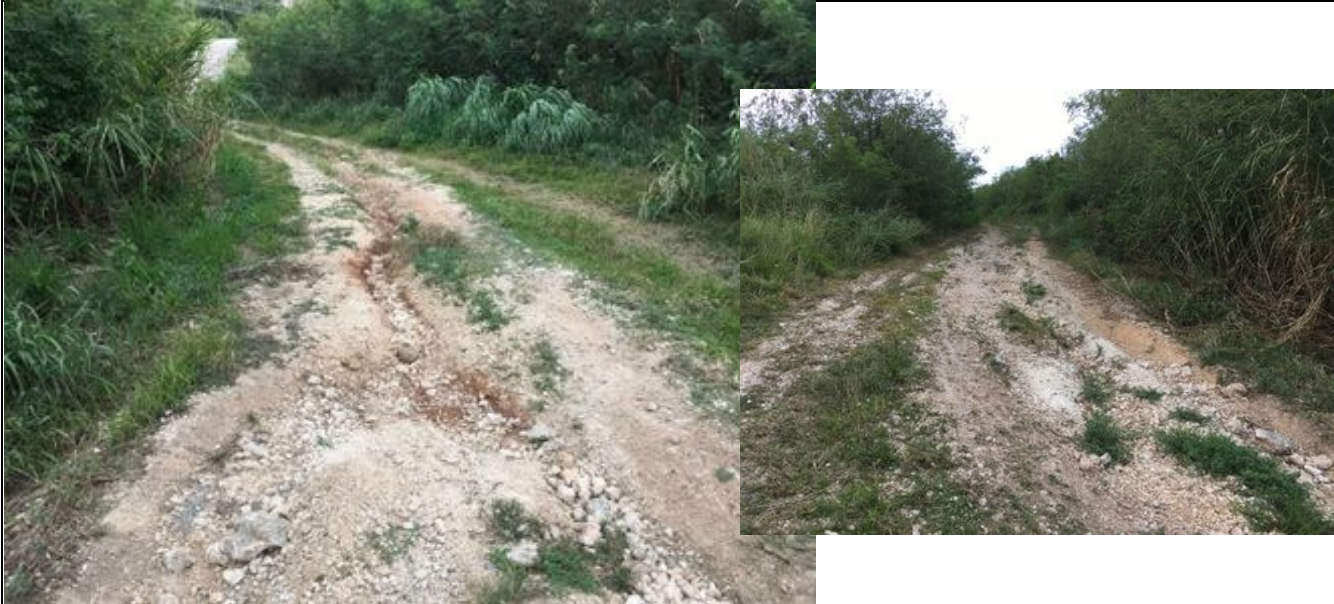
<p>Site ID: LL133</p>	<p>Watershed: Laolao</p>
<p>Crew: EH</p>	<p>Date/Time: 01/22/2020 12:00 AM</p>
<p>Project Type:</p> <ul style="list-style-type: none"> Unpaved Road Stabilization

<p>Enforcement Needed: Yes</p>	
<p>Severity Rating: 4</p>	
<p>Implementation Priority: Not that important (Low)</p>	
<p>Descriptions of Existing Conditions: Eroded dirt road to water tank at top of watershed.</p>	
<p>Description of Proposed Opportunity: Stabilize and remove sediment source. Apply dirt road strategies, such as dips and water bars to shed runoff. Regrade & stabilize.</p>	
<p>Challenges/Constraints: Steep slopes.</p>	
<p>Additional Notes:</p>	
<p>Site Photo</p>

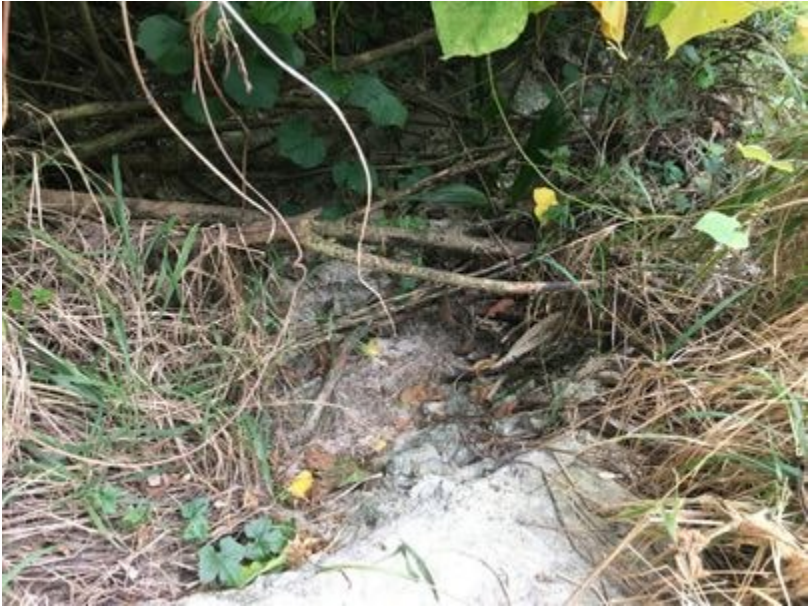
<p>Enforcement Needed: No</p>	
<p>Severity Rating: 3</p>	
<p>Implementation Priority: It's OK (Med)</p>	
<p>Descriptions of Existing Conditions: Broad dip with swales (formalized downstream)</p>	
<p>Description of Proposed Opportunity: Clean swale, regrade road. Add second broad dip uphill.</p>	
<p>Challenges/Constraints: Steel slope, erosion at edge of conc. Ongoing maintenance and erosion at interface of concrete and dirt road.</p>	
<p>Additional Notes: Appears to be functional.</p>	
<p>Site Photo</p>

<p>Site Overview Caption: Clean.</p>

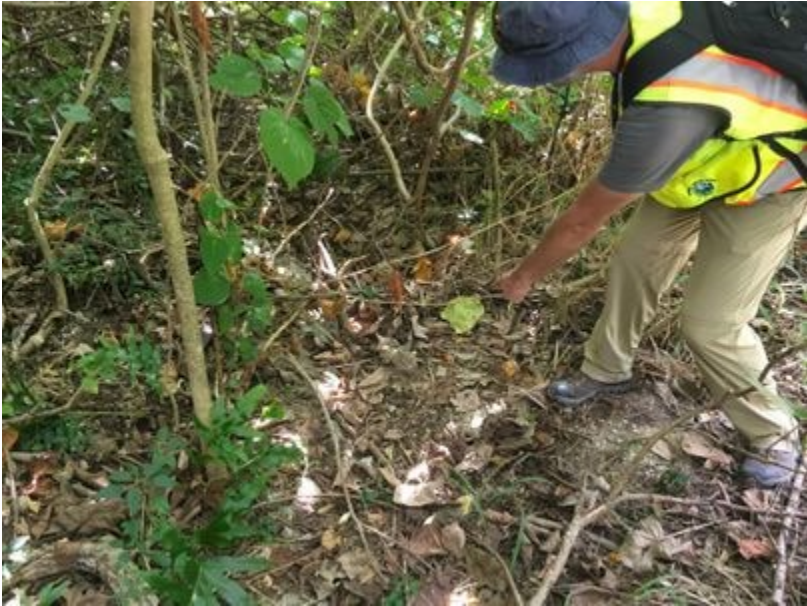
<p>Site ID: LL136</p>	<p>Watershed: Laolao</p>
<p>Crew: EH</p>	<p>Date/Time: 01/22/2020 12:51 AM</p>
<p>Project Type:</p> <ul style="list-style-type: none"> • Drainage Infrastr., Maint. & Repair • Unpaved Road Stabilization

<p>Enforcement Needed: Yes</p>	
<p>Severity Rating: 5 (Severe)</p>	
<p>Implementation Priority: Love it! (High)</p>	
<p>Descriptions of Existing Conditions: Clogged formalized swale. See LL135.</p>	
<p>Description of Proposed Opportunity: Clean and redirect to restore flow.</p>	
<p>Challenges/Constraints: Maintenance.</p>	
<p>Additional Notes:</p>	
<p>Site Photo</p>

<p>Site Overview Caption: Formalized channel to right. Current flow to left.</p>

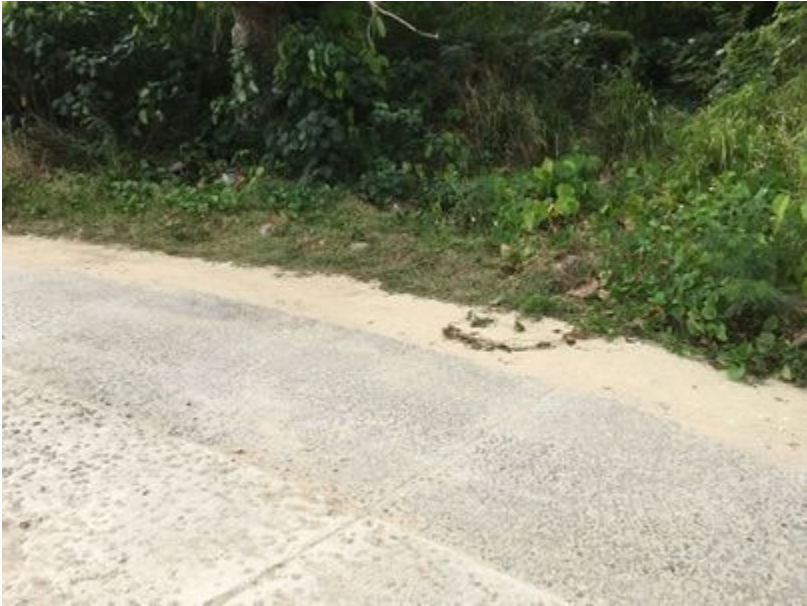
<p>Enforcement Needed: Yes</p>	
<p>Severity Rating: 5 (Severe)</p>	
<p>Implementation Priority: Love it! (High)</p>	
<p>Descriptions of Existing Conditions: Lots of sediment on broad dip and in swales.</p>	
<p>Description of Proposed Opportunity: Clean! Remove vegetation at outlet.</p>	
<p>Challenges/Constraints: Maintenance.</p>	
<p>Additional Notes:</p>	
<p>Site Photo</p>

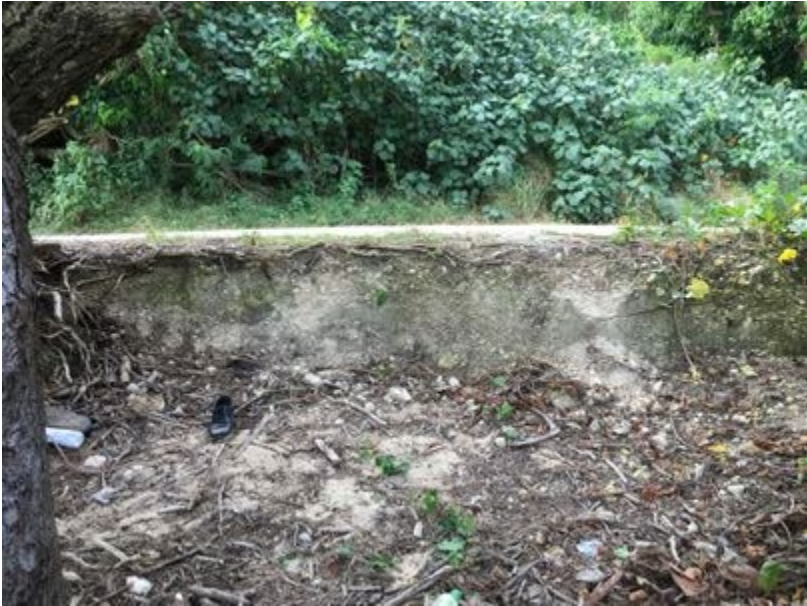
<p>Enforcement Needed: No</p>	
<p>Severity Rating: 4</p>	
<p>Implementation Priority: It's OK (Med)</p>	
<p>Descriptions of Existing Conditions: Seaward edge of road. 3' drop at start. Guess low energy. Rocky sand. Trees present. (with LL143)</p>	
<p>Description of Proposed Opportunity: Start living shoreline. Use gabion walls or green walls.</p>	
<p>Challenges/Constraints: Road abuts top of shoreline, so limited space. High traffic, exposure to future storms.</p>	
<p>Additional Notes:</p>	
<p>Site Photo</p>

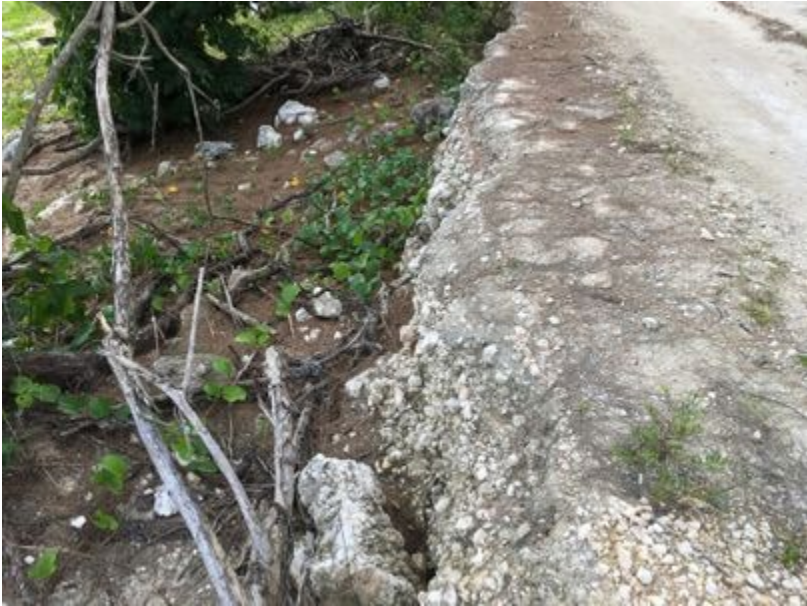
<p>Enforcement Needed: No</p>	
<p>Severity Rating: 4</p>	
<p>Implementation Priority: It's OK (Med)</p>	
<p>Descriptions of Existing Conditions: Start shoreline restoration. (with LL146)</p>	
<p>Description of Proposed Opportunity: Living shoreline (see notes for LL139/LL143/LL144)</p>	
<p>Challenges/Constraints:</p>	
<p>Additional Notes:</p>	
<p>Site Photo</p>

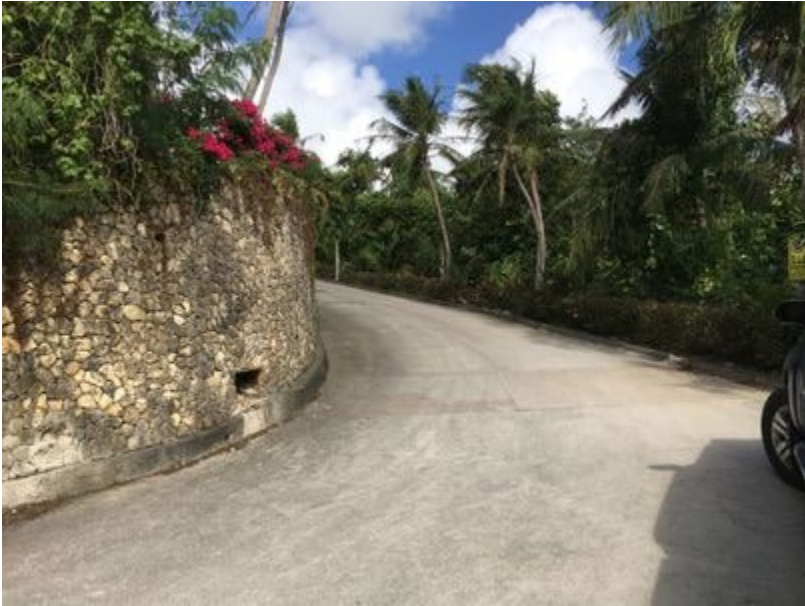
<p>Enforcement Needed: No</p>	
<p>Severity Rating: 4</p>	
<p>Implementation Priority: It's OK (Med)</p>	
<p>Descriptions of Existing Conditions: Paved road runoff flows to informal discharge point.</p>	
<p>Description of Proposed Opportunity: Formalize drainage/control outfall.</p>	
<p>Challenges/Constraints: Very steep, not much room.</p>	
<p>Additional Notes:</p>	
<p>Site Photo</p>

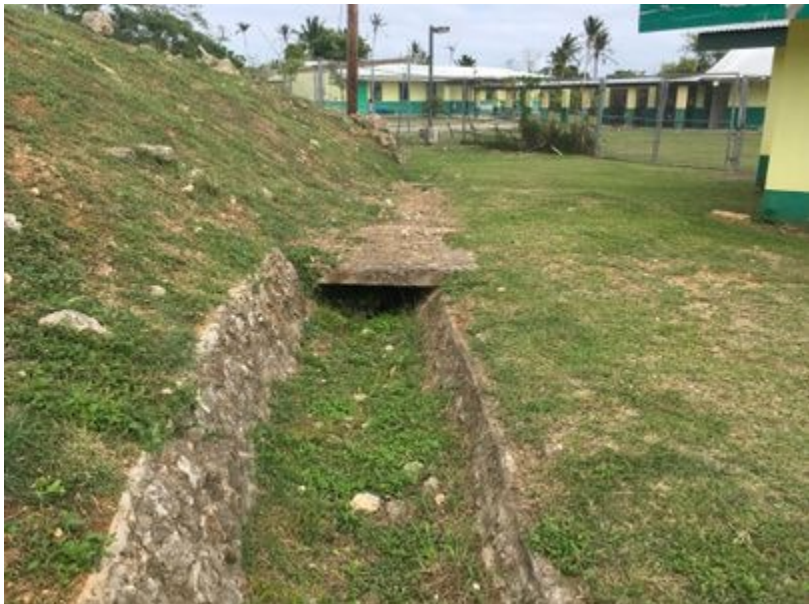
<p>Enforcement Needed: No</p>	
<p>Severity Rating: 2</p>	
<p>Implementation Priority: Not that important (Low)</p>	
<p>Descriptions of Existing Conditions: channel with 2:1 slope. Munch says grass erodes and soil slopes wash into swale.</p>	
<p>Description of Proposed Opportunity: ERSC blanket or drought tolerant vegetation. Gabion basket!</p>	
<p>Challenges/Constraints: Flex MSE wall? stone gabions? ground cover with ERSC blanket?</p>	
<p>Additional Notes:</p>	
<p>Site Photo</p>
