**GREAT POND and GREAT POND BAY  
AREA OF PARTICULAR CONCERN  
(APC)**

**AREA OF PRESERVATION AND RESTORATION  
(APR)**

***A COMPREHENSIVE ANALYTIC STUDY***

**V.I. DEPARTMENT OF PLANNING AND NATURAL RESOURCES  
*Coastal Zone Management Program***

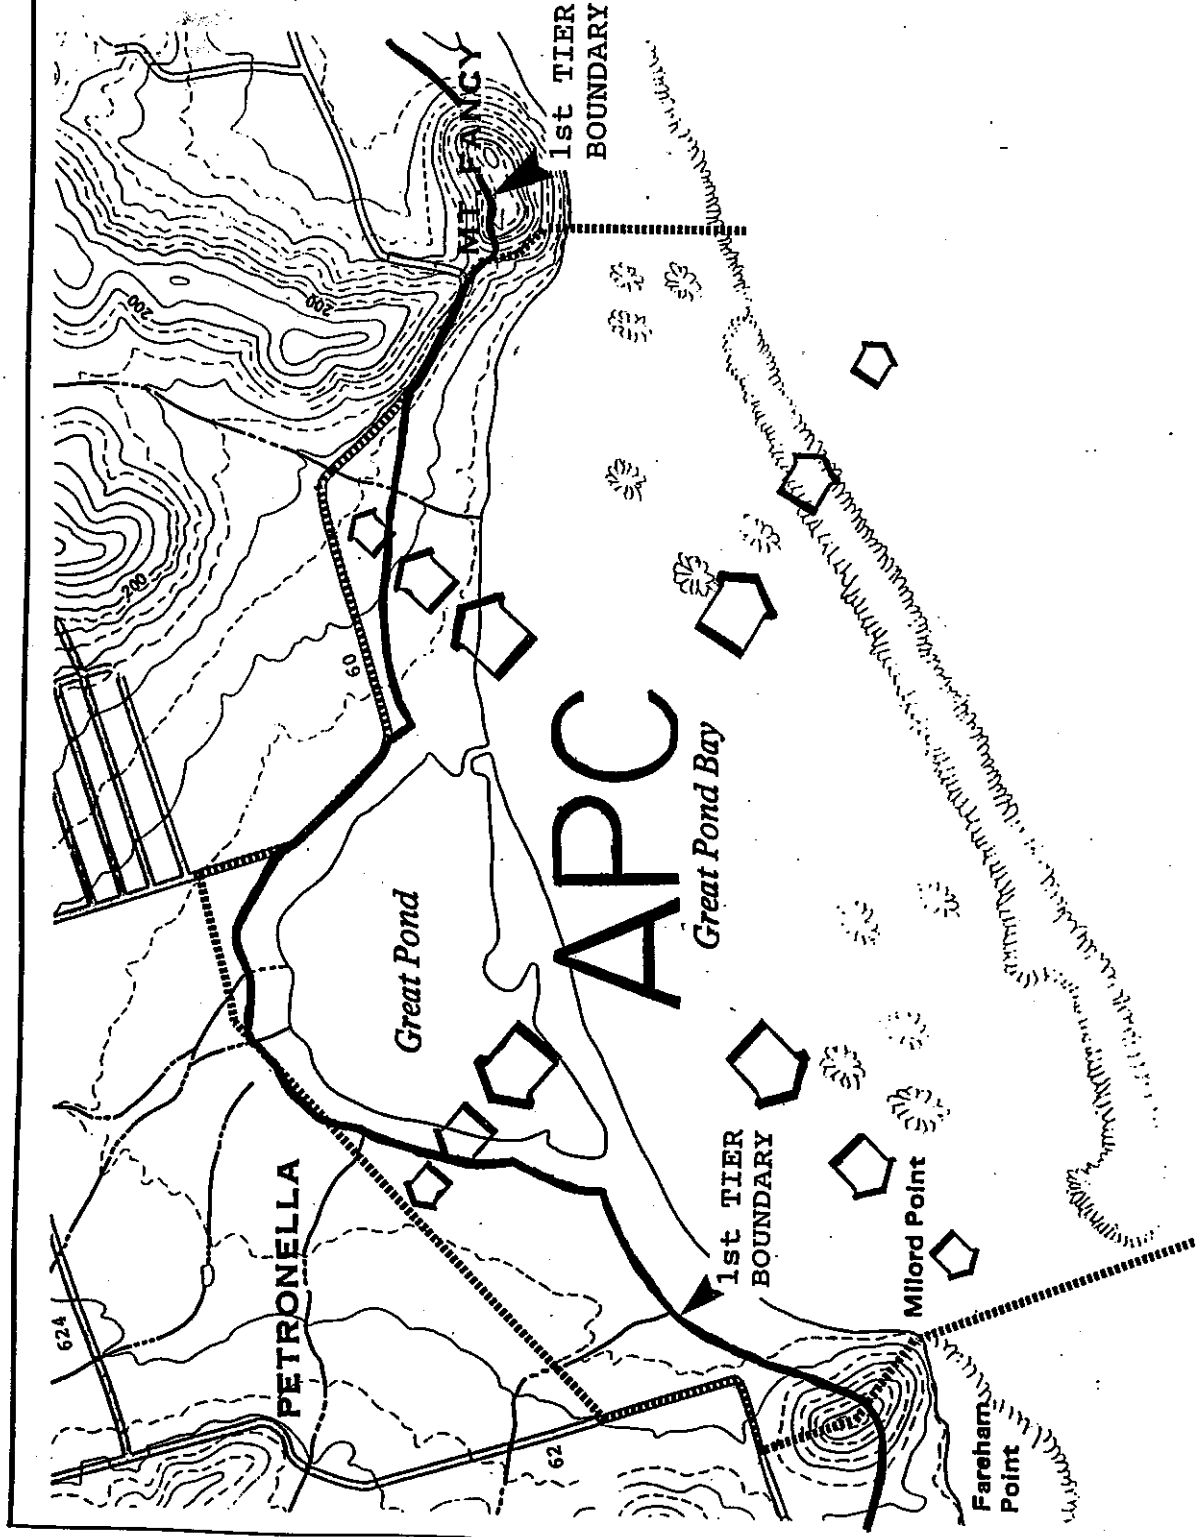
Figure 2  
APC/APR Boundary Map  
Adapted from: EC&E/CH2M Hill, 1979  
Island Resources Foundation, 1992

APC BOUNDARY  
1st TIER BOUNDARY

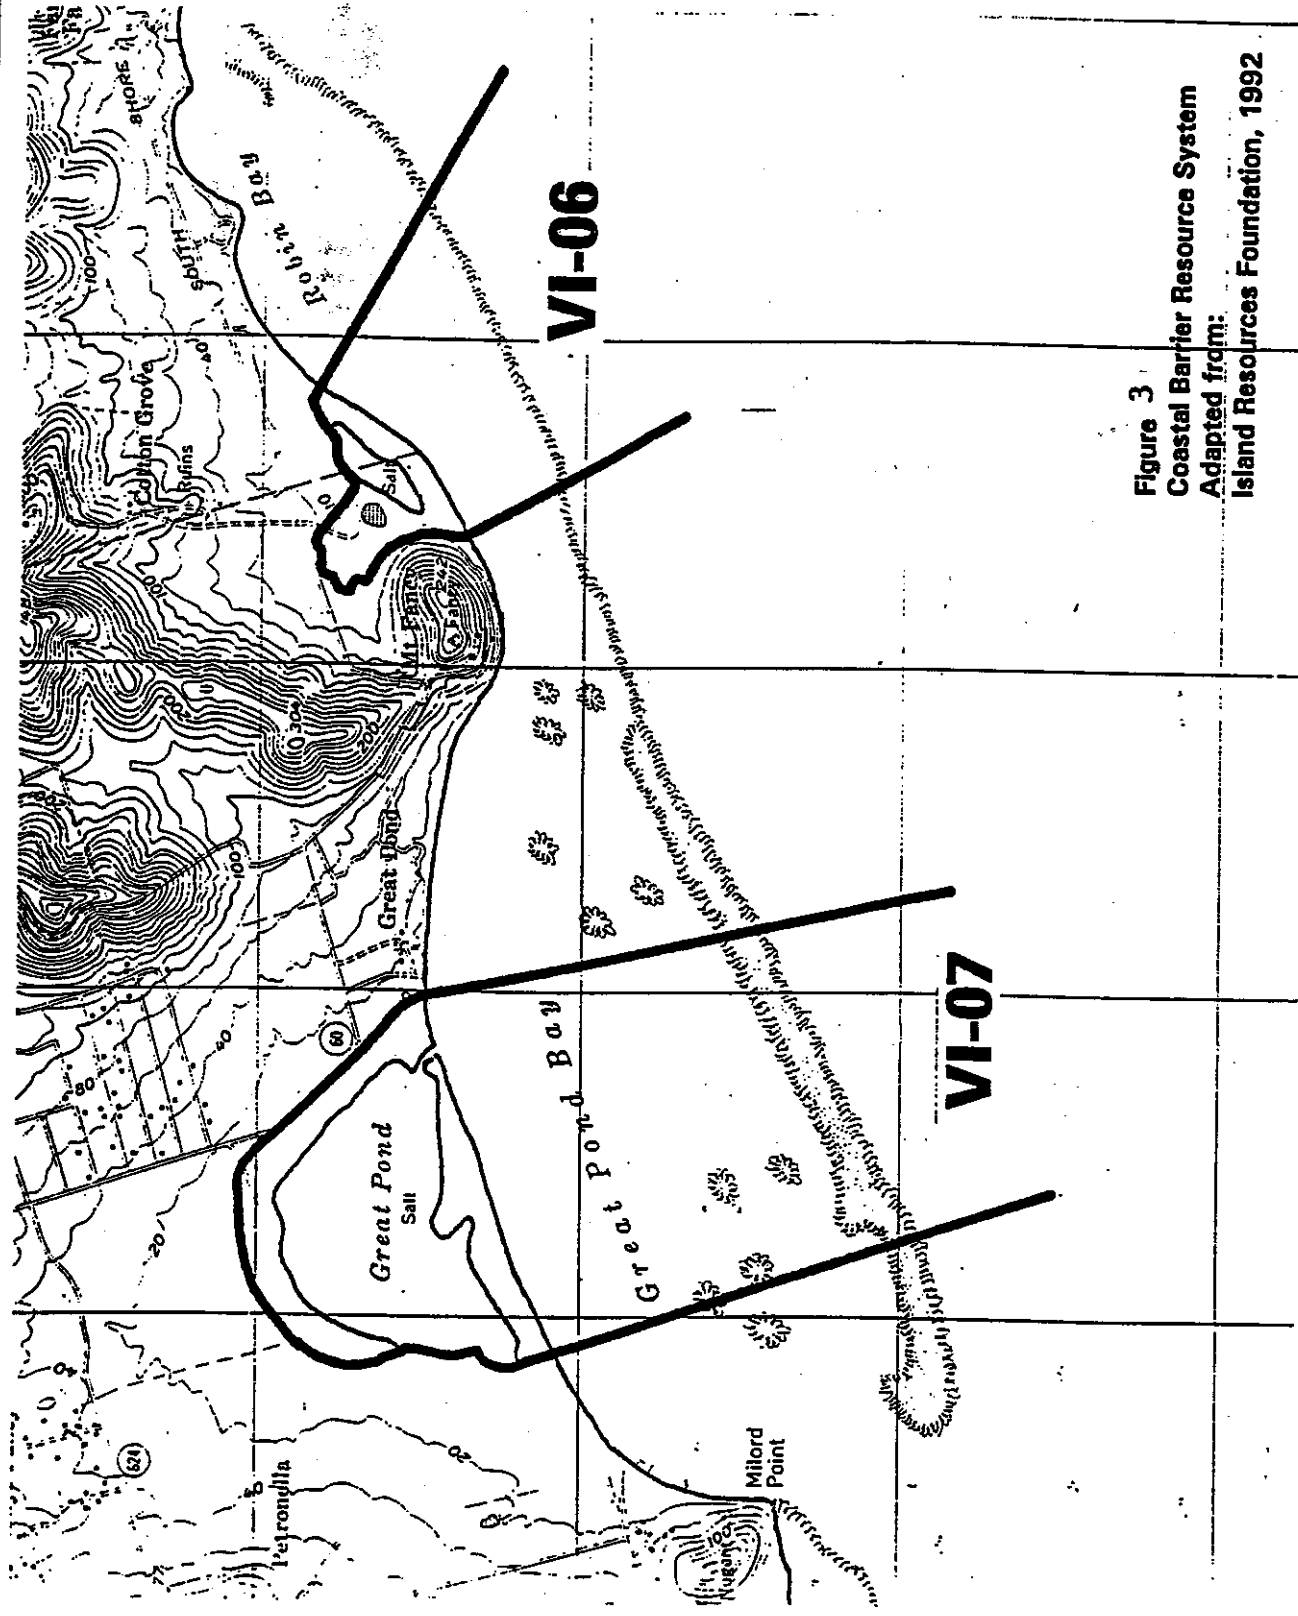
Figure 3  
Coastal Barrier Resource System  
Adapted from:  
Island Resources Foundation, 1992

Great Salt Pond has been included within the Coastal Barrier Resources System (CBRS), designated as site number VI-07 (Figure 3). This program was established to protect the natural coastal barriers remaining within the USA and its territories. CBRS designation will help protect some of the Great Pond and Bay wetlands from development in other than park-like projects.

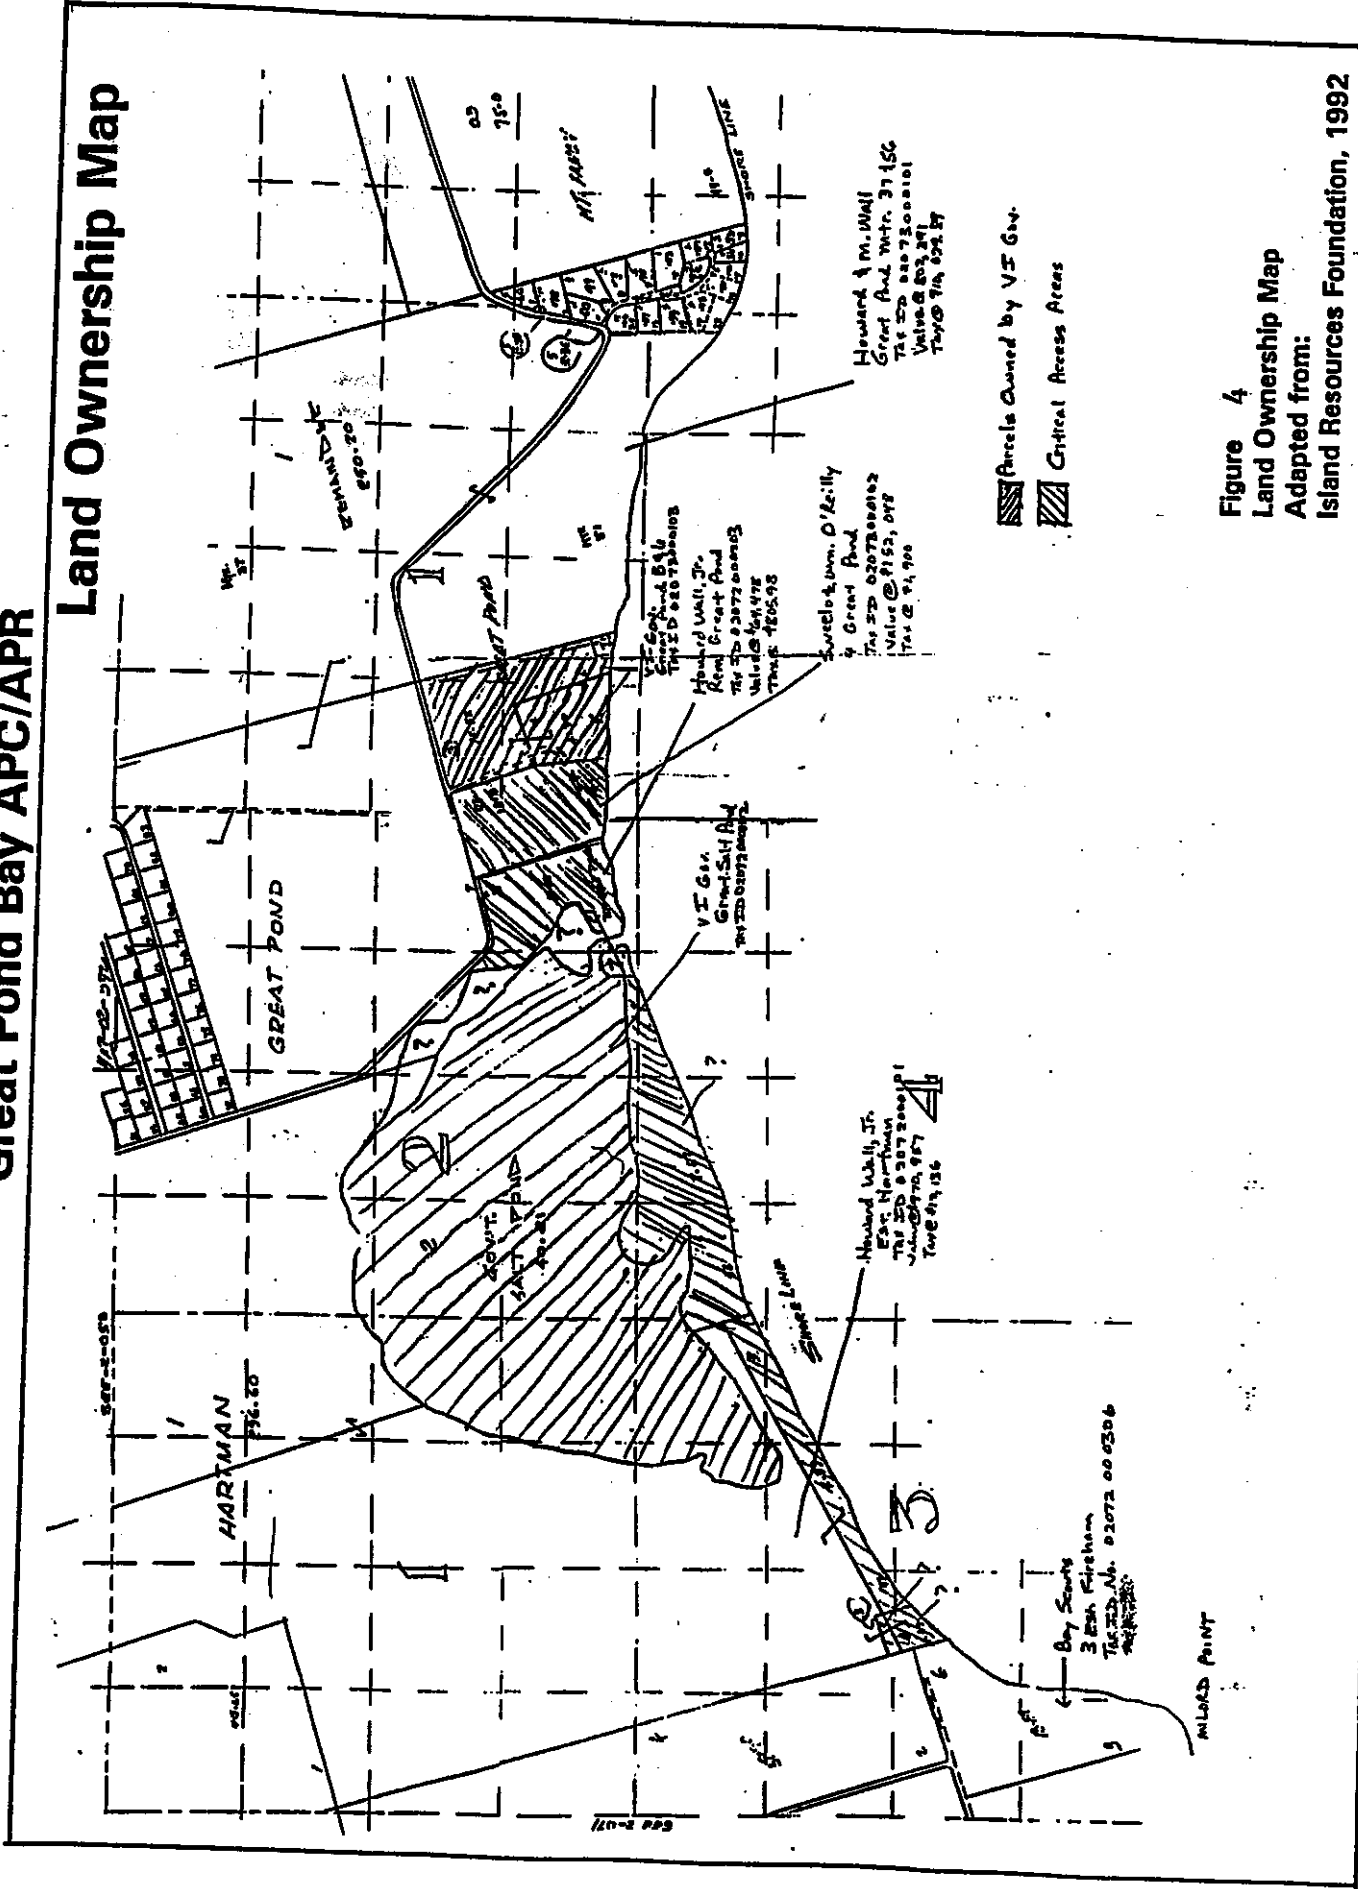
**Figure 4**  
**Land Ownership Map**  
**Adapted from:**  
**Island Resources Foundation, 1992**

The land surrounding Great Pond Bay and bounded by highways 62, 624 and 60 is in multiple ownership -- some is owned by the Boy Scouts, other tracts, including the salt pond itself, are in Virgin Islands Government ownership, while the remainder is privately held (Figure 4).

The most desirable land holding situation for the VI Government relative to the Great Pond Bay area would be for the Government to acquire the entire shoreline expanse and those portions of Estates Hartman, Petronella and Great Pond bounded by Routes 62, 624 and 60, which surrounds the pond, adding to Government ownership of the pond itself (Figure 4).

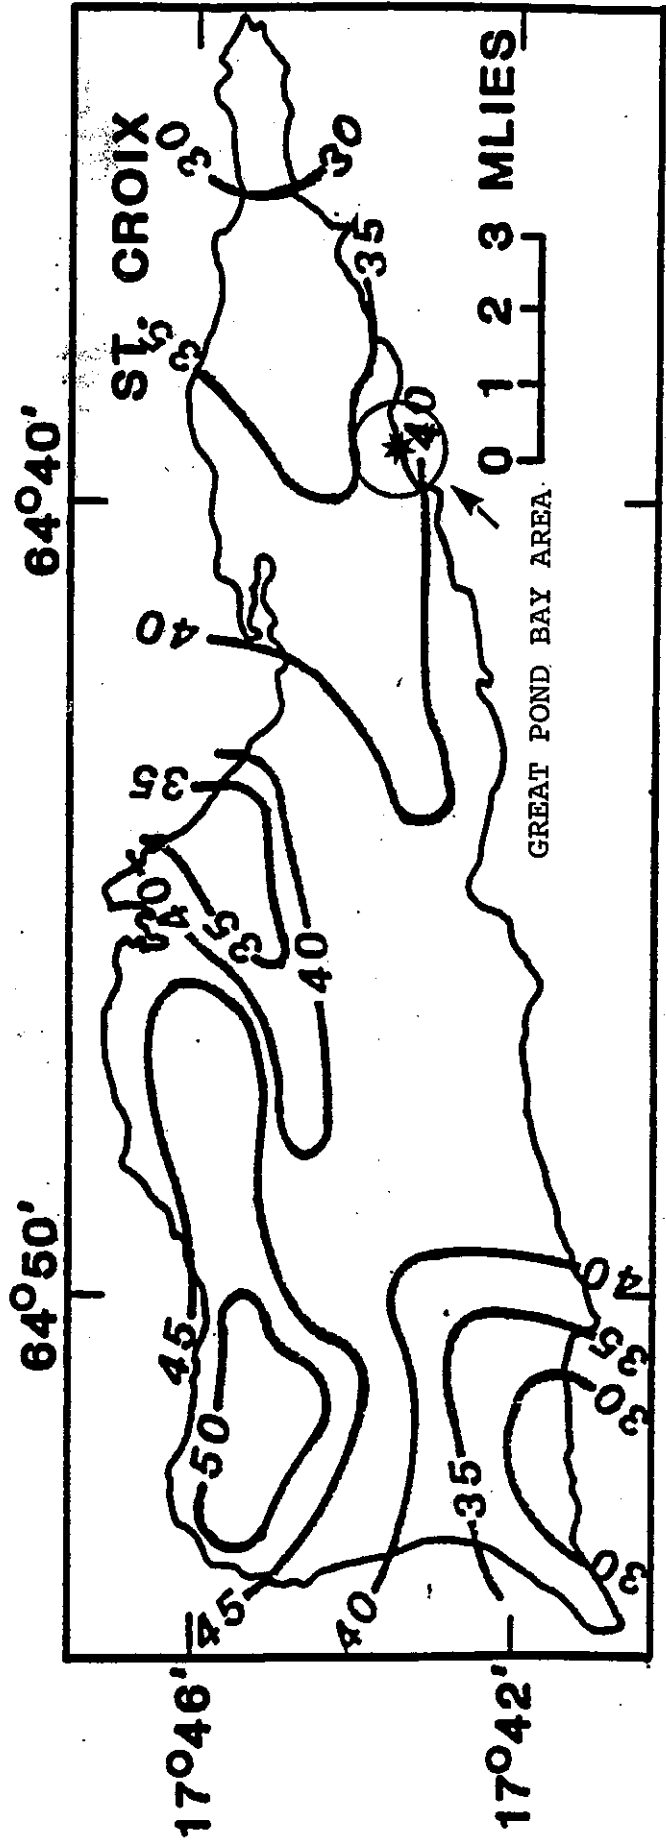
Rain Fall Map

—— 35 —— LINE OF EQUAL RAINFALL IN INCHES

Rainfall in the Virgin Islands generally increases with increasing elevation and exhibits a trend on each island of a dry-to-wet cline from east to west. Average rainfall data, compiled from several years of records at various stations can be misleading in that it probably poorly represents the available precipitation at a particular area in any given year. The U.S. Virgin Islands receive an average of 41 inches of rain per year (Bowden, 1970). The wettest months are September to December; the dry season is February to July (Island Resources Foundation, 1977). The Great Pond Bay area of St. Croix receives an average of about 40 inches of rainfall. The island on the whole receives an average of about 45 inches of rain per year. Most of the rainfall comes in brief showers. Heavy rainfall sometimes occurs during the passage of an easterly flowing tropical wave.

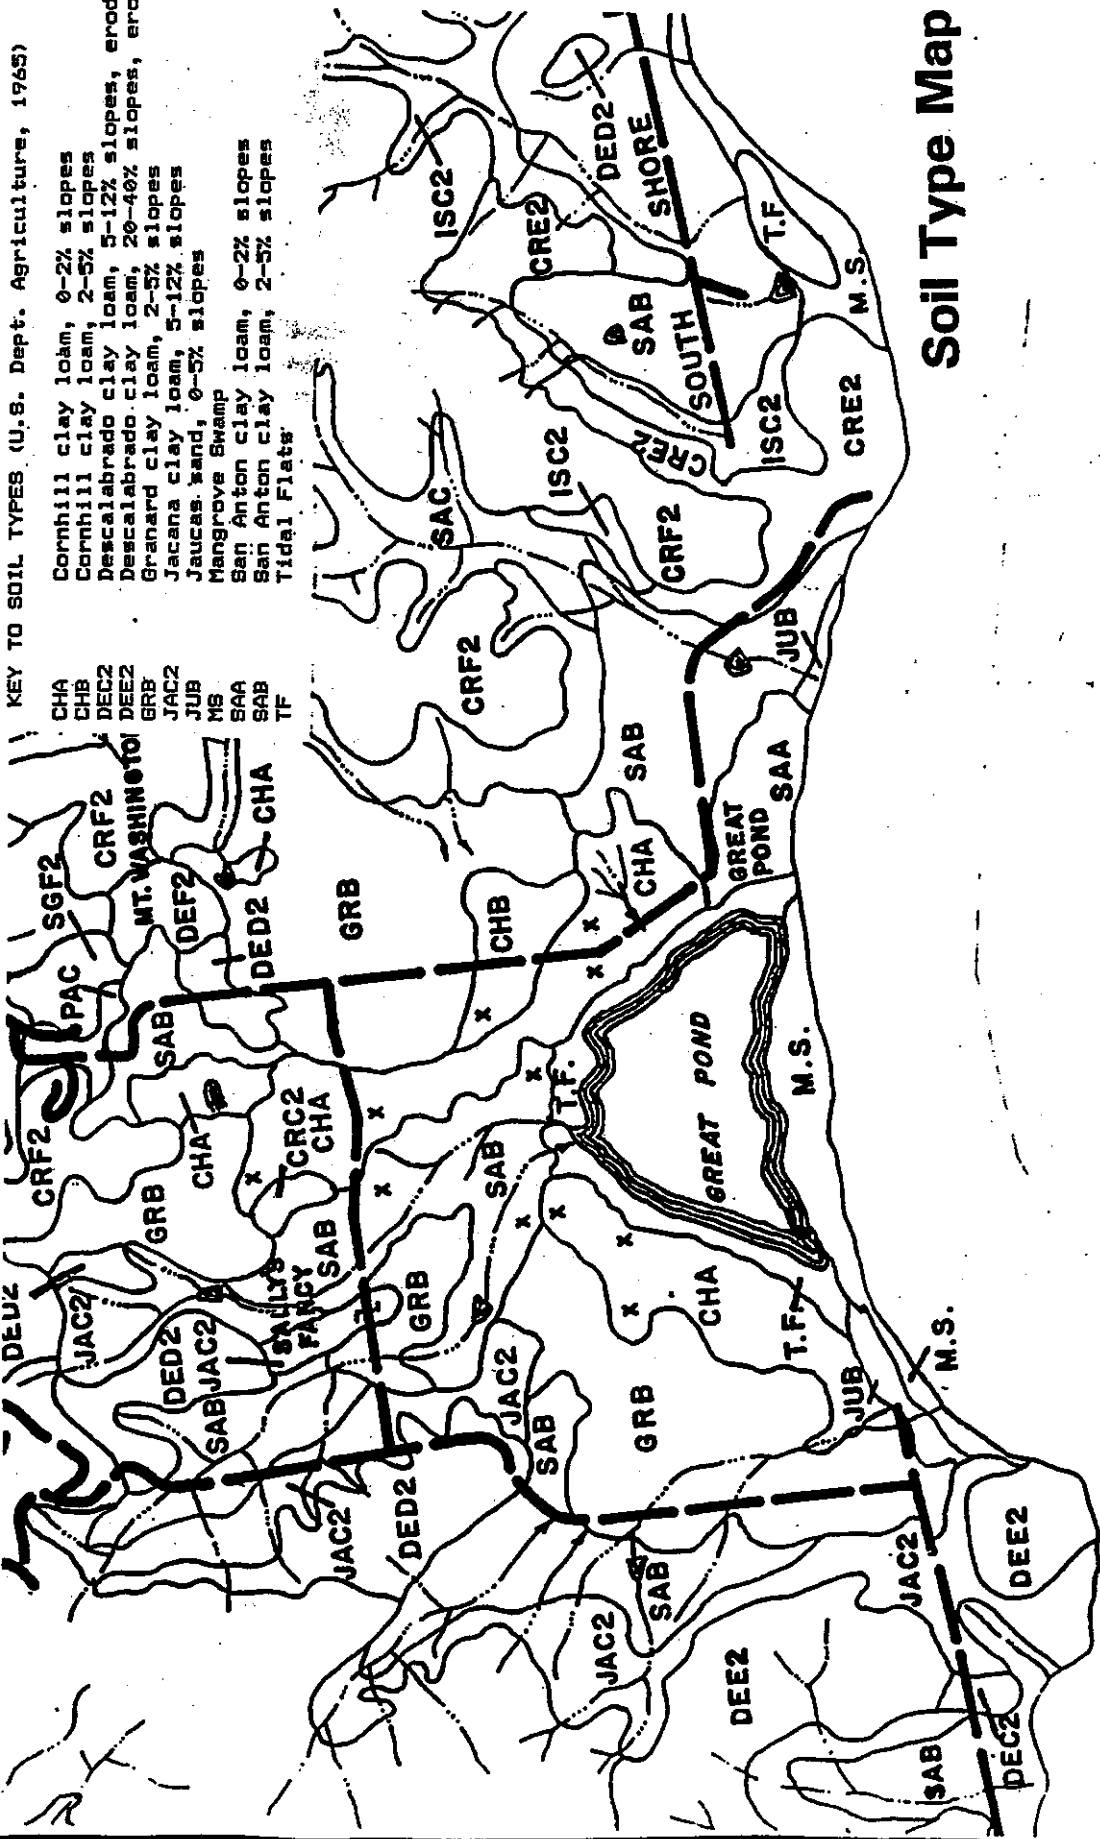
Figure 6  
Soil Type Map  
Adapted from: US Dept of Agriculture, SCS, 1965  
Island Resources Foundation, 1992

- Cornhill clay loam, 0-2% slopes
- Cornhill clay loam, 2-5% slopes
- Descalabrado clay loam, 5-12% slopes, eroded
- Descalabrado clay loam, 20-40% slopes, eroded
- Granard clay loam, 2-5% slopes
- Jacana clay loam, 5-12% slopes
- Jaucas sand, 0-5% slopes
- Mangrove Swamp
- San Anton clay loam, 0-2% slopes
- San Anton clay loam, 2-5% slopes
- Tidal Flats

In soil engineering studies, SaA clay loam shows high compressibility and poor compaction for building foundations and has moderate to severe limitations for septic tank filter fields.

CoA gravelly clay loam has severe limitations for building foundations due to poor stability and very high shrink-swell potential. CoA also has severe limitations for septic tank filter fields due to slow permeability.

CaB clay loam has fair stability for building foundations and slight limitations for septic tank filter fields.

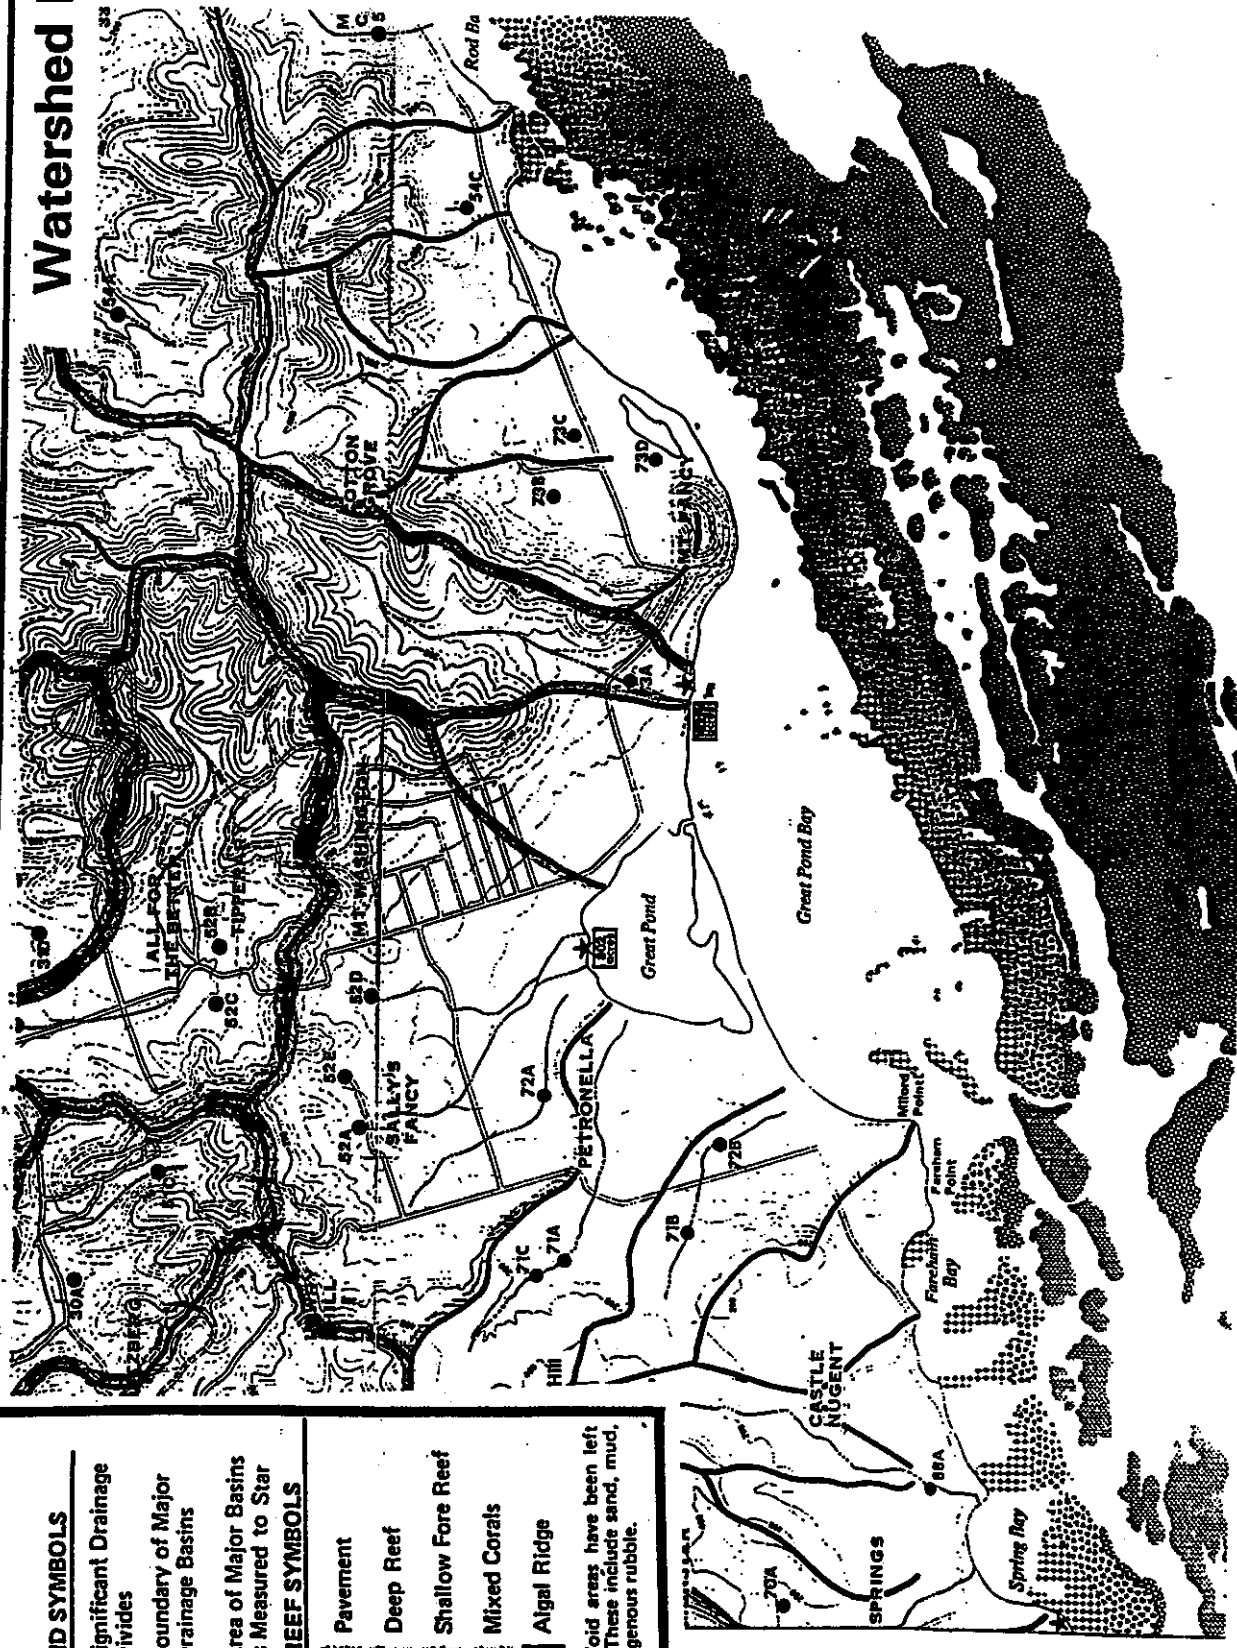
Figure 7  
Watershed Map  
Adapted from: BC&E, 1979  
Island Resources Foundation, 1992

- Significant Drainage Divides
- Boundary of Major Drainage Basins

The Great Pond Bay area receives runoff from a 1165 acre watershed which drains onto a broad alluvial plain. The volume of runoff in storm-flood conditions should be evaluated, and sediment trapping mechanisms used to help reduce the volume of sediment entering Great Pond. Drainage control should be required for any construction project in the area.

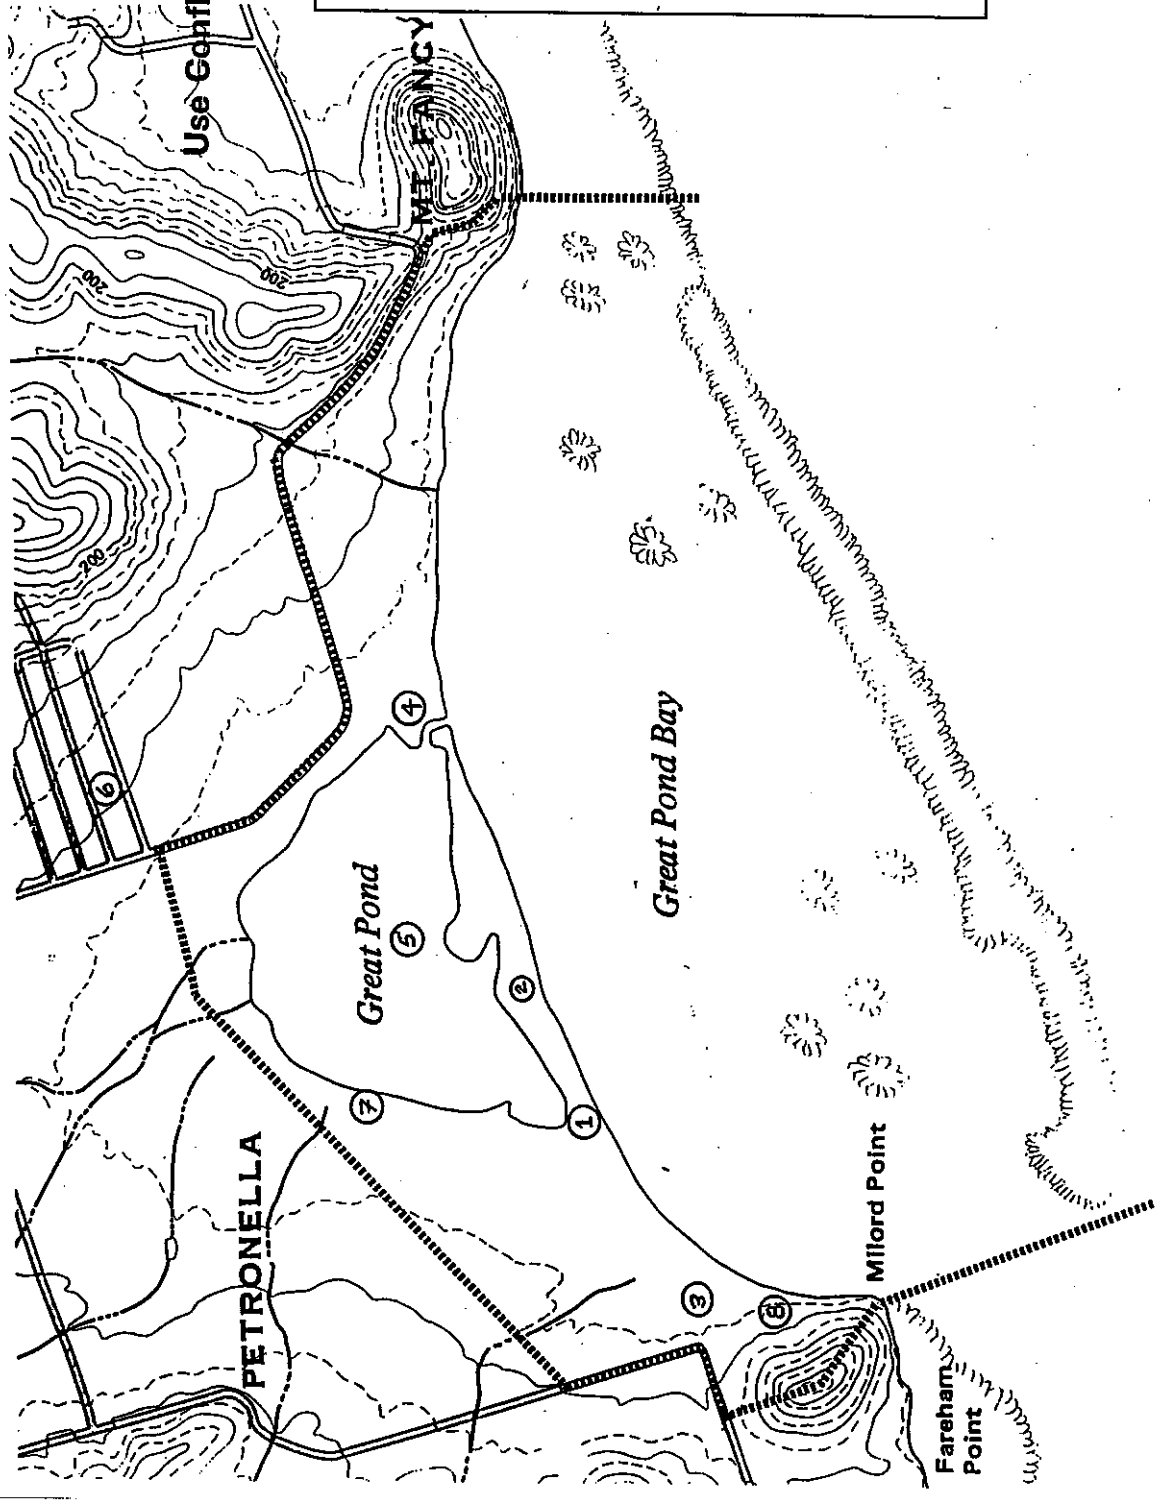
## Use Conflict/Resource Availability Map

1. Use of beach as a boat ramp - Jeeps and boat trailers seen frequently on beach.
2. Several "fish shanties" are set up on the beach berm with road along back of berm, some litter around.

Illegal solid waste dumping in the GPB area is a continuing problem (Figure 10, #4). Derelict vehicles dumped at the site are a potential source of groundwater and soil contamination from leaking crankcase and other lubricating oils, brake fluids, and heavy metals. Of particular concern is the potential for lead contamination from lead-acid car batteries.

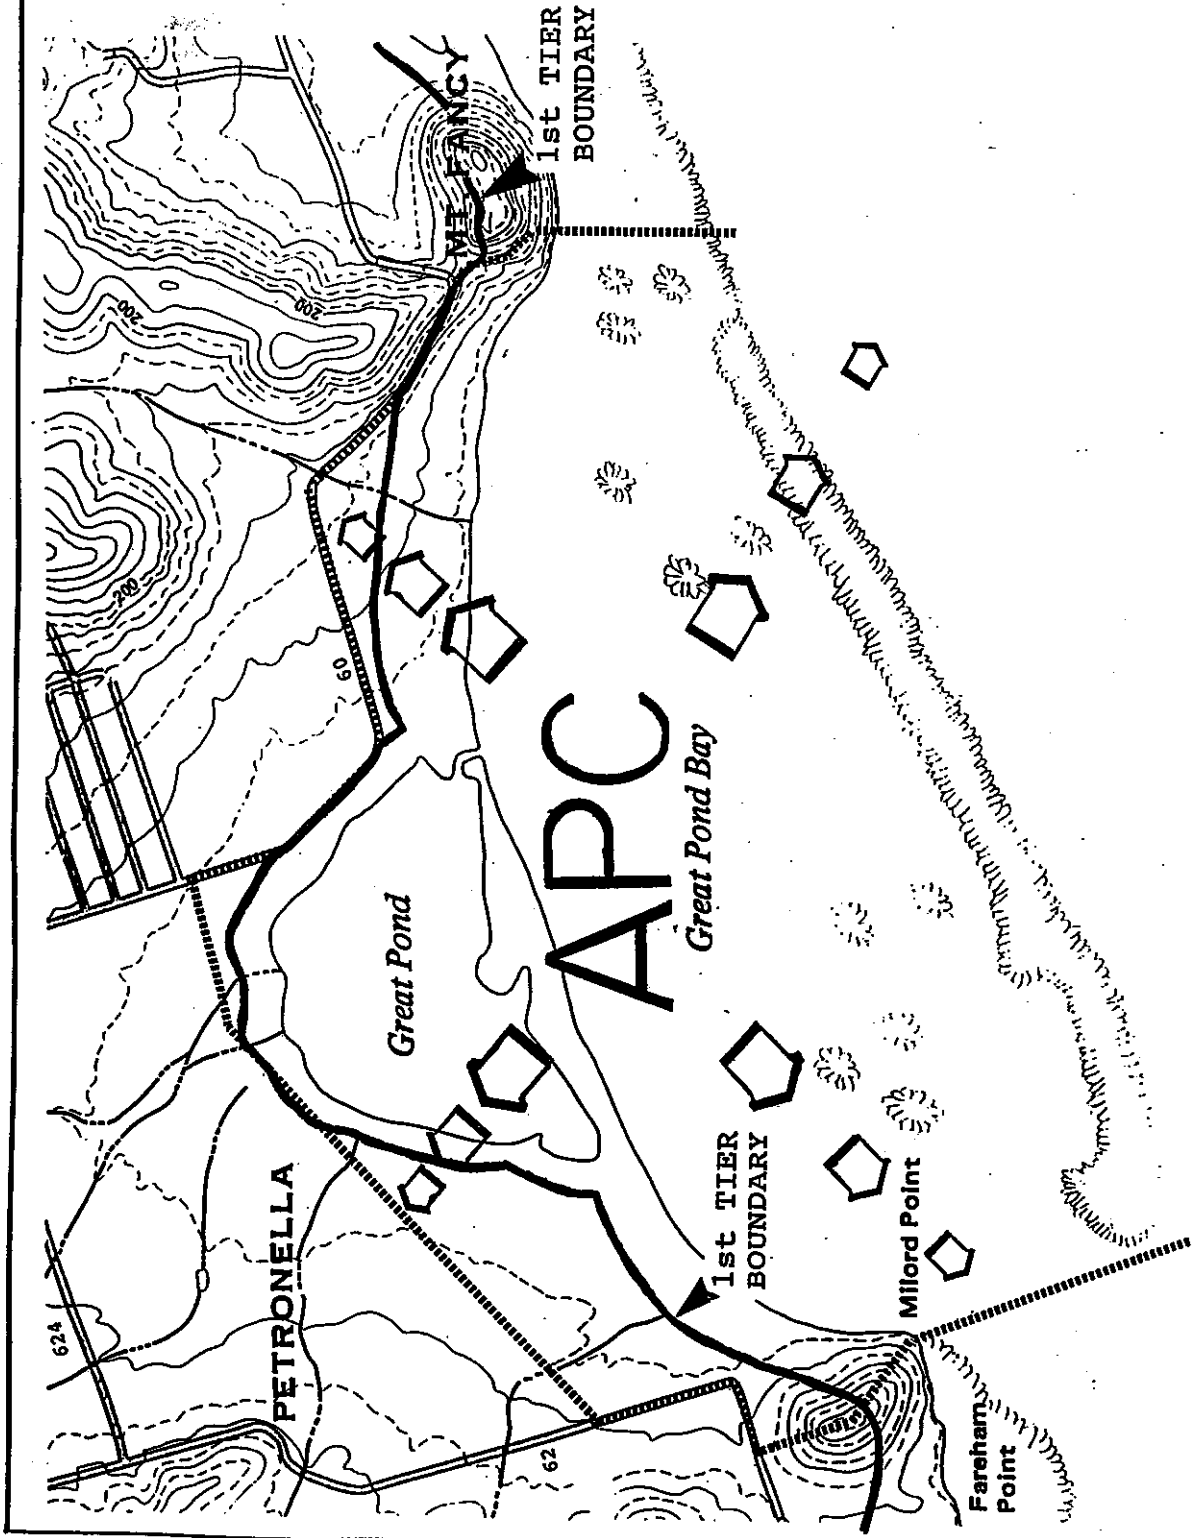
Figure 2  
APC/APR Boundary Map  
Adapted from: BC&E/CH2M HILL, 1979  
Island Resources Foundation, 1992

The pond is surrounded mostly by agricultural land, and has a residential subdivision to the north east, north of Rt. 60. The road system (Rt. 60 to the east, Rt. 624 to the north and Rt. 62 to the west) circles the bay and salt pond making an effective physical border between the upland and lowland areas (Figure 2).

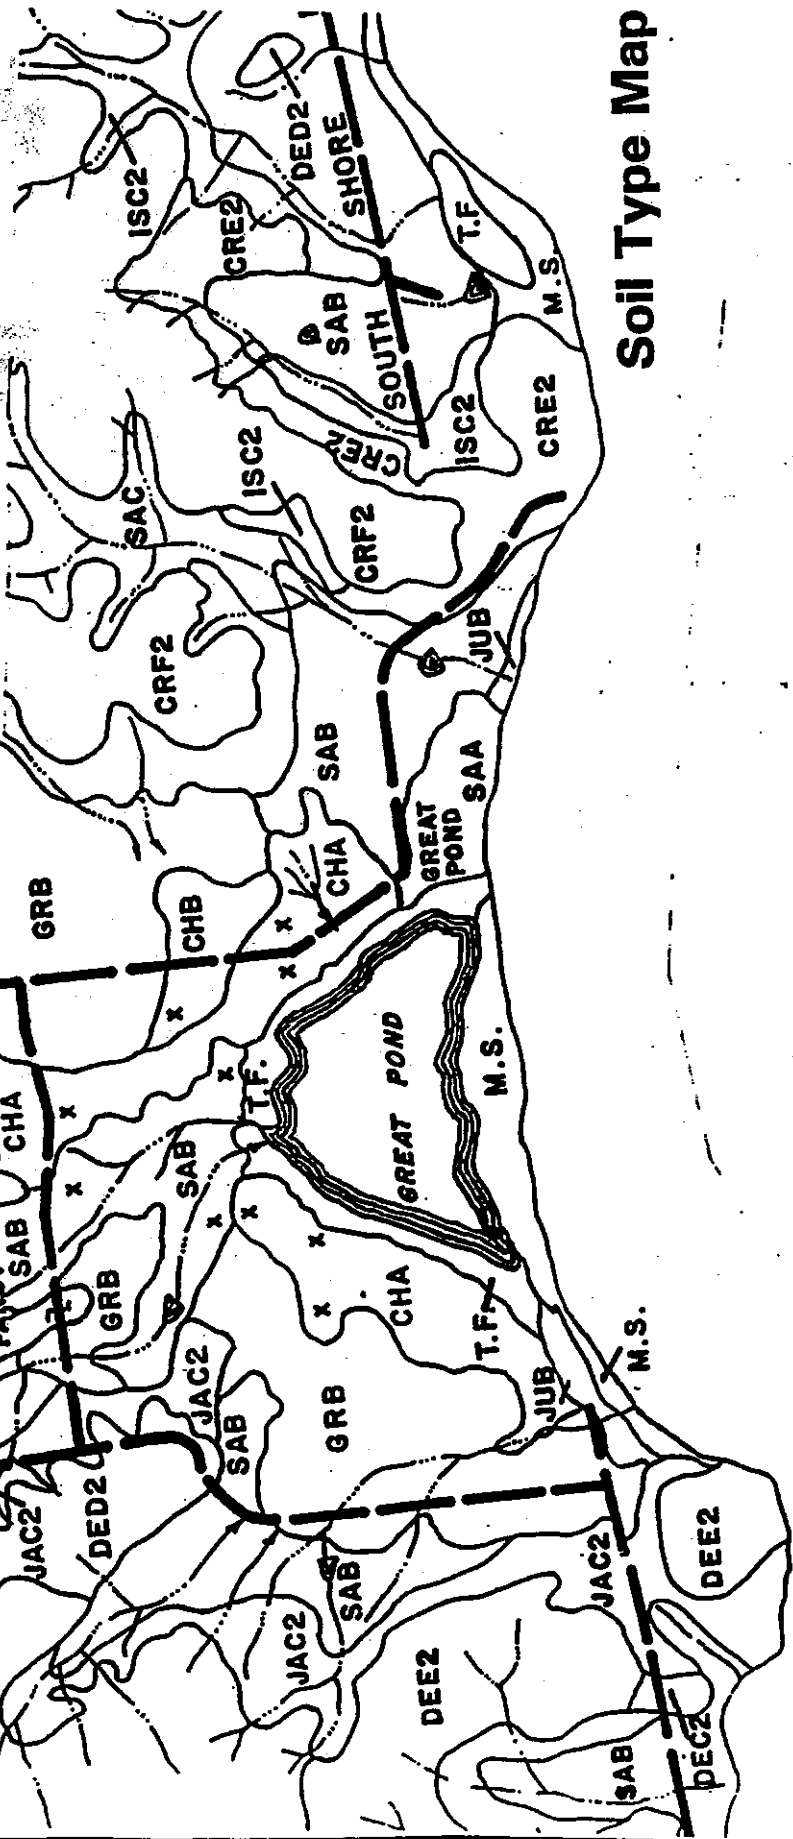
Figure 6  
Soil Type Map  
Adapted from: US Dept of Agriculture, SCS, 1965  
Island Resources Foundation, 1992

- CHA Cornhill clay loam, 0-2% slopes
- CHB Cornhill clay loam, 2-5% slopes
- DEC2 Descalabrado clay loam, 5-12% slopes, eroded
- DEE2 Desalabrado clay loam, 20-40% slopes, eroded
- GRB Granard clay loam, 2-5% slopes
- JAC2 Jacana clay loam, 5-12% slopes
- JUB Mangrove Swamp
- MS San Anton clay loam, 0-2% slopes
- SAA San Anton clay loam, 2-5% slopes
- SAB Tidal Flats
- TF

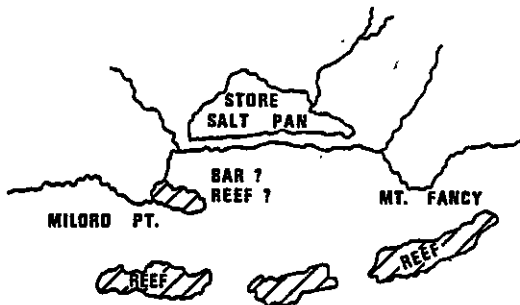
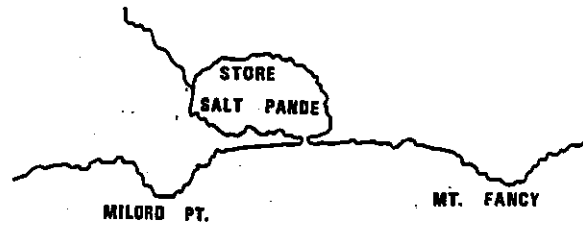
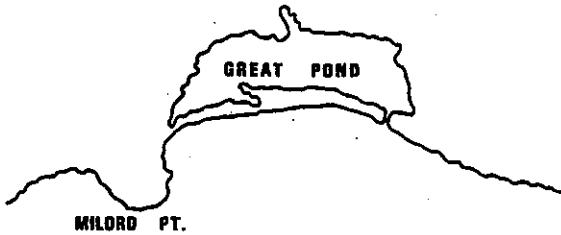
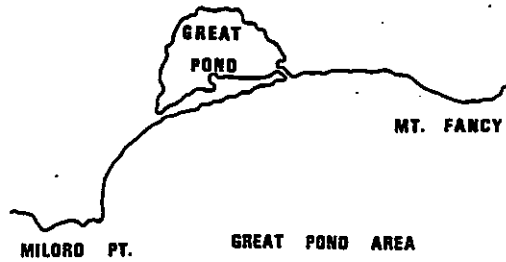
Figure 8  
Pond Configuration  
Adapted from: Multer, H. Grey, 1974  
Island Resources Foundation, 1993

GREAT POND AREA 1754  
AFTER BRONSTED, 1953

GREAT POND AREA.  
OXHOLM SURVEY 1791

GREAT POND AREA 1807  
AFTER UDGIVET, 1808

GREAT POND AREA  
U.S. COAST AND GEODETIC  
SURVEY 1924

GREAT POND AREA  
U.S. GEOLOGICAL SURVEY  
1958

Great Pond is a large (about 123 acres), shallow, essentially enclosed pond with poorly mixed, variable depth water. (In 1974 its average water depth was measured to be 18 cm compared to 30 to 50 cm in 1989.) During the wet season, the water in the pond is brackish, turning to hyper saline during the dry season. Usually the super saline (brackish after heavy rains) water is bordered by tidal flats on all sides except along the south where it is bounded by a vegetated baymouth bar. Over time, the area and depth of the pond has changed considerably as has the location and width of the narrow channel connecting it to the lagoon (Lu et al., 1972 in: Multer and Gerhard, 1974) (Figure 8).

The major historic human impact in the Great Pond area may have been salt mining in the pond. The 1791 Oxholm Survey map refers to the pond as the "Store Salt Pan" (Multer and Gerhard, 1974). Other maps depict the pond with a western outlet, no outlet, and the present eastern outlet (see Figure 8).

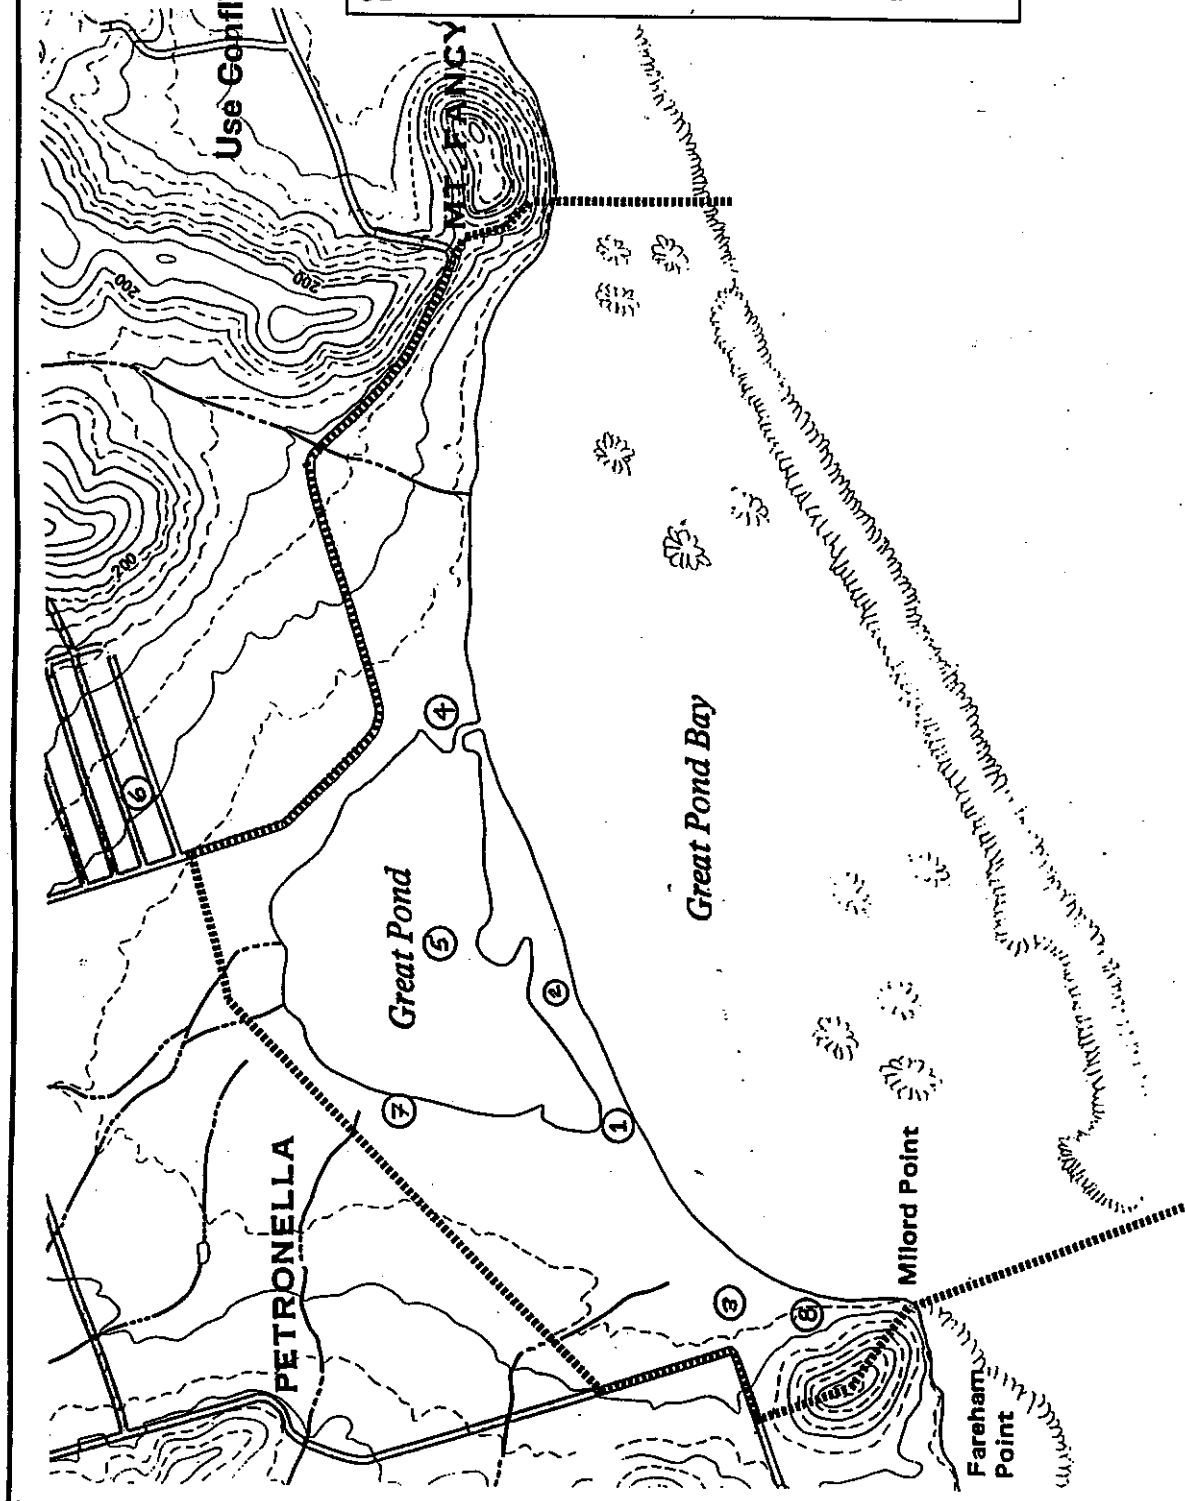
## Use Conflict/Resource Availability Map

1. Use of beach as a boat ramp - Jeeps and boat trailers seen frequently on beach.
2. Several "fish shanties" are set up on the beach berm with road along back of berm, some litter around.
