## Day 1 and Day 2: U.S. Virgin Islands, Living Shorelines/Green Infrastructure Working Session Case Study

### LONG POINT – SOUTH SHORE, ST. CROIX

### **RUST OP TWIST – NORTH SHORE, ST. CROIX**

### **MANGROVES AT GREAT POND – ST. CROIX**

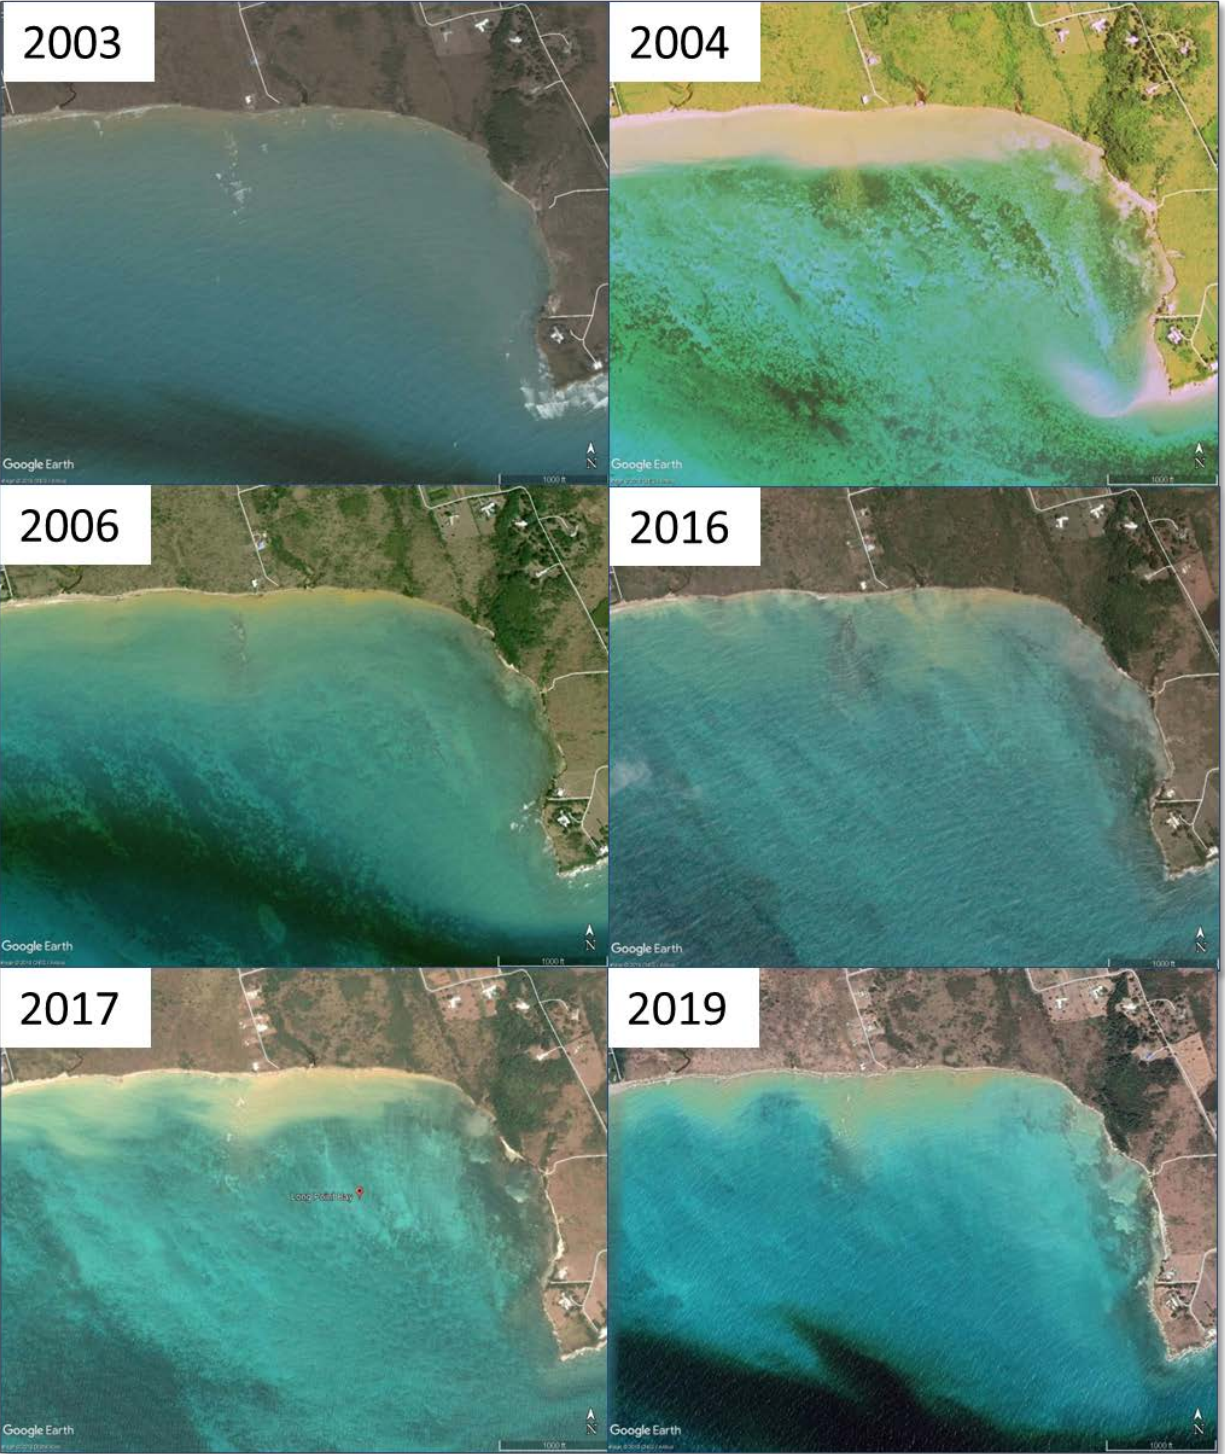
There is no stormwater management in the area. Stormwater takes the form of sheet flow from the hills north of the area to the Hope and Carlton homestead lands along the shoreline.

Images Showing Runoff over Time into Bay

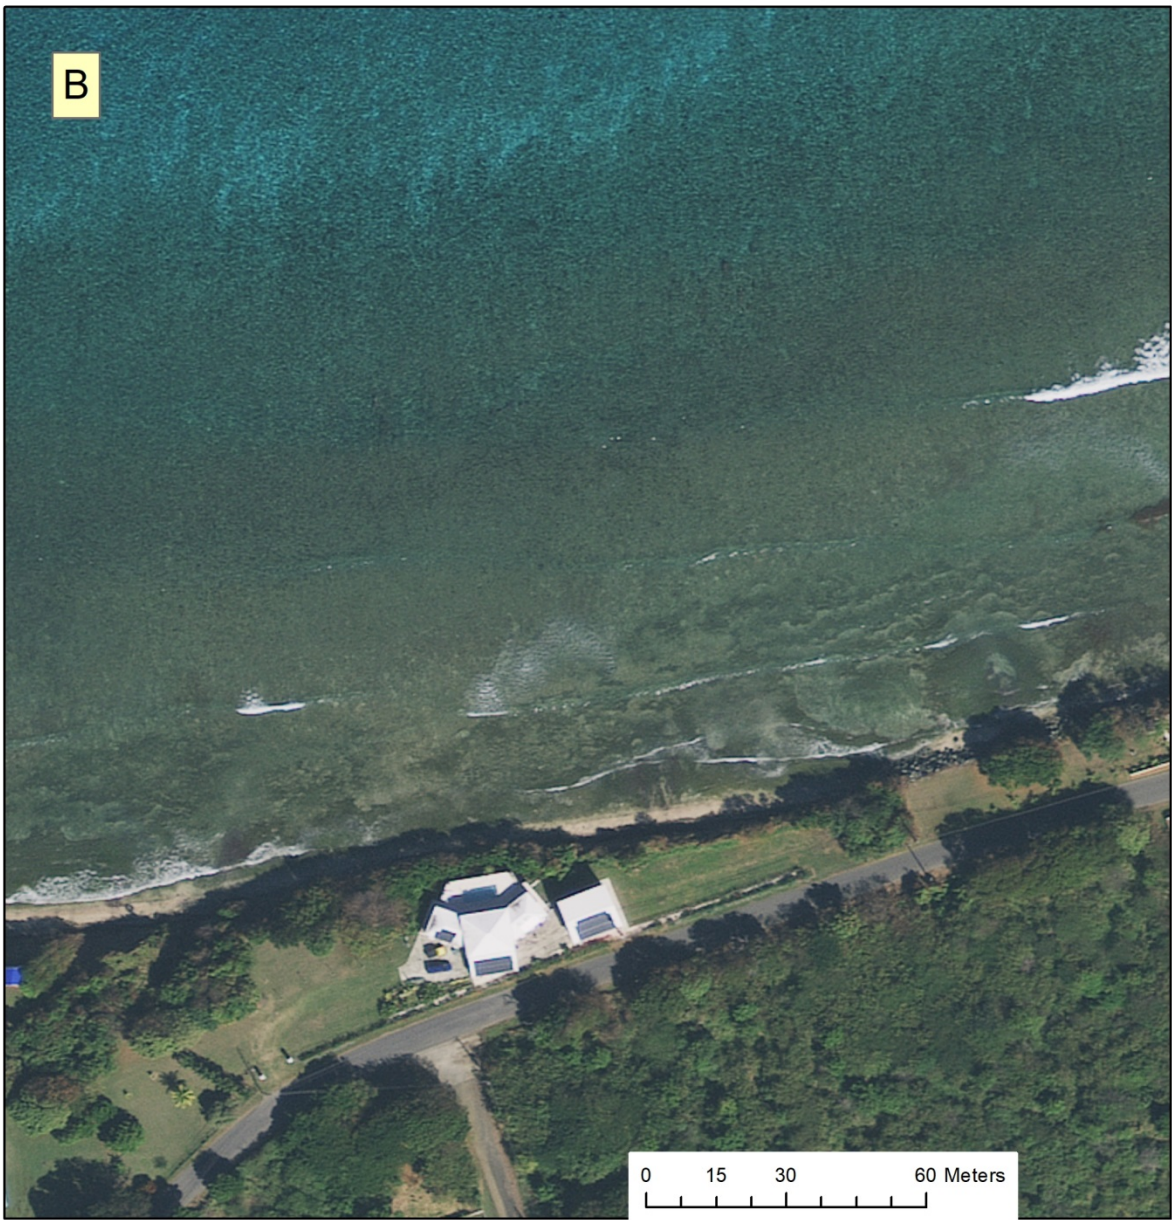
The north shore of St. Croix is significantly different from the south shore due in part to high-energy waves and the small insular shelf along the north coast. Coastal erosion along the shoreline is severe. There is one site in particular where a private property owner has been losing land for last couple of years, but coastal erosion extends along this shoreline east and west of the property. Because of the history of coastal erosion in the area, at some point in time VIDPNR placed riprap along the shoreline. This riprap is to the east of the homeowner's property and appears to have exacerbated coastal erosion to the west of the riprap, which includes the homeowner's property. The property owner is very interested in green infrastructure options but needs help to decide on preferred options, as well as suggestions regarding the permitting process and what to consider. The nearshore area is characterized by a good coastal barrier system with reef flats and seagrass beds. The beach is rocky but the cliffs behind the beach are composed of erodible soils.

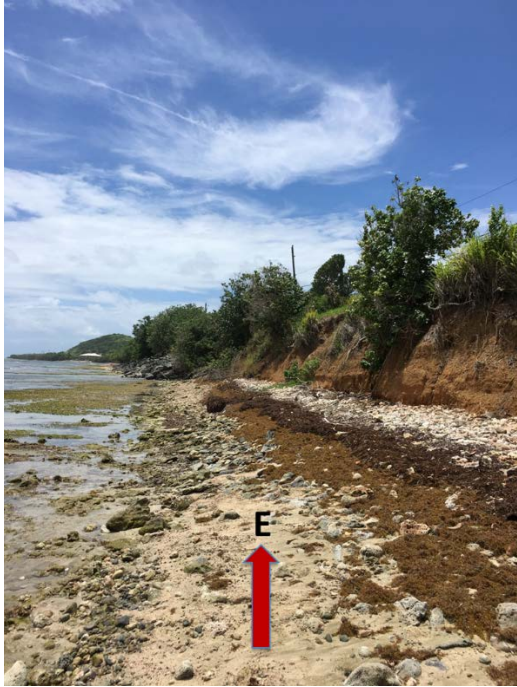
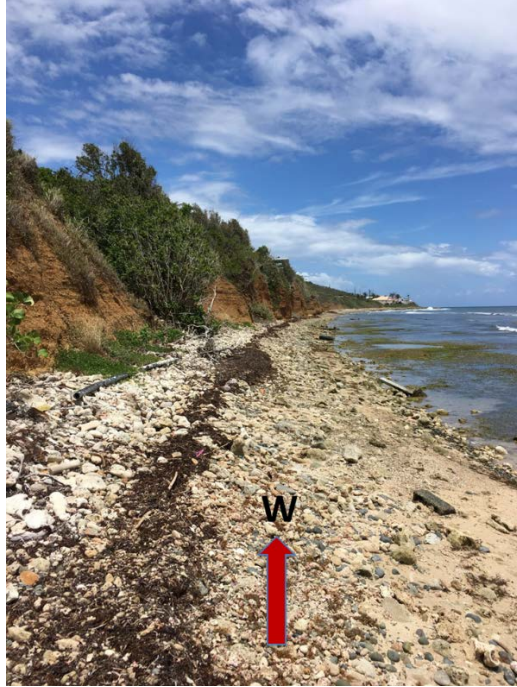
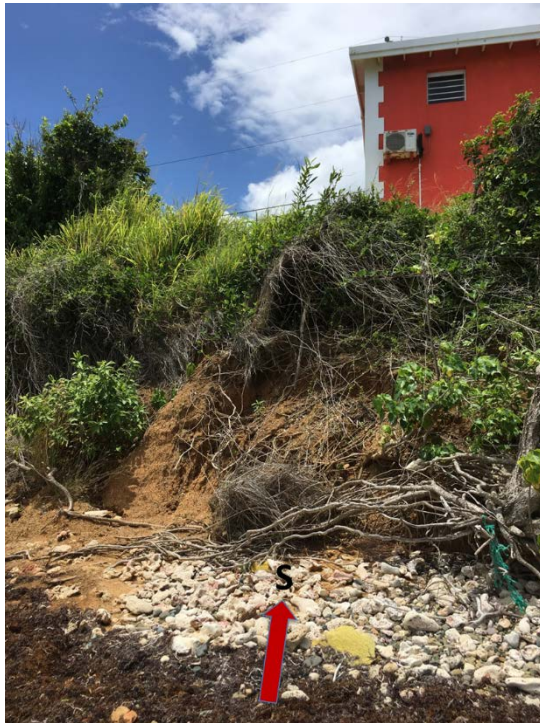
**Views to East, West, and South from Shore North of Homeowner's Property**

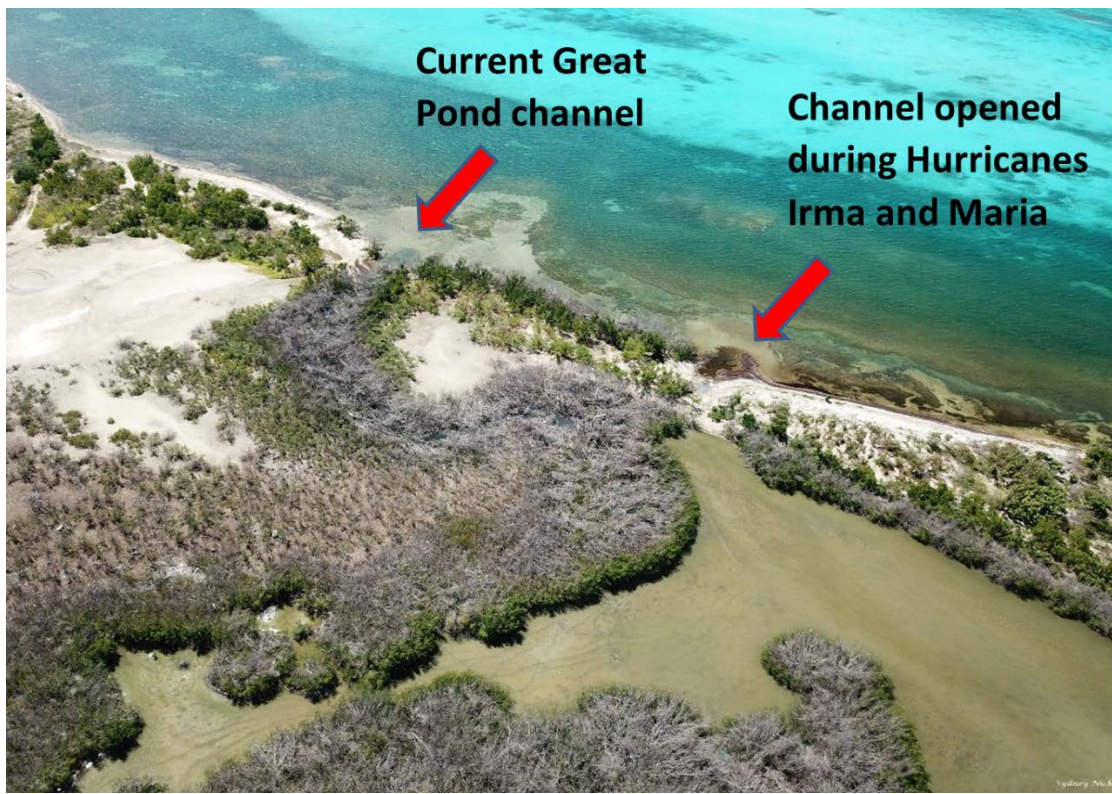
Aerial Image Showing Great Pond Mangrove Die-Off, Historic Channel, and Channel Opened During 2017 Hurricanes

Like all lagoons in the U.S. Virgin Islands, Great Pond is owned by the Government of the U.S. Virgin Islands. Fishers historically used the pond to catch bait fish but changes to the pond over time have led to fish species composition changes with cichlid species (tilapia) dominating. Fishers have been calling for VIDPNR to reopen the channel and the Department is examining alternatives for reestablishing flow and restoring the fishery function of the lagoon.

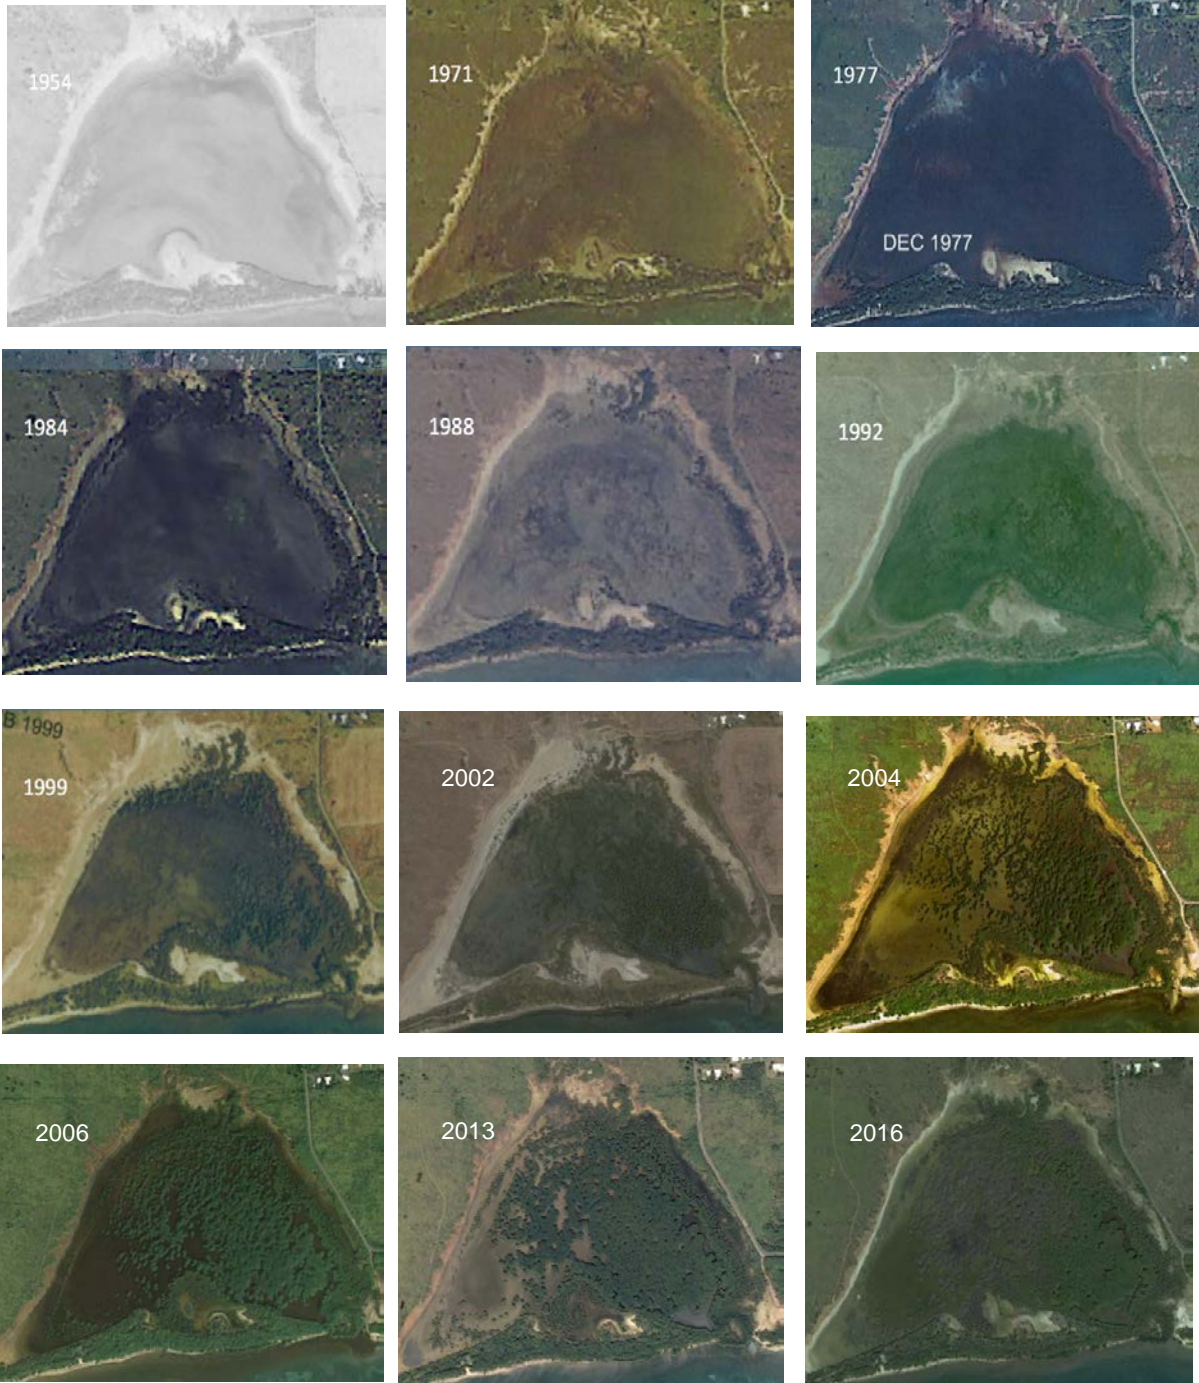
**Aerial images of Great Salt Pond, St. Croix, USVI. Photos range from 1954 to 2016 in chronological order. Note the increasing abundance of mangroves trees fringing and within the pond basin across the time series. Also, note that the scale is consistent for all images.**
