Saipan Watershed Assessment 2020

<p>Site ID: AS102</p>	<p>Watershed: Achugao South</p>
<p>Crew: EH</p>	<p>Date/Time: 01/19/2020 8:33 PM</p>
<p>Project Type:</p> <ul style="list-style-type: none"> • Drainage Infrastr., Maint. & Repair

2020 SAIPAN WATERSHED FIELD NOTES

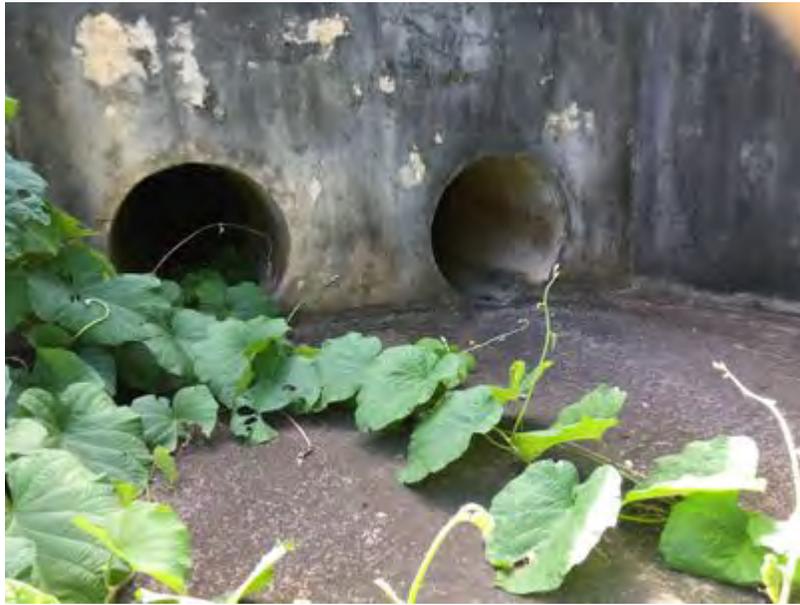
<p>Enforcement Needed: Yes</p>	
<p>Severity Rating: 2</p>	
<p>Implementation Priority: It's OK (Med)</p>	
<p>Descriptions of Existing Conditions: Ditch on uphill side of road, crosses road in 90 deg culvert to headwall.</p>	
<p>Description of Proposed Opportunity: Maintenance: clean. Repair trash rack, increase swale and pipe size. Reduce angles of 90 degree turn, add sediment forebay.</p>	
<p>Challenges/Constraints: Main road, limited space, developed</p>	
<p>Additional Notes:</p>	
<p>Site Photo</p>

Additional Photo Caption: Headwall on downstream end

Ditch crosses road via 90° culvert.
Headwall on downstream end.
Lots of trash.

At minimum - clean.
Install trash rack, increase swale & pipe size. Add sediment forebay.
Possibly change angle of culvert?

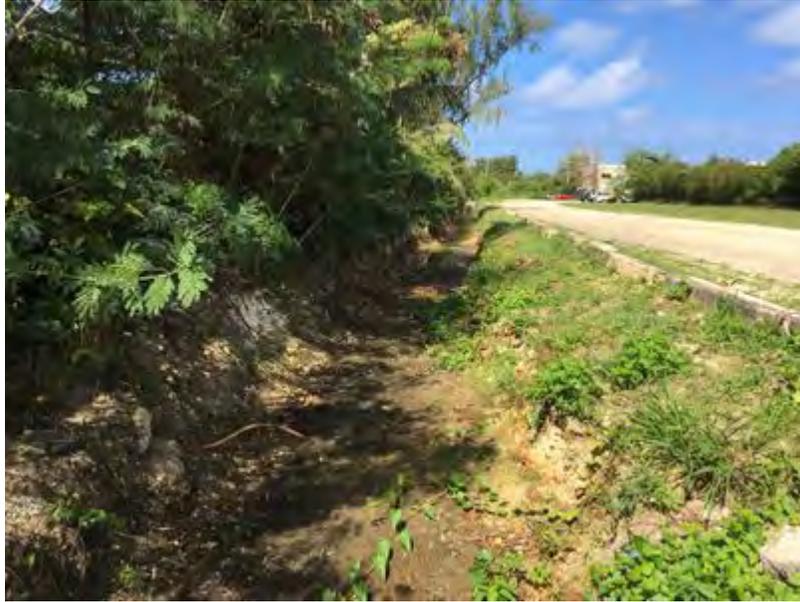
<p>Enforcement Needed: No</p>	
<p>Severity Rating: 2</p>	
<p>Implementation Priority: Love it! (High)</p>	
<p>Descriptions of Existing Conditions: Catch basin & inlet to dry swale. Flow goes through culvert to drainage ditch with standing water (recently cleared by DPW Roads & Grounds).</p>	
<p>Description of Proposed Opportunity: Install a sediment forebay at inlet to wet swale for enhanced water quality treatment and reduced maintenance. Possibility for educational signage.</p>	
<p>Challenges/Constraints: Industrial area. Road with catch basin may be redone. Land ownership/future use could be an issue. Side slope stabilization could be difficult in steep ditch.</p>	
<p>Additional Notes: Recently excavated drainage ditch</p>

Additional Photo Caption: Ditch

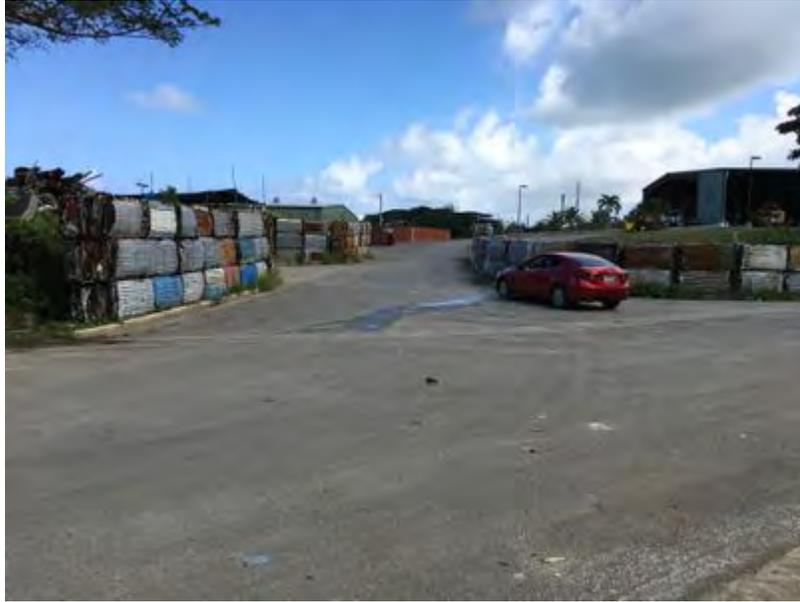
<p>Enforcement Needed: No</p>	
<p>Severity Rating: 5 (Severe)</p>	
<p>Implementation Priority: Love it! (High)</p>	
<p>Descriptions of Existing Conditions: Transfer station drainage network clogged. Unclear where runoff is discharged.</p>	
<p>Description of Proposed Opportunity: Build swale along landscape strip between wetland, fence, and roadway.</p>	
<p>Challenges/Constraints: Transfer station, maintenance, pollutants, large tree.</p>	
<p>Additional Notes:</p>	
<p>Site Photo</p>

Additional Photo Caption: Transfer station (photo from the swale area)

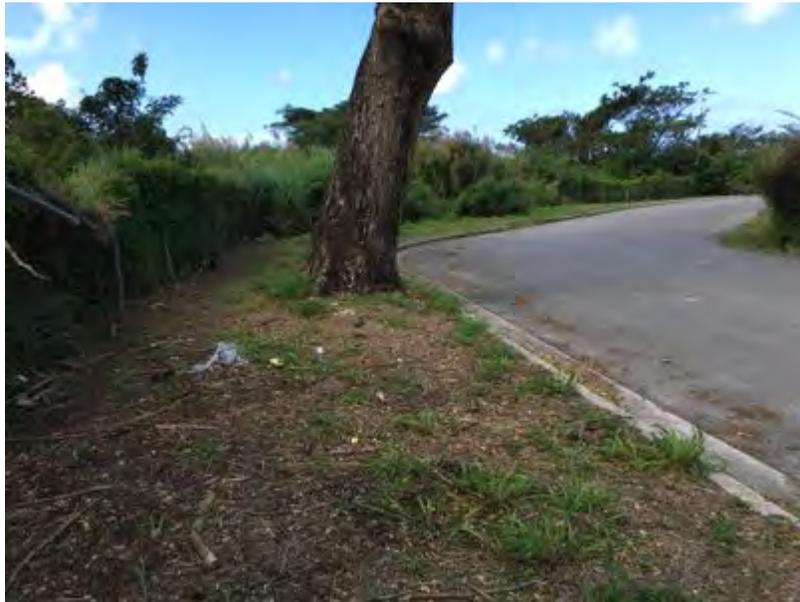
Additional Photo Caption: Proposed swale location.

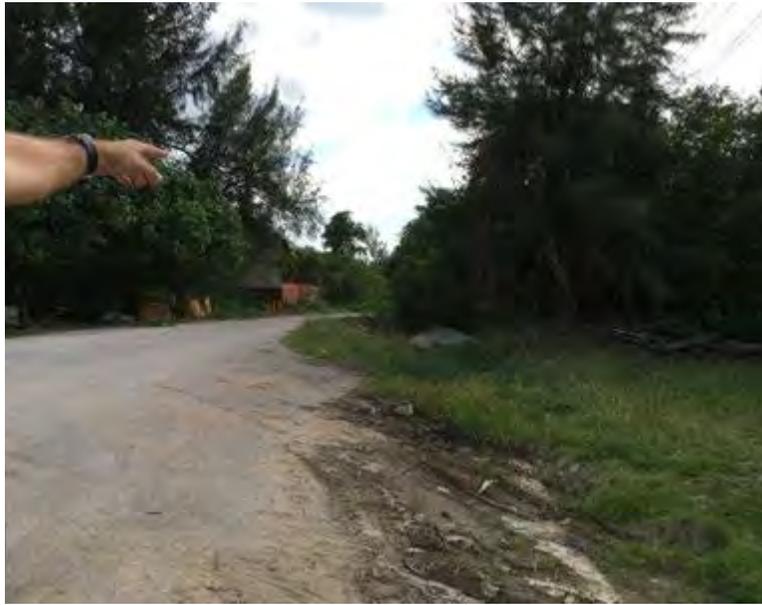
<p>Enforcement Needed: No</p>	
<p>Severity Rating: 5 (Severe)</p>	
<p>Implementation Priority: Love it! (High)</p>	
<p>Descriptions of Existing Conditions: Concrete swale along side of road. Collapsed culvert. Old tidal gate (WWII era?)</p>	
<p>Description of Proposed Opportunity: Formalize inlet and add sediment forebay. For industrial businesses nearby-- implement individual BMPs to control sediment. Replace culvert & restore side slopes. (also see AS168)</p>	
<p>Challenges/Constraints: Access to down gradient/outfall area is difficult. Abutting private property.</p>	
<p>Additional Notes:</p>	
<p>Site Photo</p>

Additional Photo Caption: Proposed location of sediment forebay, with swale to forested area (stream).

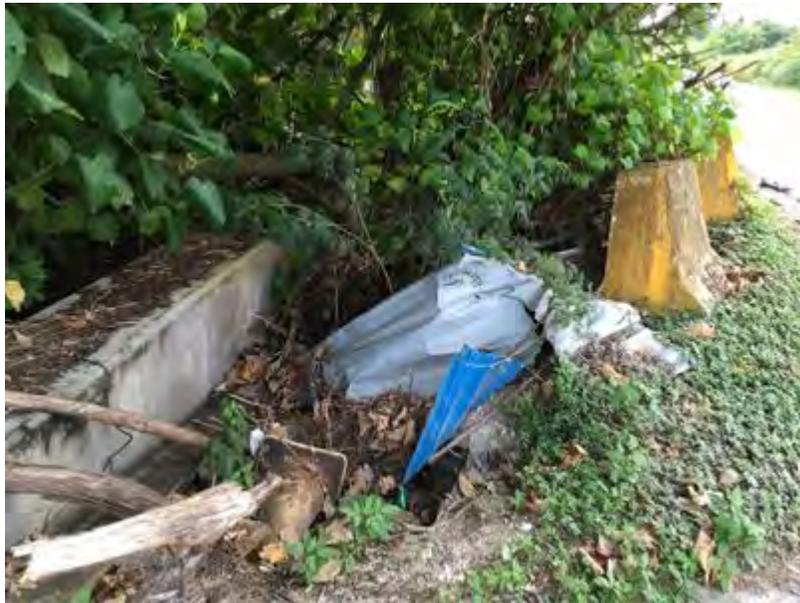
Additional Photo Caption: Trash near headwall of culvert (left)

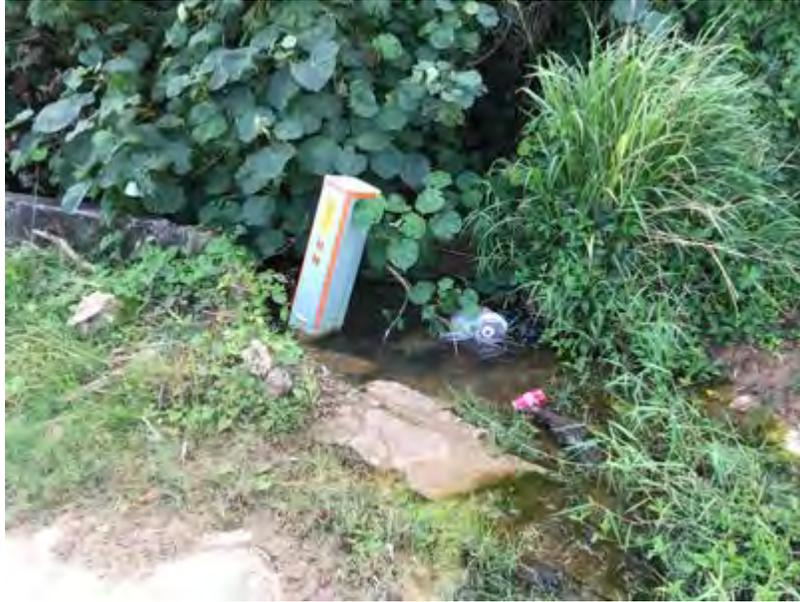
<p>Enforcement Needed: Yes</p>	
<p>Severity Rating: 5 (Severe)</p>	
<p>Implementation Priority: Love it! (High)</p>	
<p>Descriptions of Existing Conditions: Agatan Stream has base flow and has been rerouted as part of development. Stream runs freely across the road and then along gutter line. Constant flow to another gut. (Also see AS134)</p>	
<p>Description of Proposed Opportunity: PRIORITY PROJECT. Restore and reestablish stream to remove water and erosion of road gutter line. Fix culvert (AS133).</p>	
<p>Challenges/Constraints: Middle Road and property access.</p>	
<p>Additional Notes:</p>	
<p>Site Photo</p>

Additional Photo Caption: Standing water (with electric box) at the end of driveway from old garment factory.

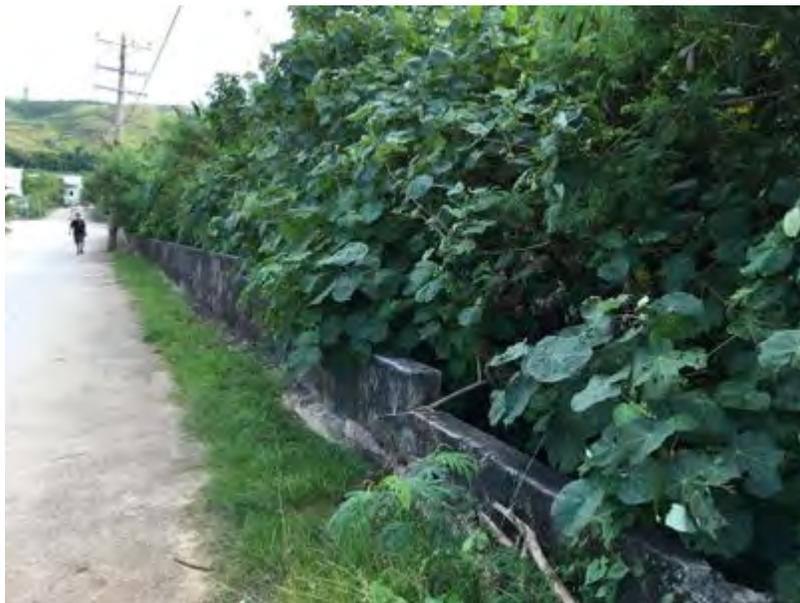
Additional Photo Caption: Stream runs along the outside of this wall.

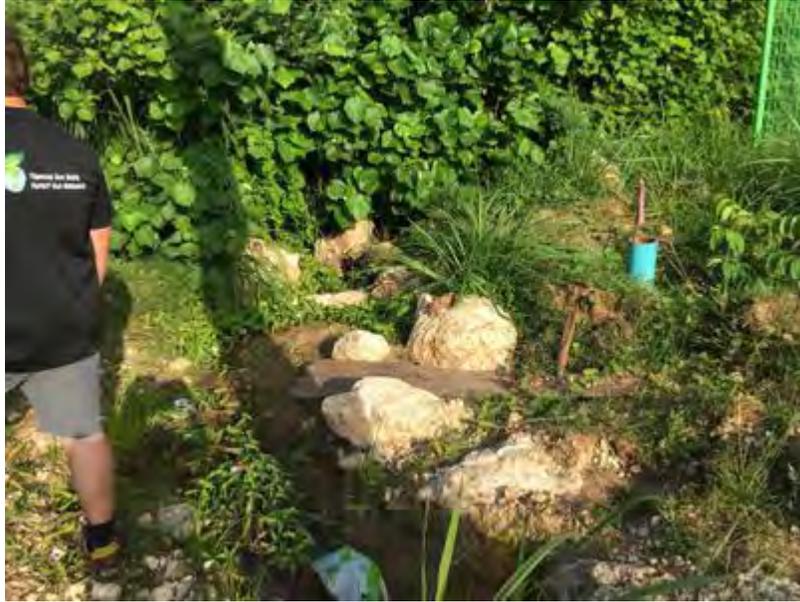
<p>Enforcement Needed: Yes</p>	
<p>Severity Rating: 5 (Severe)</p>	
<p>Implementation Priority: Love it! (High)</p>	
<p>Descriptions of Existing Conditions: Clogged culvert. Part of AS132 restoration.</p>	
<p>Description of Proposed Opportunity: Stream restoration along Middle Road and culvert restoration.</p>	
<p>Challenges/Constraints:</p>	
<p>Additional Notes:</p>	
<p>Site Photo</p>

Additional Photo Caption: Informal drainage from along Middle Road into streambed.

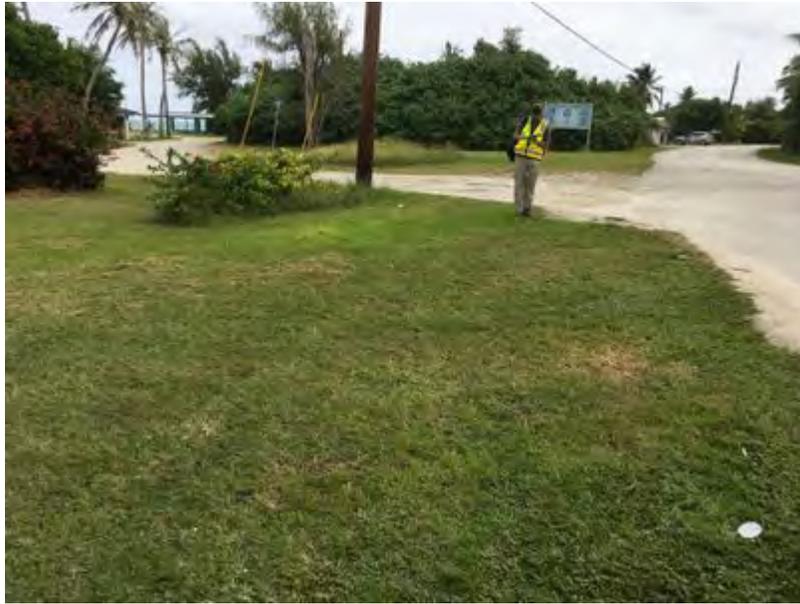
Additional Photo Caption: Swale location.

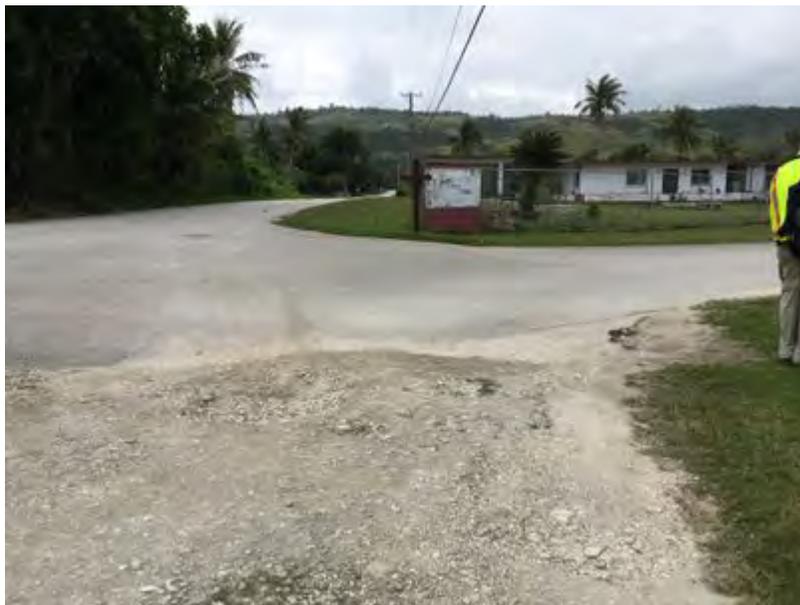
<p>Enforcement Needed: No</p>	
<p>Severity Rating: 3</p>	
<p>Implementation Priority: Love it! (High)</p>	
<p>Descriptions of Existing Conditions: Paved roads drain to unpaved dirt road in park. Road runoff appears to pond and scour.</p>	
<p>Description of Proposed Opportunity: Add waterbar or cross drain to direct runoff from Tanapag Ave (paved) to forebay and bio/rain garden in park. May have to be a wet swale. Education opportunity in park.</p>	
<p>Challenges/Constraints: Overflow-- where would that go? Maintenance could be difficult. Should be careful to not change/damage park. Very flat paved roads could make getting the water into swale difficult.</p>

Additional Photo Caption: Paved/dirt interface. Tanapag Ave (top) and Santa Remedio Drive to left and right.

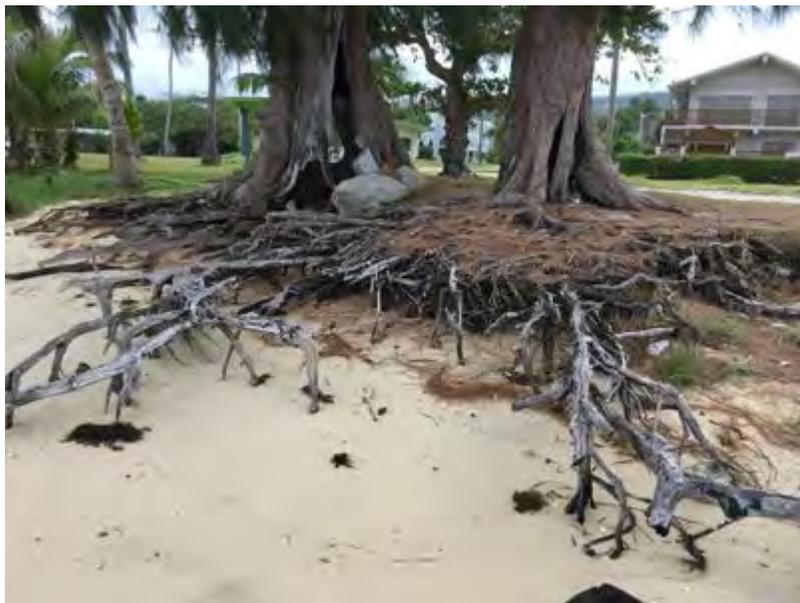
<p>Enforcement Needed: No</p>	
<p>Severity Rating: 2</p>	
<p>Implementation Priority: Not that important (Low)</p>	
<p>Descriptions of Existing Conditions: Park with boat ramp and several roads with unorganized vehicular traffic. Dirt roads causing minor erosion and sedimentation. Overall park is in good condition except lots of trash.</p>	
<p>Description of Proposed Opportunity: Eliminate some roads by reorganizing circulation and re-vegetating former roads. Add signage for litter.</p>	
<p>Challenges/Constraints: None-- complete as part of a larger improvement project of the entire park.</p>	
<p>Additional Notes:</p>	
<p>Site Photo</p>

Additional Photo Caption: Erosion at trees along shoreline.

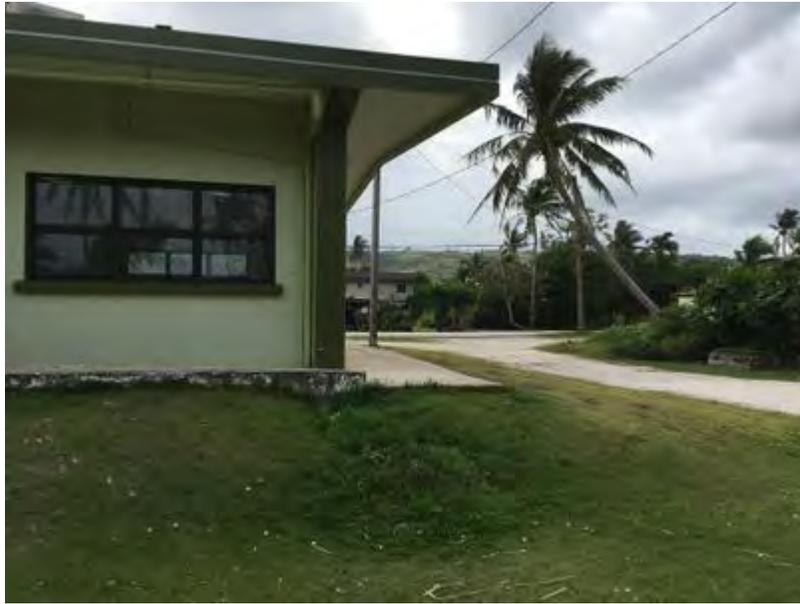
Additional Photo Caption: Back of building.

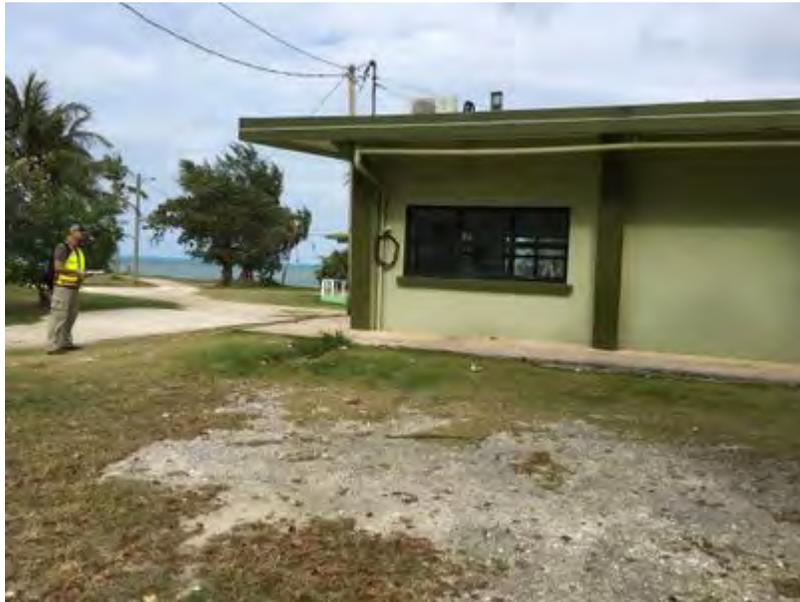
<p>Enforcement Needed: No</p>	
<p>Severity Rating: 2</p>	
<p>Implementation Priority: Love it! (High)</p>	
<p>Descriptions of Existing Conditions: Roof runoff discharges directly to park through downpipes.</p>	
<p>Description of Proposed Opportunity: Rain garden to capture runoff from building roof, eliminate nearby dirt access road. (See AS138)</p>	
<p>Challenges/Constraints:</p>	
<p>Additional Notes:</p>	
<p>Site Photo</p>

Additional Photo Caption: Front of building, rain garden location.

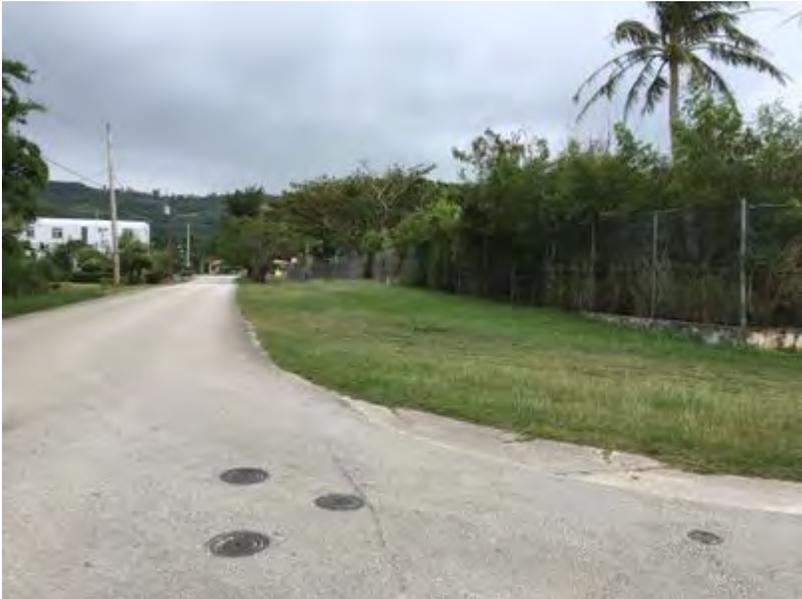
<p>USGS The National Map: National Boun... Powered by Esri</p>
<p>Enforcement Needed: No</p>	
<p>Severity Rating: 1</p>	
<p>Implementation Priority: It's OK (Med)</p>	
<p>Descriptions of Existing Conditions: Road has little/no drainage infrastructure, so runoff goes into grass.</p>	
<p>Description of Proposed Opportunity: Stormwater practice in grass area (NW corner of school).</p>	
<p>Challenges/Constraints: Possibly soil?</p>	
<p>Additional Notes:</p>	
<p>Site Photo</p>

<p>Site Overview Caption: Talaabwogh Rd</p>

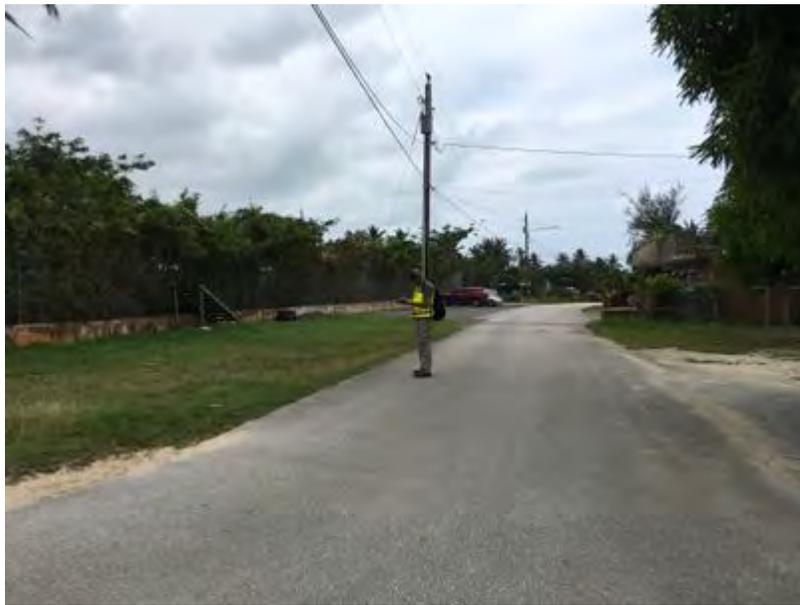
Additional Photo Caption: Chamolinian Dr

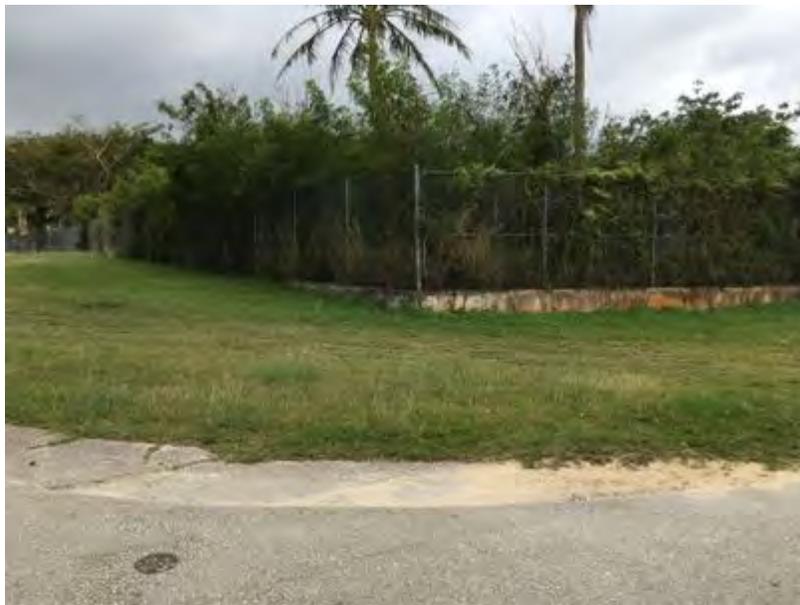
Additional Photo Caption: intersection and corner of school yard (behind fence).

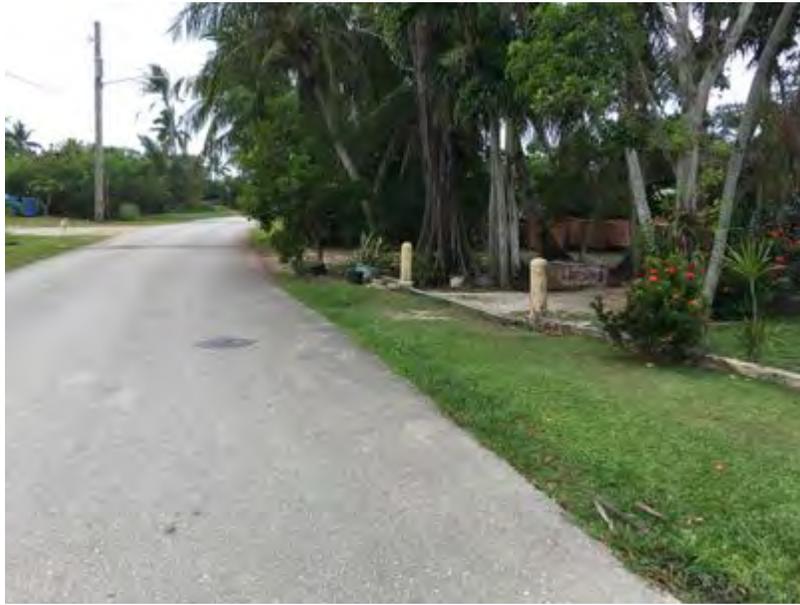
<p>Enforcement Needed: No</p>	
<p>Severity Rating: 1</p>	
<p>Implementation Priority: It's OK (Med)</p>	
<p>Descriptions of Existing Conditions: Paved parking lot drains to swale and weep holes in school wall drain to infiltration trench with pipe overflow. Water from paved swale discharges to lawn w/ erosion and then crosses road.</p>	
<p>Description of Proposed Opportunity: Drainage/vegetated swale along road and tie into infiltration trench overflow near the school yard wall. Possible combination with AS140.</p>	
<p>Challenges/Constraints: Possibly soil?</p>	
<p>Additional Notes:</p>	
<p>Site Photo</p>

Additional Photo Caption: Right side of road where water crosses.

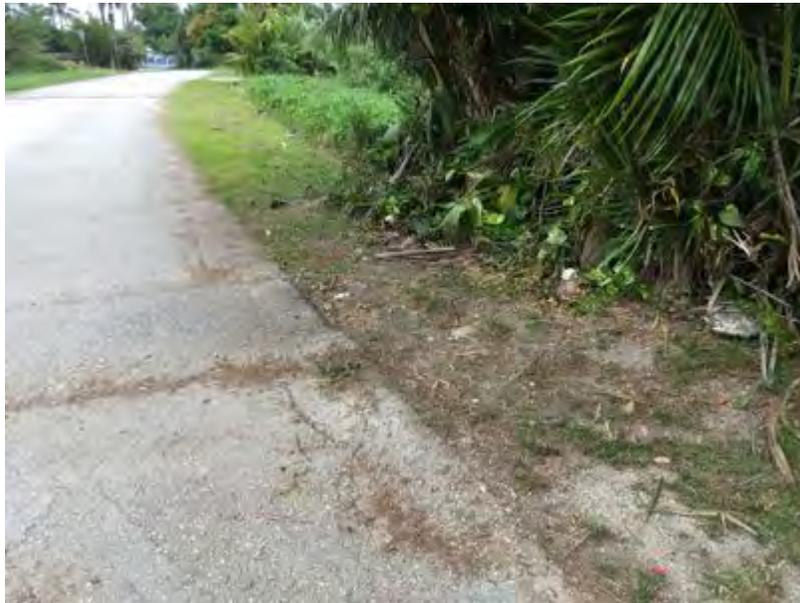
Additional Photo Caption: Right side of road where water crosses.

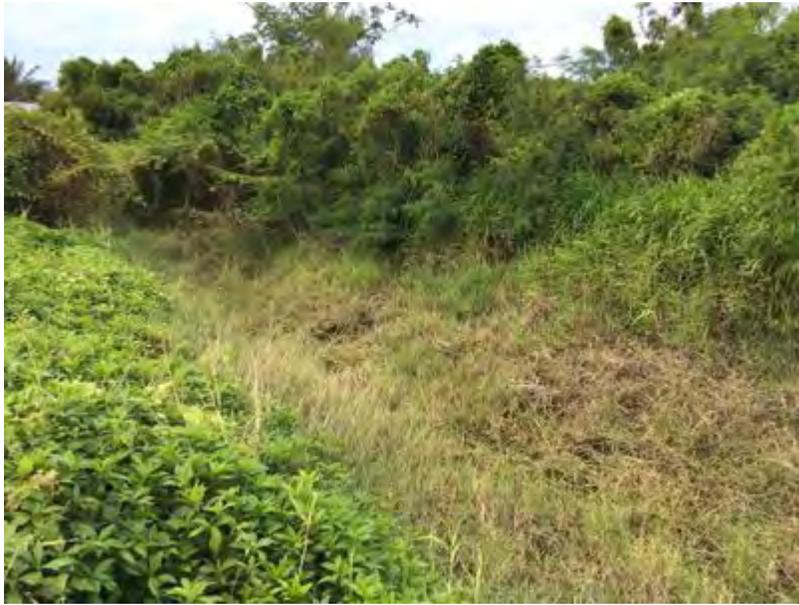
<p>Enforcement Needed: Yes</p>	
<p>Severity Rating: 3</p>	
<p>Implementation Priority: Love it! (High)</p>	
<p>Descriptions of Existing Conditions: Large basin in the NW corner of school site. Takes roof, walkway and field runoff. Vegetation is overgrown and should be cleared/cut and maintained. Standing water observed. Water overtops in the SW corner of basin and contributes to drainage issues at AS142. Basin is 4-6' deep, varies in width; up to 20'.</p>	
<p>Description of Proposed Opportunity: Clean basin. Explore possibility of expanding capacity and address overflow issue?</p>	
<p>Challenges/Constraints: Access-- will disturb school yard field if capacity is expanded.</p>

Additional Photo Caption: Downstream

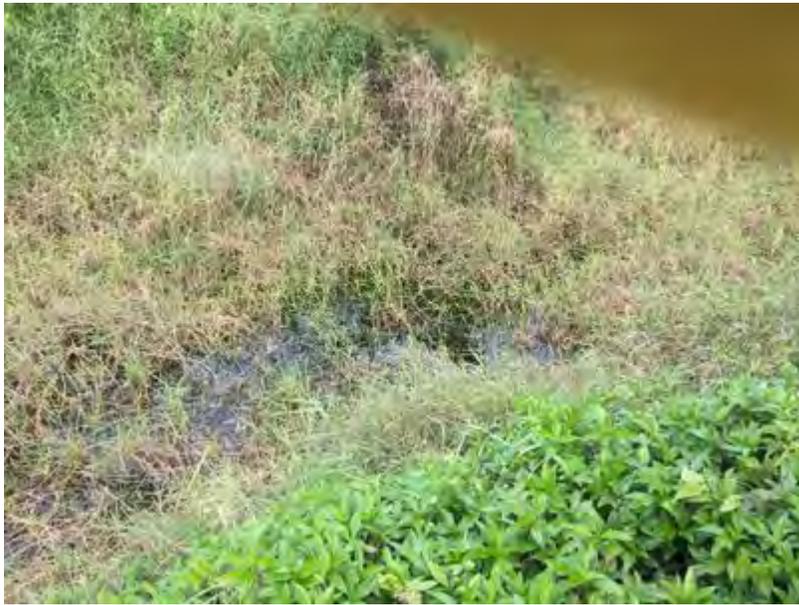
Additional Photo Caption: Standing water

LARGE BASIN IN THE NW CORNER OF SCHOOL SITE TAKED
 ROOF, WALKWAY; FIELD RUNOFF. VEGETATION IS OVERGROWN
 AND SHOULD BE CLEARED/CUT MAINTAINED. STANDING
 WATER OBSERVED.
 WATER OVER TOPS IN THE SW CORNER OF BASIN; CONTRIBUTED
 TO DRAINAGE ISSUES @ SITE AS - ~~141~~ 142

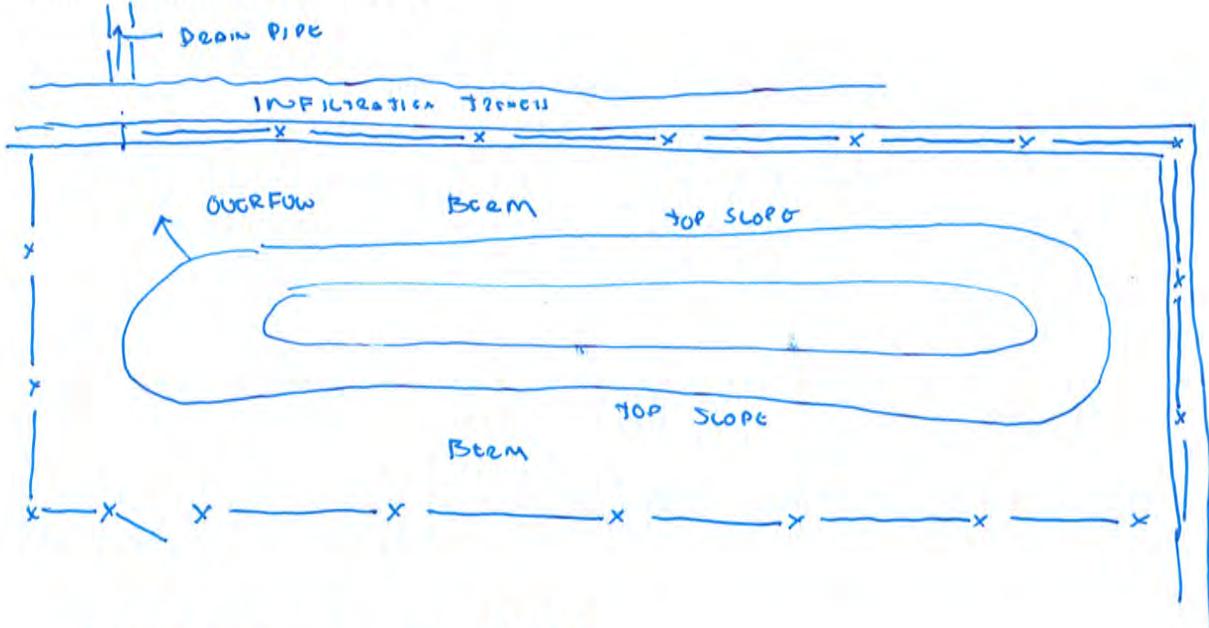
↑ OVERGROWN - CLEAN

↑ EXTEND CAPACITY?

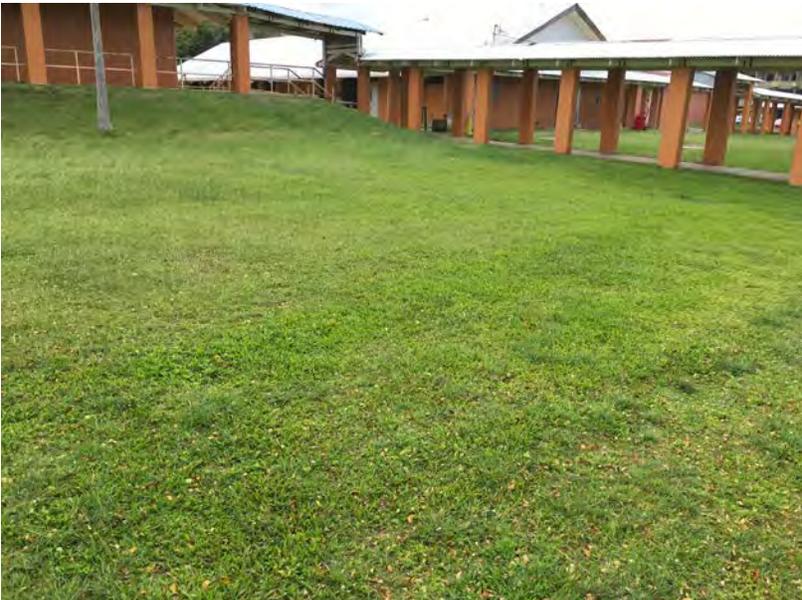
<p>Enforcement Needed: No</p>	
<p>Severity Rating: 1</p>	
<p>Implementation Priority: Love it! (High)</p>	
<p>Descriptions of Existing Conditions: Roof runoff and overland flow uncontrolled in courtyard at school. Does not appear to be a problem but could be an opportunity to integrate stormwater into school/curriculum. Spoke with principal, who thought students and faculty would like that.</p>	
<p>Description of Proposed Opportunity: Stormwater BMP to manage roof runoff. Great possible outreach (cool project) but not big impact.</p>	
<p>Challenges/Constraints: Use of open area by kids</p>	
<p>Additional Notes:</p>	
<p>Site Photo</p>

<p>Site Overview Caption: Grass courtyard</p>

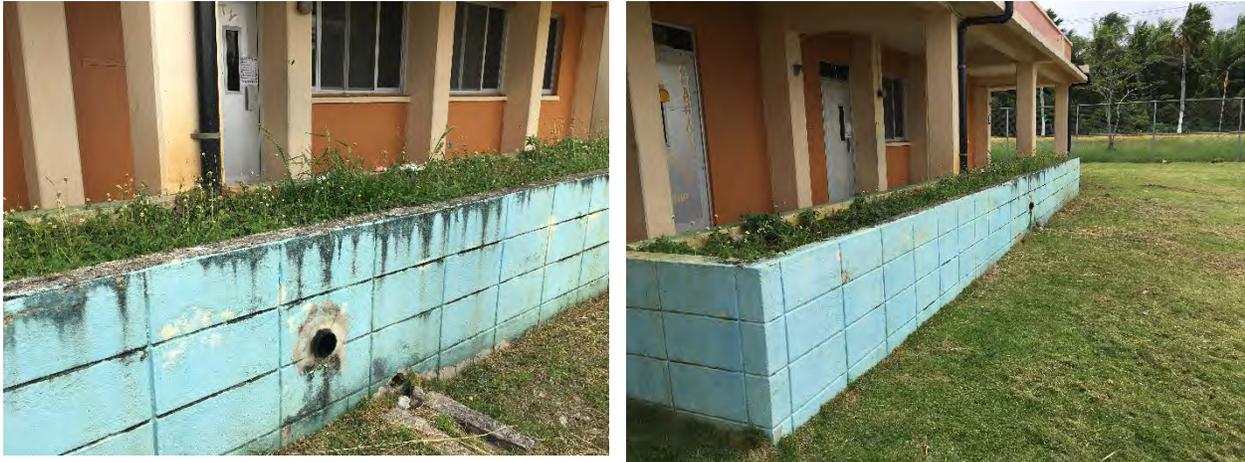
<p>Enforcement Needed: No</p>	
<p>Severity Rating: 2</p>	
<p>Implementation Priority: Love it! (High)</p>	
<p>Descriptions of Existing Conditions: Existing planters at school with downspouts directed to them. Downspouts may not actually discharge into planters (may go underneath). No plants. Spoke to principal: they have tried to grow plants but have issues with watering.</p>	
<p>Description of Proposed Opportunity: Convert planters into stormwater planters. Low hanging fruit and great education opportunity!</p>	
<p>Challenges/Constraints:</p>	
<p>Additional Notes:</p>	
<p>Site Photo</p>

<p>Site Overview Caption: Planters.</p>

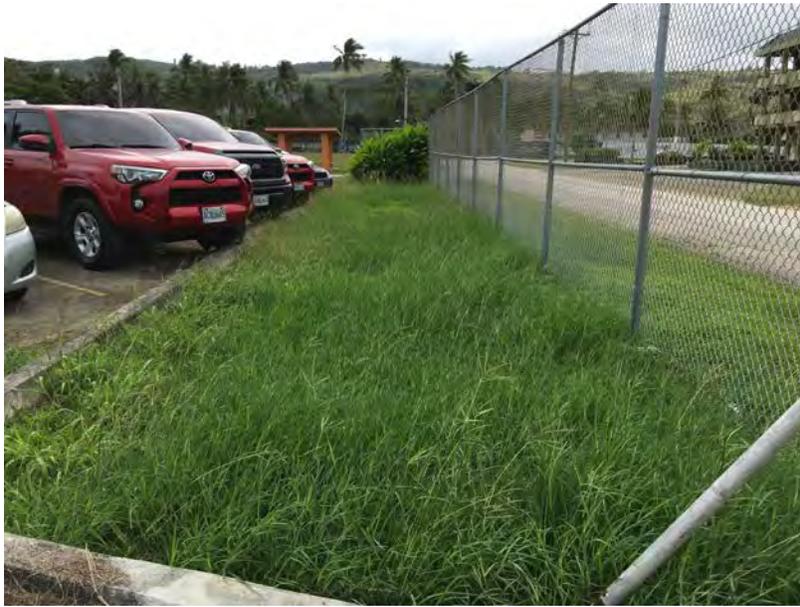
<p>Enforcement Needed: No</p>	
<p>Severity Rating: 2</p>	
<p>Implementation Priority: It's OK (Med)</p>	
<p>Descriptions of Existing Conditions: Parking lot drainage directed to existing swale. Two inlets and one outlet. Inlets clogged- too small. Runoff may not actually be entering swale. Drainage area is parking lot of school and runoff overflow via concrete swales.</p>	
<p>Description of Proposed Opportunity: Add inlets to allow for better drainage/more inflow. Fix existing inverts and outlets to ensure flow. Clean swale and replant.</p>	
<p>Challenges/Constraints: Soils and water table seem to be an issue at the middle school in general. (see AS 152)</p>	
<p>Additional Notes:</p>	
<p>Site Photo</p>

Additional Photo Caption: Swale from outlet upstream

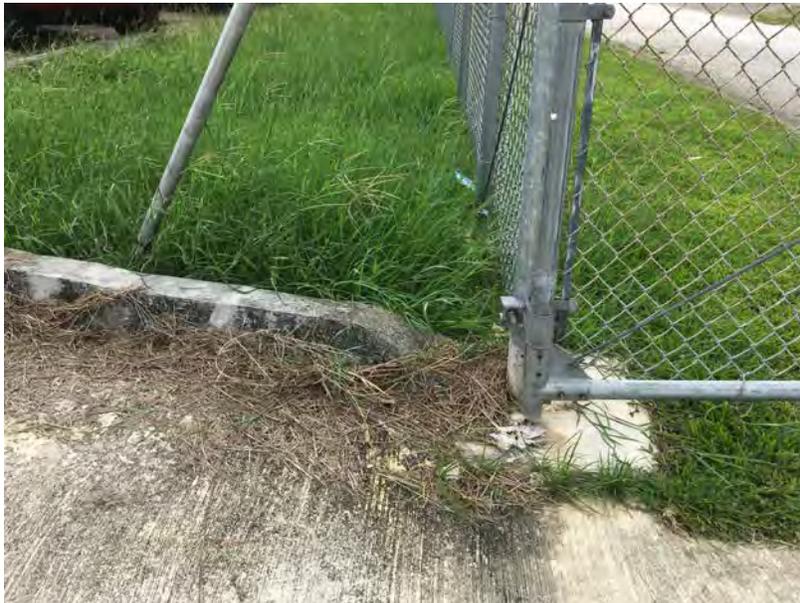
Additional Photo Caption: Single outlet

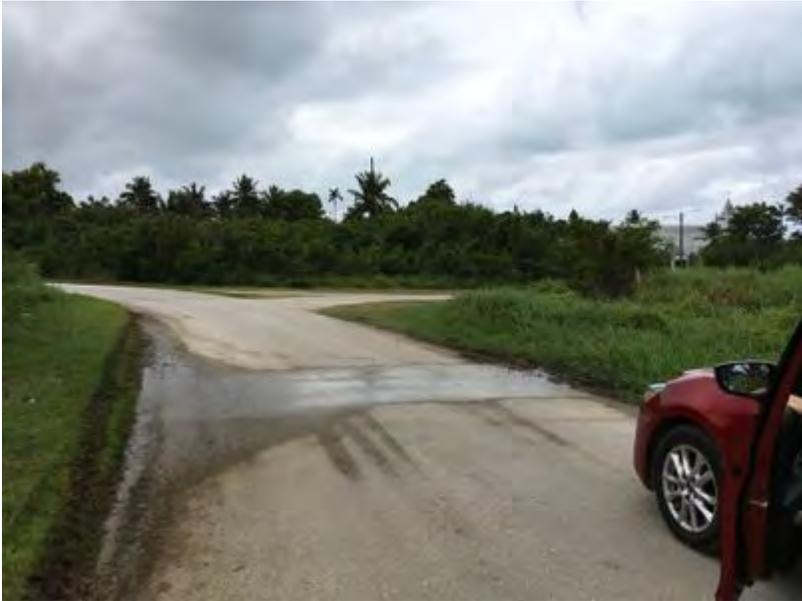
<p>USGS The National Map: National Bound... Powered by Esri</p>
<p>Enforcement Needed: Yes</p>	
<p>Severity Rating: 2</p>	
<p>Implementation Priority: It's OK (Med)</p>	
<p>Descriptions of Existing Conditions: Water on road</p>	
<p>Description of Proposed Opportunity: Confirm water source. Eliminate water from road.</p>	
<p>Challenges/Constraints:</p>	
<p>Additional Notes:</p>	
<p>Site Photo</p>

<p>Site Overview Caption: Water</p>

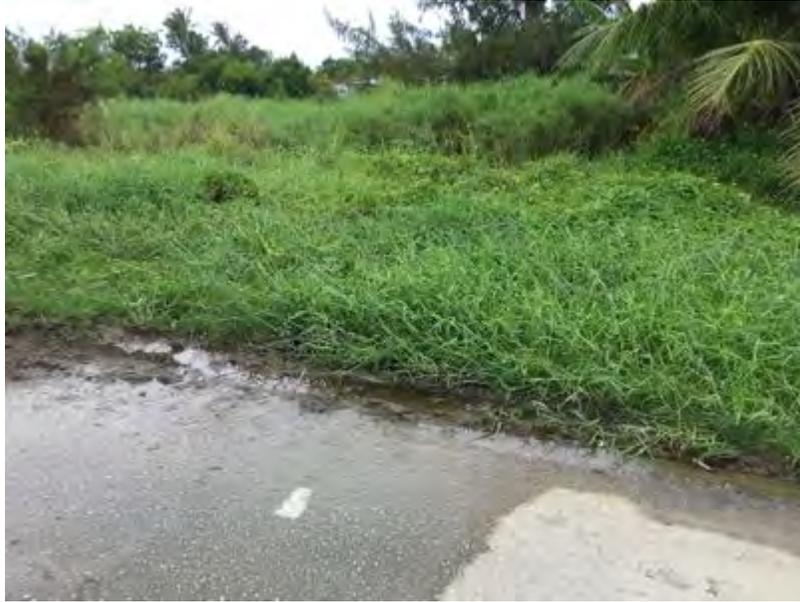
Additional Photo Caption: upstream of puddle

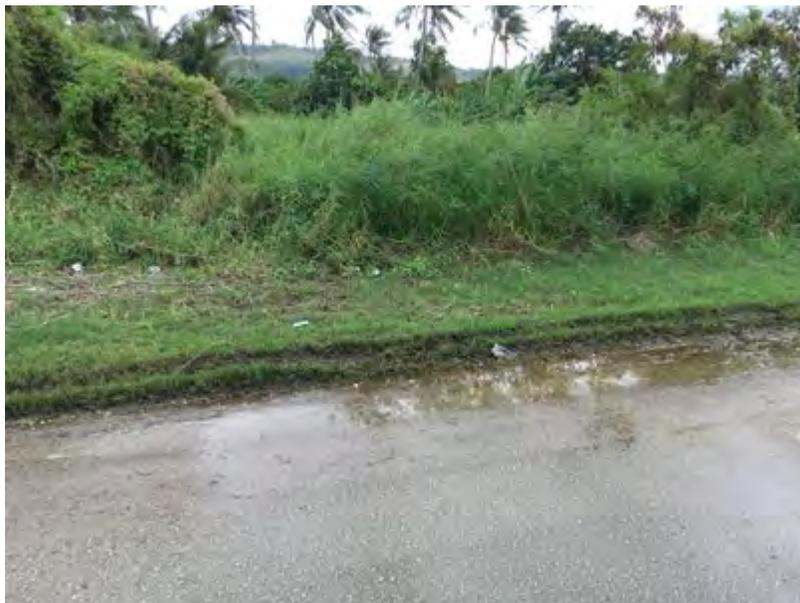
Additional Photo Caption: Downstream of puddle

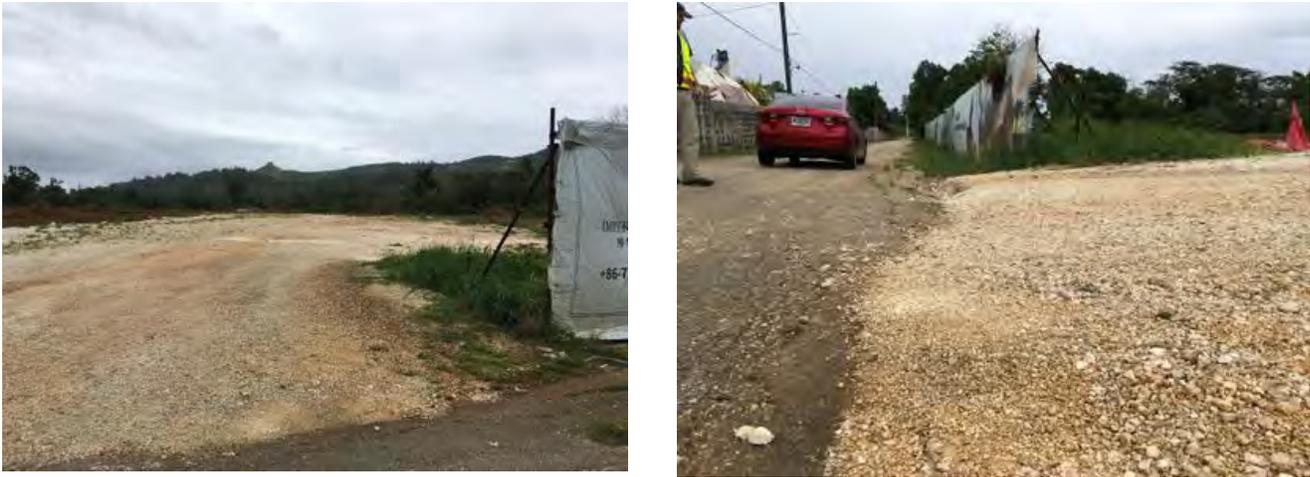
<p>Enforcement Needed: Yes</p>	
<p>Severity Rating: 4</p>	
<p>Implementation Priority: Love it! (High)</p>	
<p>Descriptions of Existing Conditions: Imperial Casha construction site. Gravel drive to main road. Runoff from inactive site discharges to road at construction entrance without erosion controls.</p>	
<p>Description of Proposed Opportunity: Erosion control on site at entrance. Stabilize site if construction is inactive.</p>	
<p>Challenges/Constraints: Cooperation from property owner and enforcement.</p>	
<p>Additional Notes:</p>	
<p>Site Photo</p>

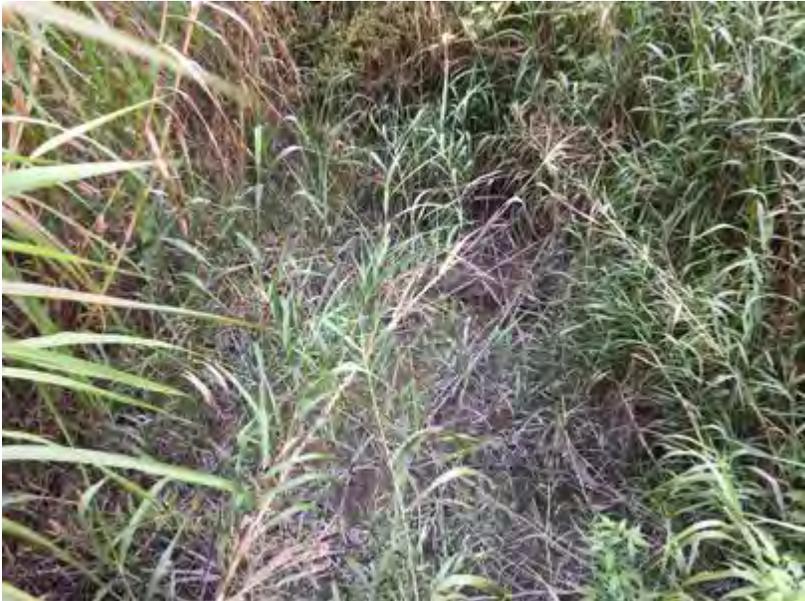
<p>Enforcement Needed: Yes</p>	
<p>Severity Rating: 4</p>	
<p>Implementation Priority: Love it! (High)</p>	
<p>Descriptions of Existing Conditions: Concrete swale with sump box. Clogged with sediment. Culvert discharges to wetland. Sedimentation observed in wetland. Evidence of past cleaning and removal of sediment from wetland.</p>	
<p>Description of Proposed Opportunity: Clean box sump. Unclog pipe. Remove sediment from wetland. BMPs needed for all the sites in this area to manage disturbed surfaces with no stabilization. Make box sump easier to clean.</p>	
<p>Challenges/Constraints: Removal of sediment from wetland. Encouraging/forcing companies along the road to manage sediment on site may be difficult. Land use (next to power plant). Very flat.</p>

<p>Site Overview Caption: Wetland on south side.</p>

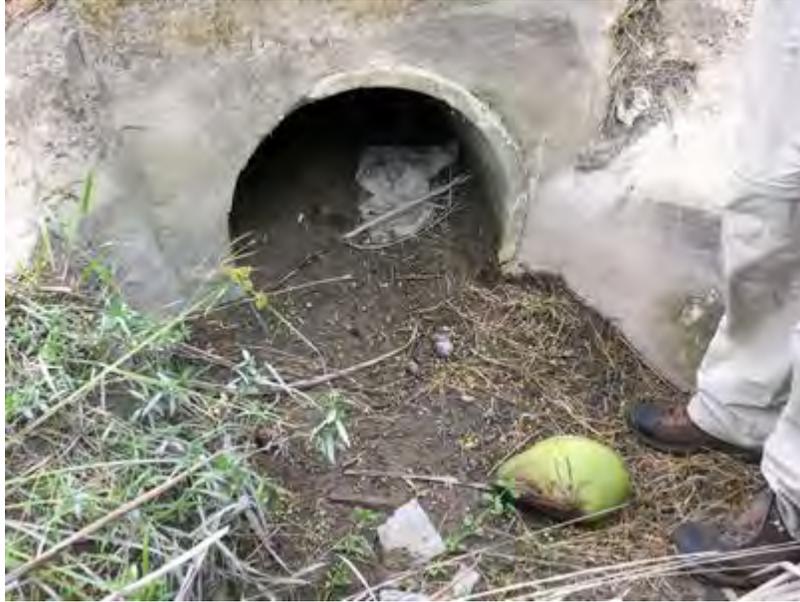
Additional Photo Caption: Clogged north side.

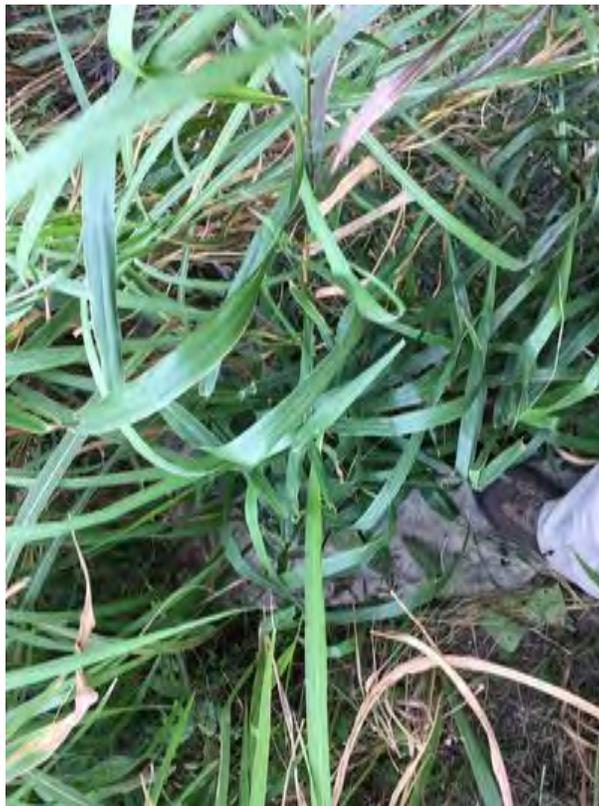
Additional Photo Caption: South.

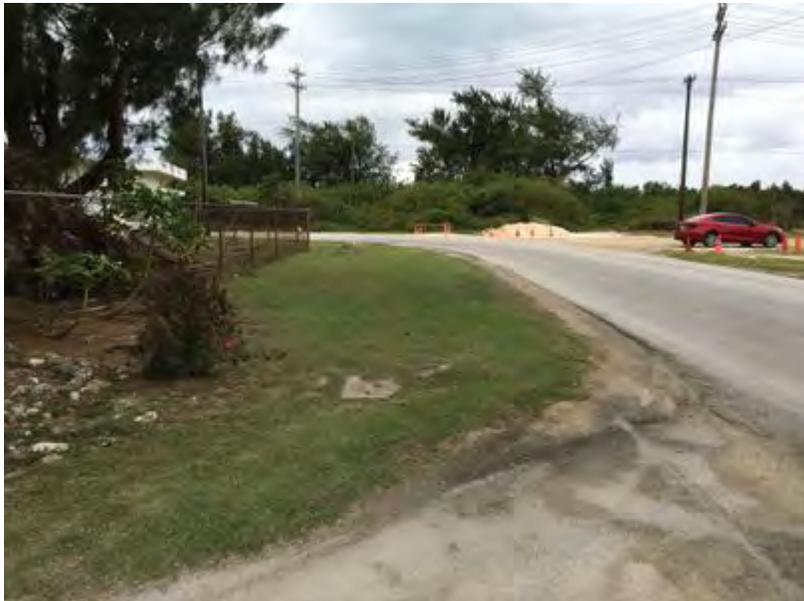
<p>Enforcement Needed: No</p>	
<p>Severity Rating: 2</p>	
<p>Implementation Priority: It's OK (Med)</p>	
<p>Descriptions of Existing Conditions: Open space in front of DFW building. Appears that road runoff drains there now. There is a lot of sediment on the road.</p>	
<p>Description of Proposed Opportunity: Great spot for a bioretention facility near DFW sign to treat small amount of road runoff from crowned road. Small drainage area but highly visible. Would like to get DFW involved as educational/public opportunity.</p>	
<p>Challenges/Constraints: Possibly soils/groundwater?</p>	
<p>Additional Notes:</p>	
<p>Site Photo</p>

<p>Site Overview Caption: DFW sign to the left of this photo.</p>

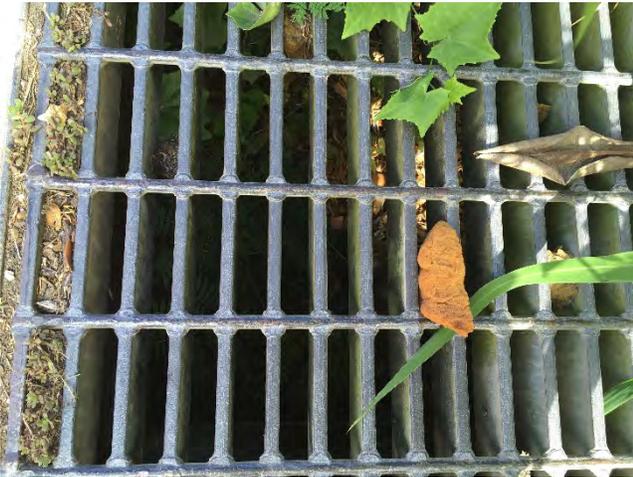
<p>Enforcement Needed: Yes</p>	
<p>Severity Rating: 3</p>	
<p>Implementation Priority: Love it! (High)</p>	
<p>Descriptions of Existing Conditions: Full Catchbasin</p>	
<p>Description of Proposed Opportunity: Clean</p>	
<p>Challenges/Constraints: None</p>	
<p>Additional Notes:</p>	
<p>Site Photo</p>

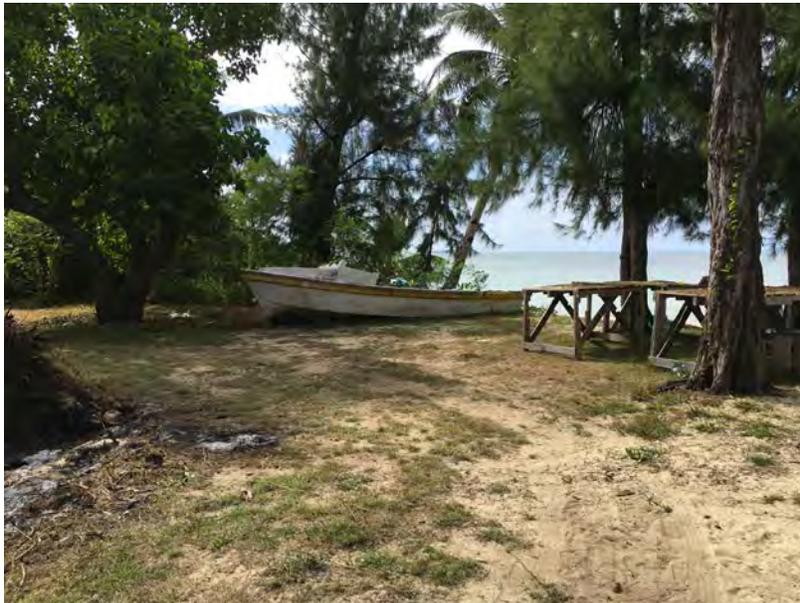
<p>Enforcement Needed: Yes</p>	
<p>Severity Rating: 5 (Severe)</p>	
<p>Implementation Priority: Love it! (High)</p>	
<p>Descriptions of Existing Conditions: Outfall of Dogas stream. LOTS of trash, including human waste (diapers).</p>	
<p>Description of Proposed Opportunity: Remove trash and discourage future dumping (signs, community education). Focus location for MINA.</p>	
<p>Challenges/Constraints: Changing habits.</p>	
<p>Additional Notes:</p>	
<p>Site Photo</p>

Additional Photo Caption: Abandoned boat (?)

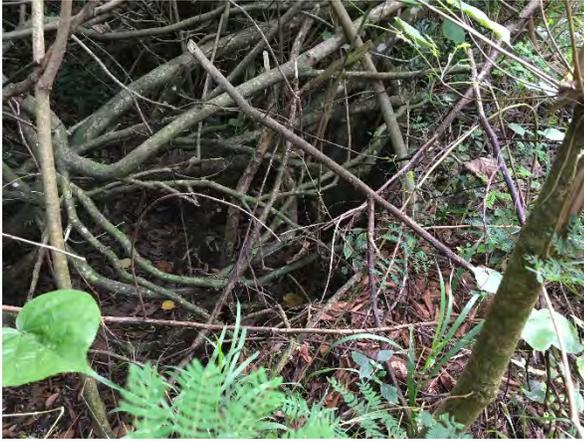
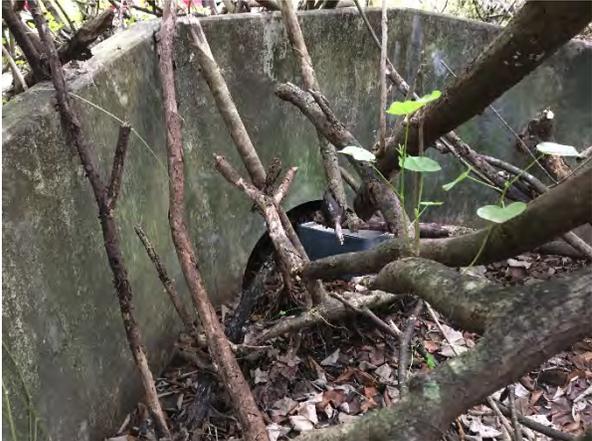
<p>Site ID: AS175</p>	<p>Watershed: Achugao South</p>
<p>Crew: EH</p>	<p>Date/Time:</p>
<p>Project Type:</p> <ul style="list-style-type: none"> • Drainage Infrastr., Maint. & Repair

<p>Enforcement Needed: Yes</p>	
<p>Severity Rating: 4</p>	
<p>Implementation Priority: Not that important (Low)</p>	
<p>Descriptions of Existing Conditions: Overgrown and clogged culvert (see AS131)</p>	
<p>Description of Proposed Opportunity: Clean and clear.</p>	
<p>Challenges/Constraints: Not main road.</p>	
<p>Additional Notes:</p>	
<p>Site Photo</p>
