Saipan Watershed Assessment 2020

<p>Site ID: AS102</p>	<p>Watershed: Achugao South</p>
<p>Crew: EH</p>	<p>Date/Time: 01/19/2020 8:33 PM</p>
<p>Project Type:</p> <ul style="list-style-type: none"> • Drainage Infrastr., Maint. & Repair

2020 SAIPAN WATERSHED FIELD NOTES

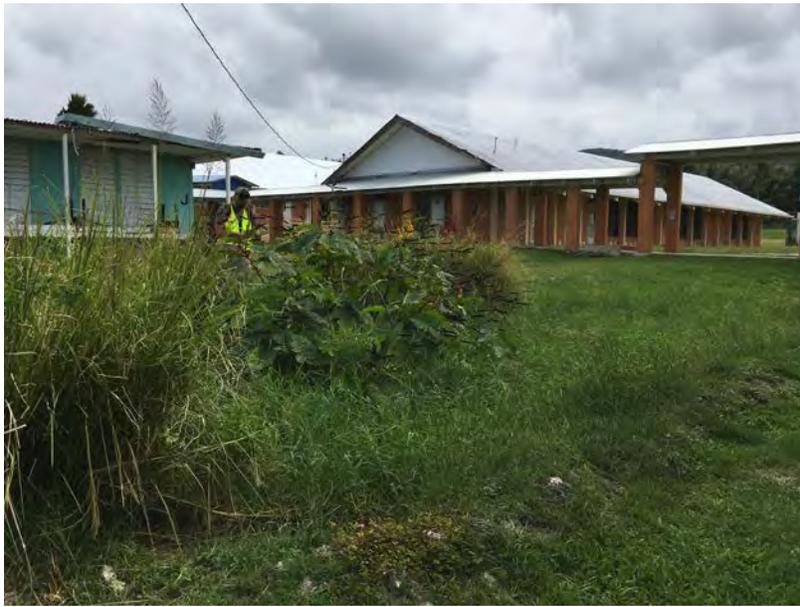
<p>Enforcement Needed: Yes</p>	
<p>Severity Rating: 5 (Severe)</p>	
<p>Implementation Priority: Love it! (High)</p>	
<p>Descriptions of Existing Conditions: Clogged inlet of rain garden at Tanapag Middle School (see AS145). May contribute to flooding of building. Also, rain garden outlet may be at too high an elevation causing backup.</p>	
<p>Description of Proposed Opportunity: Clean inlet. Widen and clean outlet spillway. Maintain positive drainage from outlet to road. Consider replanting with native plants</p>	
<p>Challenges/Constraints: Poor soils and/or high groundwater (poor infiltration nearby).</p>	
<p>Additional Notes:</p>	
<p>Site Photo</p>

Additional Photo Caption: Outlet spillway

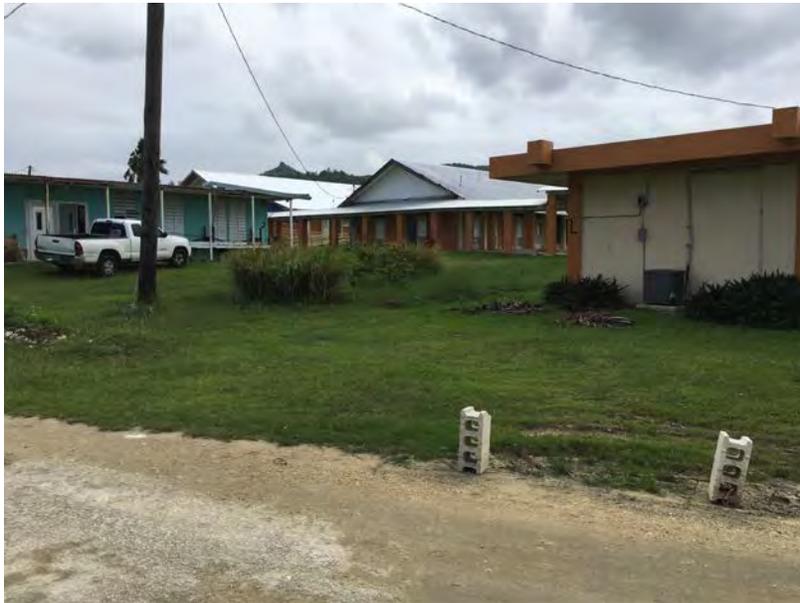
Additional Photo Caption: Behind rain garden.

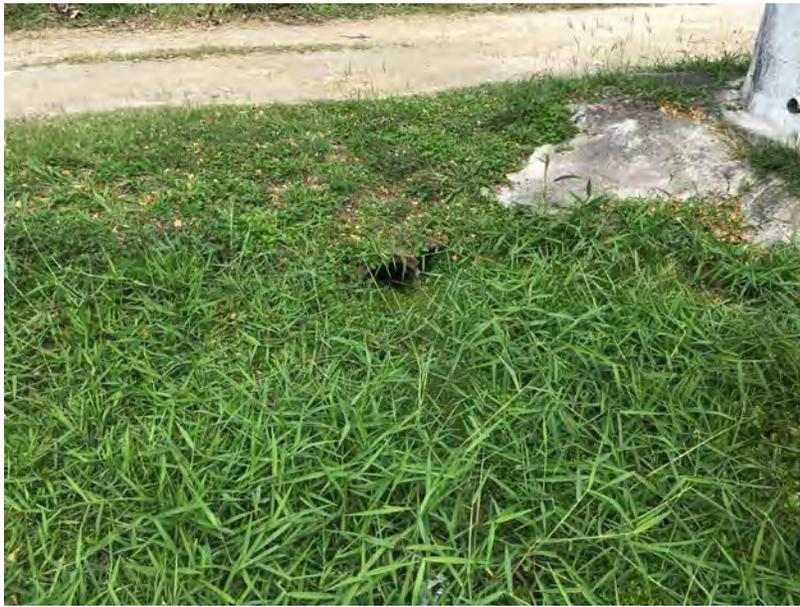
<p>USGS The National Map: National Boun... Powered by Esri</p>
<p>Enforcement Needed: No</p>	
<p>Severity Rating: 3</p>	
<p>Implementation Priority: It's OK (Med)</p>	
<p>Descriptions of Existing Conditions: Existing culvert clogged and unclear where it goes (off school property?).</p>	
<p>Description of Proposed Opportunity: Unclog culvert and consider a stormwater BMP at the downstream inlet.</p>	
<p>Challenges/Constraints:</p>	
<p>Additional Notes:</p>	
<p>Site Photo</p>

Additional Photo Caption: Outlet of culvert

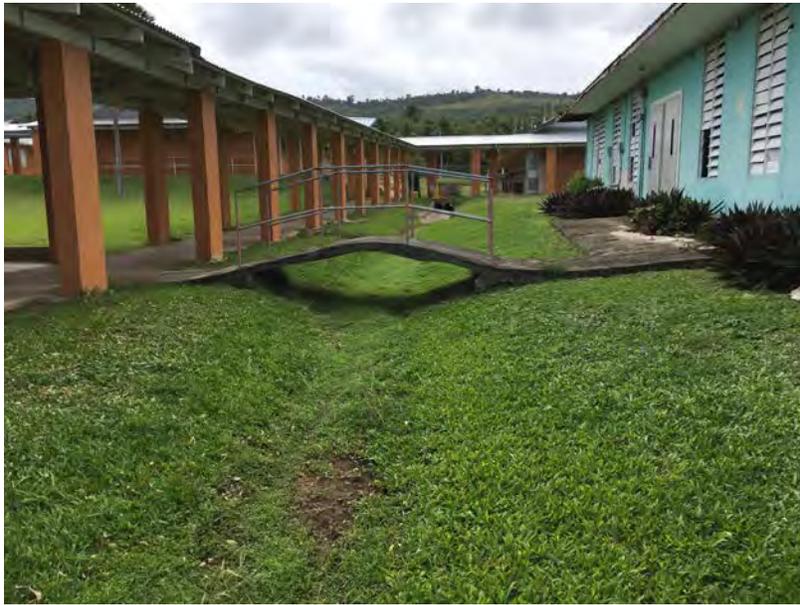
Additional Photo Caption: farther downstream of culvert

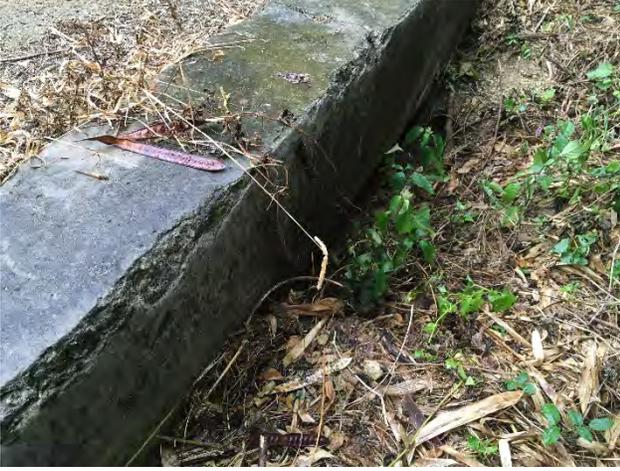
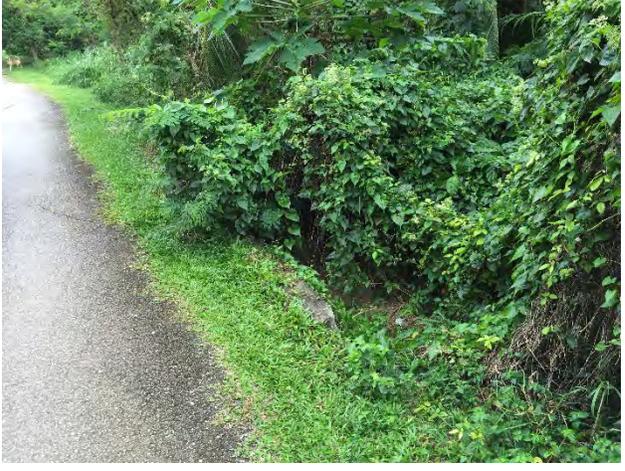
<p>Site ID: AS178</p>	<p>Watershed: Achugao South</p>
<p>Crew: EH</p>	<p>Date/Time:</p>
<p>Project Type:</p> <ul style="list-style-type: none"> • Drainage Infrastr., Maint. & Repair

<p>Enforcement Needed: Yes</p>	
<p>Severity Rating: 3</p>	
<p>Implementation Priority: Not that important (Low)</p>	
<p>Descriptions of Existing Conditions: Culvert clogged with lots of sediment (see AS158).</p>	
<p>Description of Proposed Opportunity: Clean culvert</p>	
<p>Challenges/Constraints: Off main roads.</p>	
<p>Additional Notes:</p>	
<p>Site Photo</p>

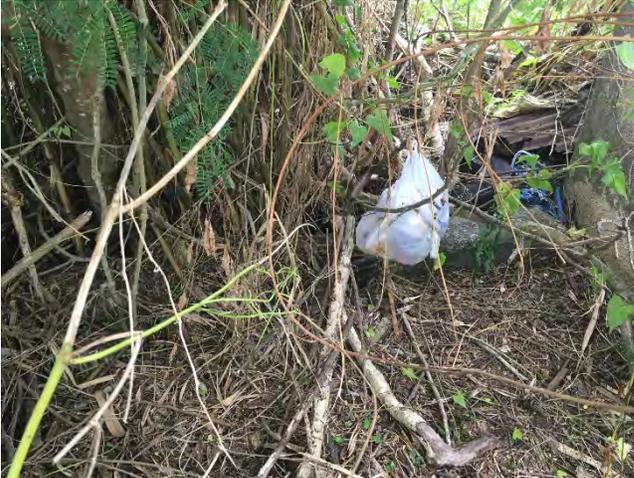
<p>Site ID: AS201</p>	<p>Watershed: Achugao South</p>
<p>Crew: JI</p>	<p>Date/Time:</p>
<p>Project Type:</p> <ul style="list-style-type: none"> • Drainage Infrastr., Maint. & Repair

<p>Enforcement Needed: Yes</p>	
<p>Severity Rating: 4</p>	
<p>Implementation Priority: It's OK (Med)</p>	
<p>Descriptions of Existing Conditions: Standing water and trash on open side. Trash and large vegetation on other side of the road/culvert with no standing water.</p>	
<p>Description of Proposed Opportunity: Clean out trash. Remove large vegetation restricting flow.</p>	
<p>Challenges/Constraints:</p>	
<p>Additional Notes:</p>	
<p>Site Photo</p>

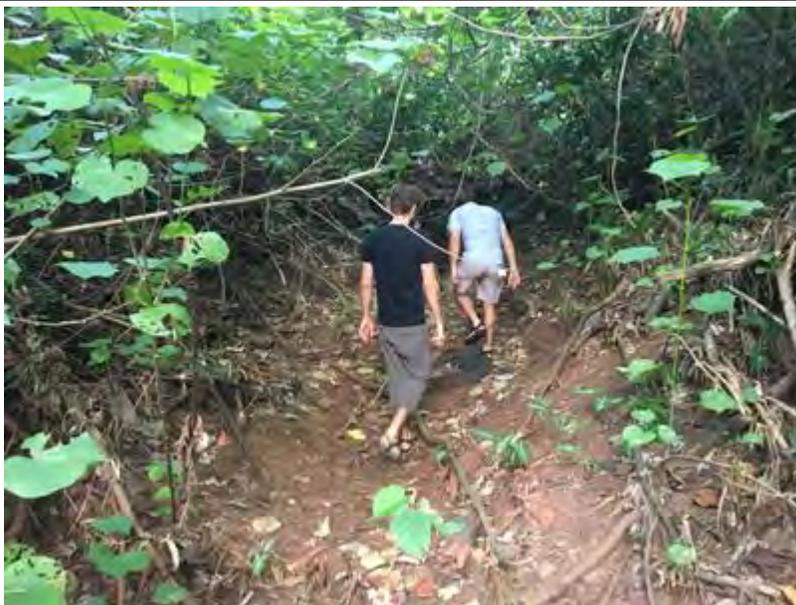
Descriptions of Existing Conditions:
 Imperial Casha. Site to be stabilized with vegetation, mulch, or other cover — it’s been left exposed for 2 yr+. Stream buffer encroachment and removal of vegetation in the buffer. Significant sedimentation is evident in stream bed. Existing sediment basins in need of maintenance/removal of accumulated sediment. What happened to the small isolated wetland that was supposed to be protected on site? This construction site is in clear violation of regulations. Is there a performance bond?

Site Overview Caption: Stream channel full of accumulated sediment from site, no perimeter controls or phased approach to site clearing. They are violating construction general permit leaving cleared soils exposed. Replant stream buffer and install perimeter controls.

Description of Proposed Opportunity:
 Site stabilization and restoration/protection of stream. Use money from fines to intervene on behalf of the owner who is not doing the work. Start with replanting vegetation in the buffer; add a perimeter berm to divert flows away from stream into additional sediment traps; clean out existing sediment basins; hydroseed remaining site. Take down the billboards so everyone can see what a horrific mess this place is.

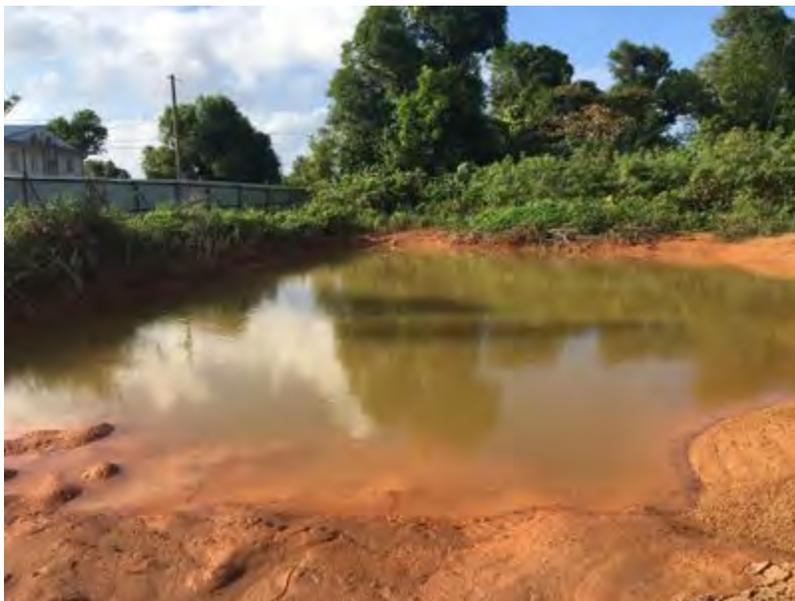
Additional Photo Caption: Sediment basin at entrance

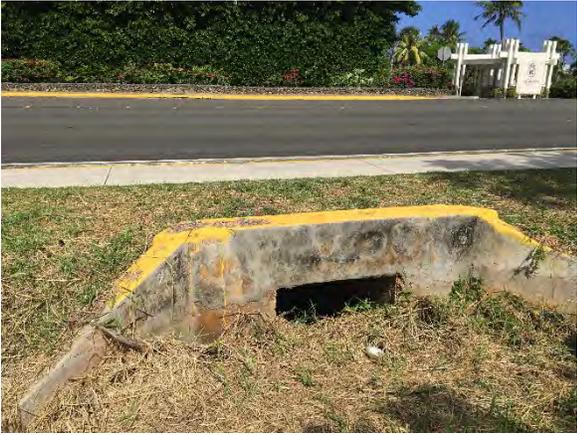
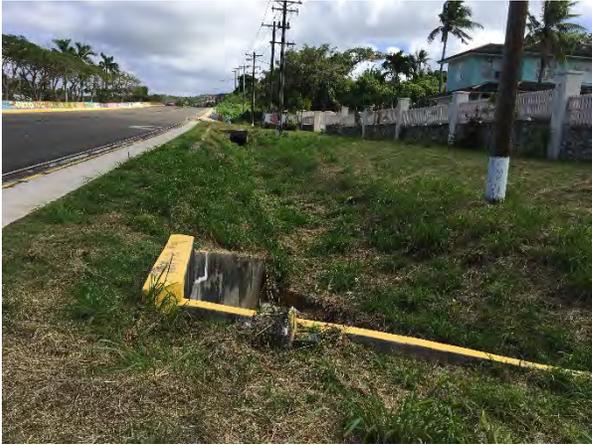
<p>Site ID: AN303</p>	<p>Watershed: Achugao North</p>
<p>Crew: JI</p>	<p>Date/Time: 01/20/2020 2:45 PM</p>
<p>Project Type:</p> <ul style="list-style-type: none"> Stormwater Retrofit

<p>Enforcement Needed: No</p>	
<p>Severity Rating: 3</p>	
<p>Implementation Priority: Love it! (High)</p>	
<p>Descriptions of Existing Conditions: Edge of road between sidewalk and utility poles approximately 25'Wx1000' owned by municipality. Dual box culverts as outlet</p>	
<p>Description of Proposed Opportunity: Green street. extend detention time and add check dams to road. Simple depression no more than 12" to maintain invert elevations for flow. Trash rack and sediment forebay are optional. Significant amount of road</p>	
<p>Challenges/Constraints:</p>	
<p>Additional Notes: Space available. Linear green street. Tree plantings - mature below UT lines. Same applies to AN304</p>	
<p>Site Photo</p>	
<div style="display: flex; justify-content: space-around;">

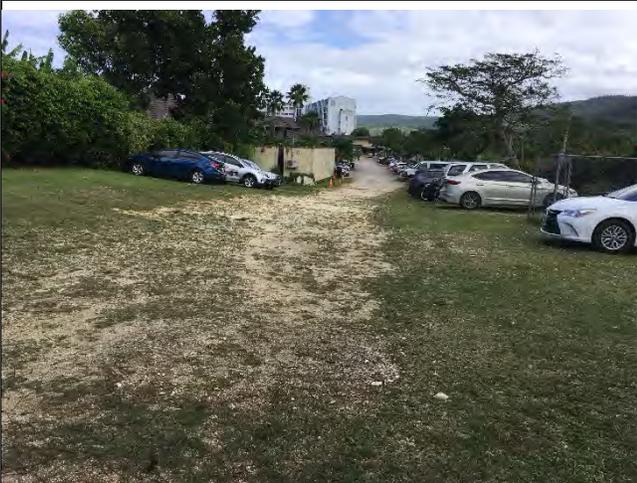
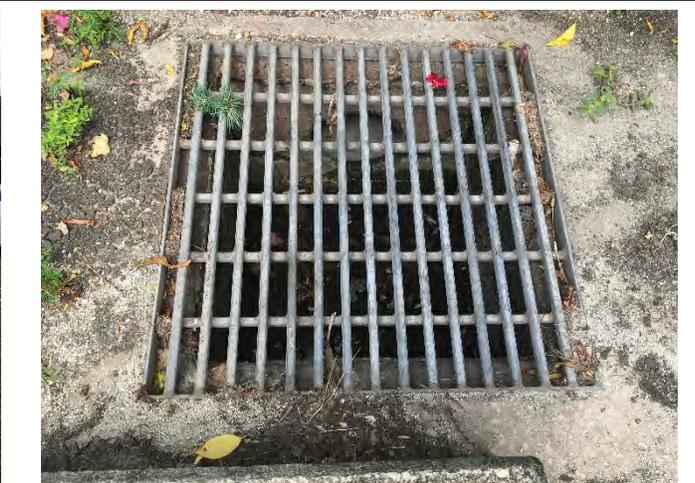
<p>USGS The National Map: National Boun... Powered by Esri</p>
<p>Enforcement Needed: No</p>	
<p>Severity Rating: 2</p>	
<p>Implementation Priority: It's OK (Med)</p>	
<p>Descriptions of Existing Conditions: Grass/Gravel lot overflow parking area contributes sediment to parking lot at Aqua Resort. -</p>	
<p>Description of Proposed Opportunity: access lane could be stabilized with grass pave or similar. Maintain/improve porosity and reduce channelized flow. This would be a great project to help achieve water quality improvement objectives of the CNMI Sustainable Hotels Guide</p>	
<p>Challenges/Constraints:</p>	
<p>Additional Notes:</p>	
<p>Site Photo</p>

<p>Site Overview Caption: Looking down flow path to the paved lot.</p>

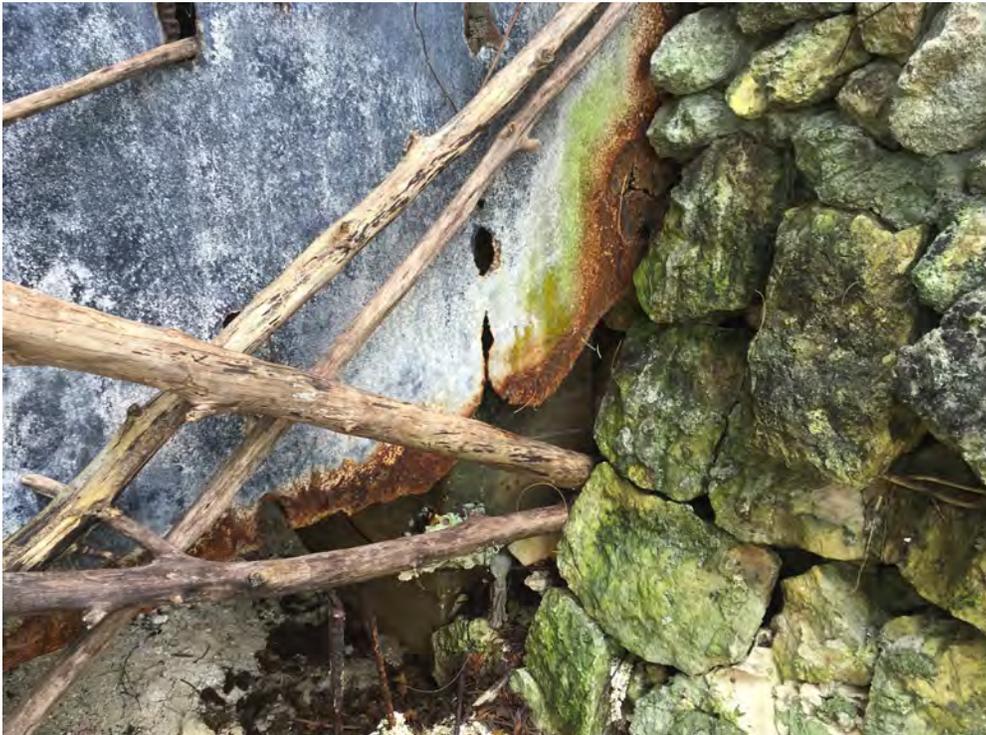
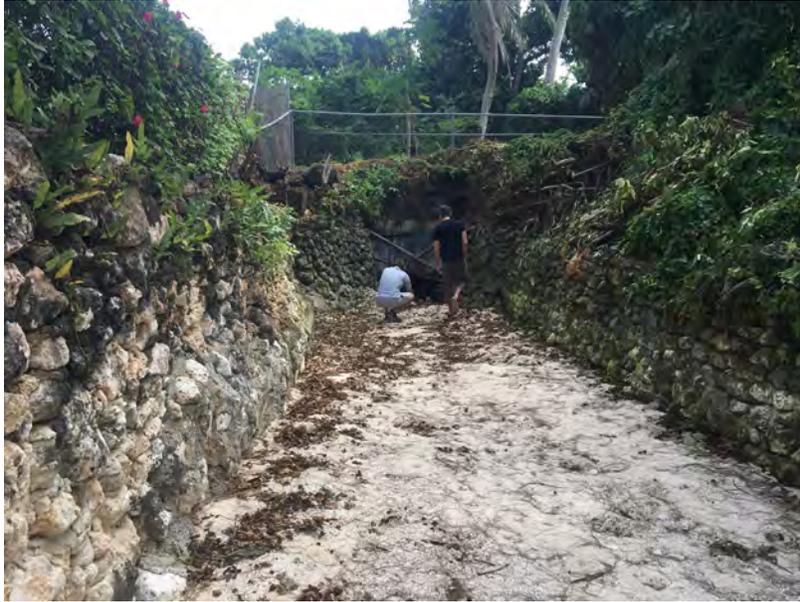
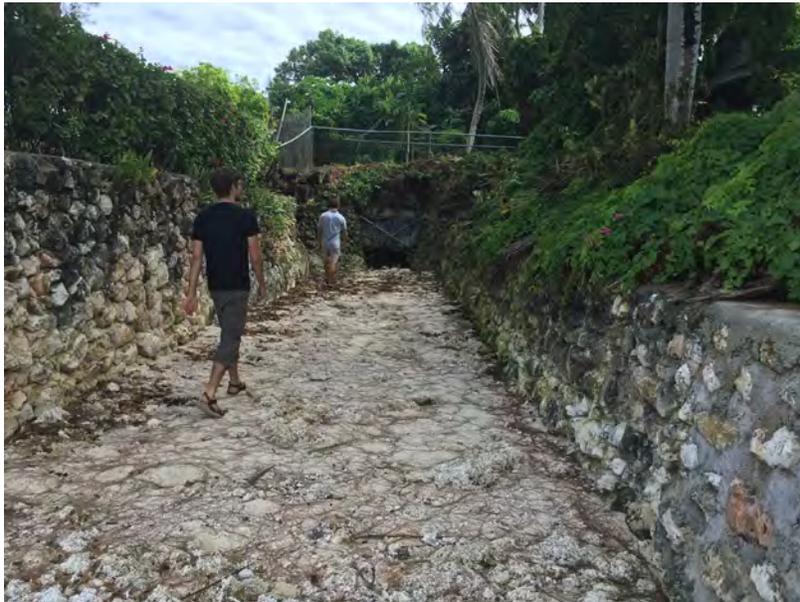
<p>Site ID: AN308</p>	<p>Watershed: Achugao North</p>
<p>Crew: JI</p>	<p>Date/Time:</p>
<p>Project Type:</p> <ul style="list-style-type: none"> • Drainage Infrastr., Maint. & Repair

<p>USGS The National Map: National Boun... Powered by Esri</p>
<p>Enforcement Needed: Yes</p>	
<p>Severity Rating: 3</p>	
<p>Implementation Priority: It's OK (Med)</p>	
<p>Descriptions of Existing Conditions: Damaged storm gate at channelized outlet north of the Aqua Resort held up by sticks and some rebar</p>	
<p>Description of Proposed Opportunity: Remove debris and repair or replace gate; determine if the purpose of metal cover is to block access to the outfall/culvert, or if it to prevent storm surge.</p>	
<p>Challenges/Constraints:</p>	
<p>Additional Notes:</p>	
<p>Site Photo</p>

outfall - Damaged storm gate held up by sticks. Existing rebar. some existing rebar is still there

Repair storm gate structure

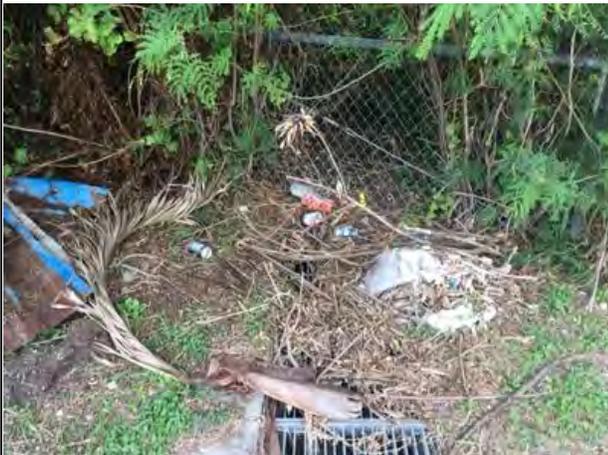
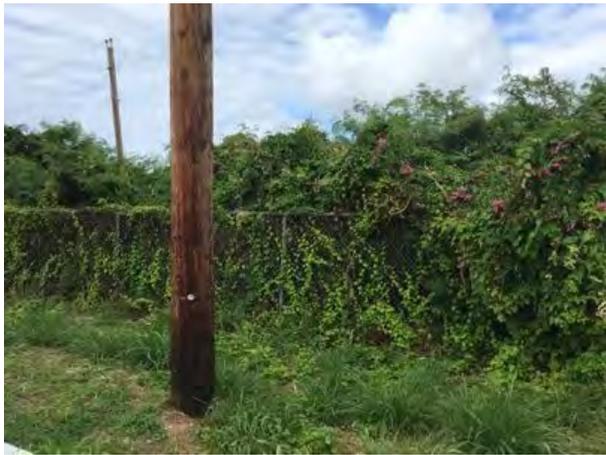
<p>Enforcement Needed: No</p>	
<p>Severity Rating: 4</p>	
<p>Implementation Priority: It's OK (Med)</p>	
<p>Descriptions of Existing Conditions: Existing trench drain at school drains to infiltration or ponding basin; overflow backs up into trench drain at south of school at access road and discharges into wooded basin. Trash and debris collecting along drain line.</p>	
<p>Description of Proposed Opportunity: Educational opportunity at school for invasive management and conversion of basin into bioretention basin. Overgrowth could be thinned and bio basin formed. Plant bioretention with native species. Highly visible educational opportunity. Enhanced capacity with more appreciation. Develop a routine maintenance plan for the drainage system.</p>

<p>Site Overview Caption: Trench drain and fenced in area</p>

<p>Challenges/Constraints: Buried electrical or communication lines</p>	
<p>Additional Notes: Should evaluate existing basin to determine if lack of maintenance is the capacity issue or if enhanced capacity is warranted with a retrofit</p>	
<p>Site Photo</p>

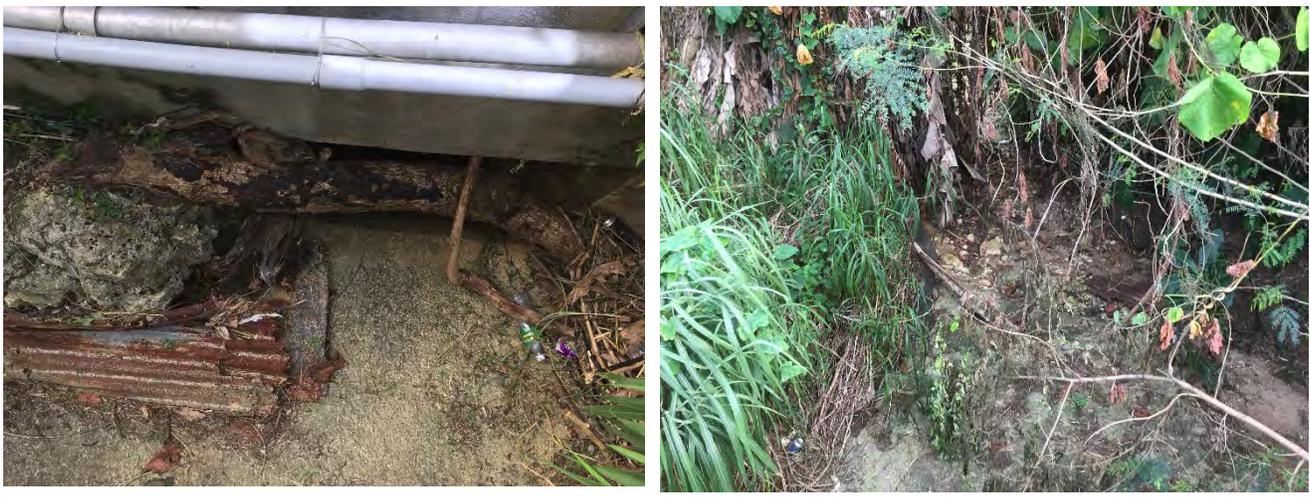
<p>Site ID: AN314</p>	<p>Watershed: Achugao North</p>
<p>Crew:</p>	<p>Date/Time:</p>
<p>Project Type:</p> <ul style="list-style-type: none"> • Drainage Infrastr., Maint. & Repair

<p>Enforcement Needed: Yes</p>	
<p>Severity Rating: 3</p>	
<p>Implementation Priority: It's OK (Med)</p>	
<p>Descriptions of Existing Conditions: trash and debris blocking culvert. Damage to structure</p>	
<p>Description of Proposed Opportunity: Clean out culvert and make repairs</p>	
<p>Challenges/Constraints: none</p>	
<p>Additional Notes:</p>	
<p>Site Photo</p>

trash & debris blocking culvert
damage to structure

Clean out culvert & make repairs

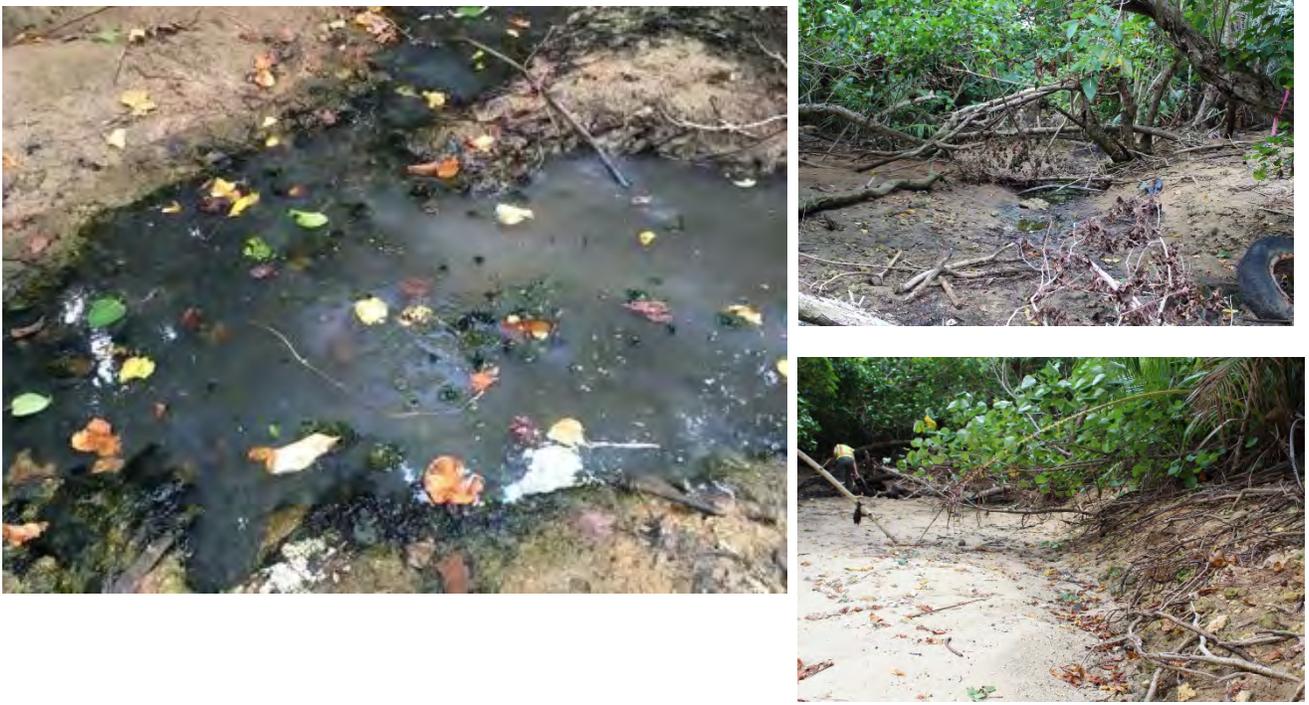
<p>Site ID: AN318</p>	<p>Watershed: Achugao North</p>
<p>Crew: JI</p>	<p>Date/Time: 01/20/2020 7:17 PM</p>
<p>Project Type:</p> <ul style="list-style-type: none"> • Stream/Wetland Restoration • Shoreline stabilization

<p>Enforcement Needed: No</p>	
<p>Severity Rating: 3</p>	
<p>Implementation Priority: Low</p>	
<p>Descriptions of Existing Conditions: Dogas Channel width 17' at outlet on shoreline. Channel showing hairline root exposure/erosion. Mild sheen on open water pockets - minimal trash. Likely bacteria sheen. No infrastructure being threatened.</p>	
<p>Description of Proposed Opportunity: Restoration and stabilization. Channel edge/revegetation/stabilization; likely projects further up in the watershed to help reduce bank erosion.</p>	
<p>Challenges/Constraints: Storm surge; accessibility</p>	
<p>Additional Notes:</p>	
<p>Site Photo</p>

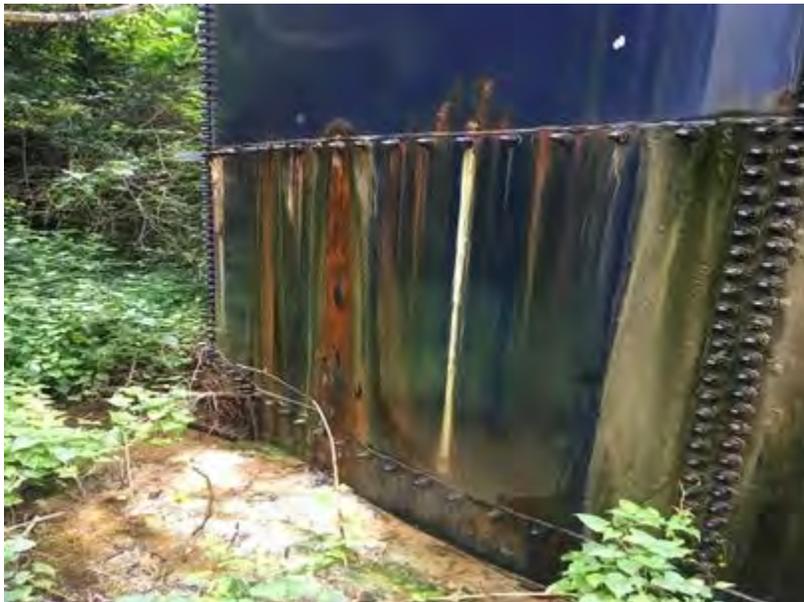
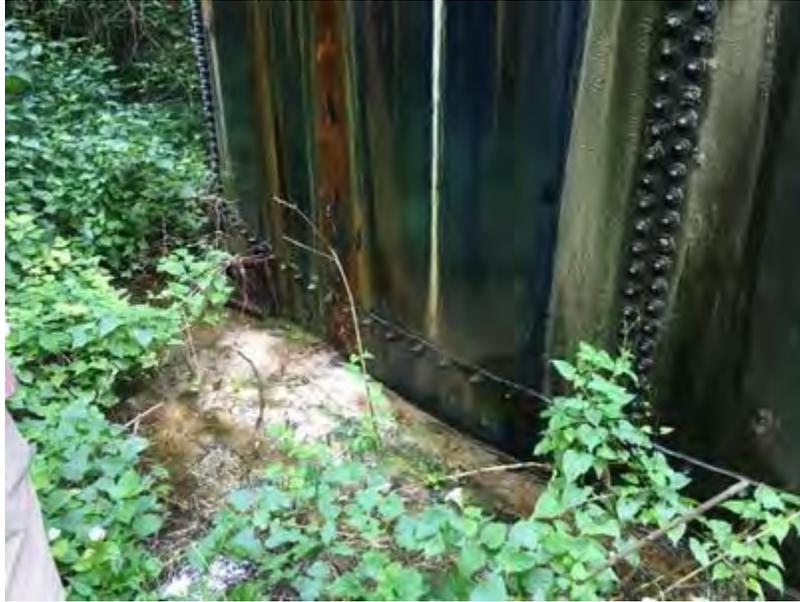
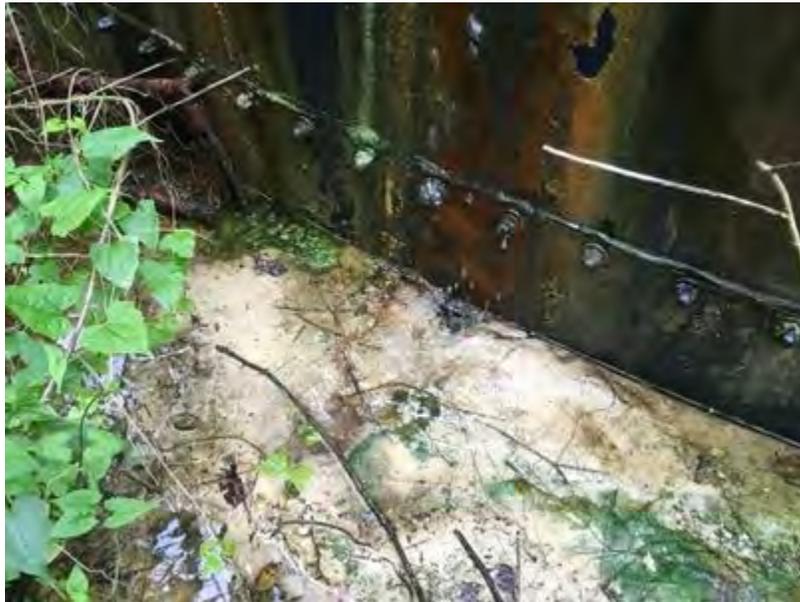
<p>Site ID: AN319</p>	<p>Watershed: Achugao North</p>
<p>Crew: JI</p>	<p>Date/Time: 01/20/2020 7:35 PM</p>
<p>Project Type:</p> <ul style="list-style-type: none"> Maintenance of tank

<p>Enforcement Needed: Yes</p>	
<p>Severity Rating: 0 (Not significant)</p>	
<p>Implementation Priority: Not that important (Low)</p>	
<p>Descriptions of Existing Conditions: Tank leaking through hole. Looks like it hasn't been used in a while, is this active CUC water tank? Standing water around tank.</p>	
<p>Description of Proposed Opportunity: Investigate leak to determine if it is an issue or simply an overflow. Clear vegetation around tank for better access.</p>	
<p>Challenges/Constraints: Access to the site is not easy, but there is an unpaved road to the site</p>	
<p>Additional Notes: Are these still actively used as part of the waters system or have they been abandoned?</p>	
<p>Site Photo</p>

Tank leaking through hole. Looks like it hasn't been used in awhile. Standing water around tank

Fix leak?

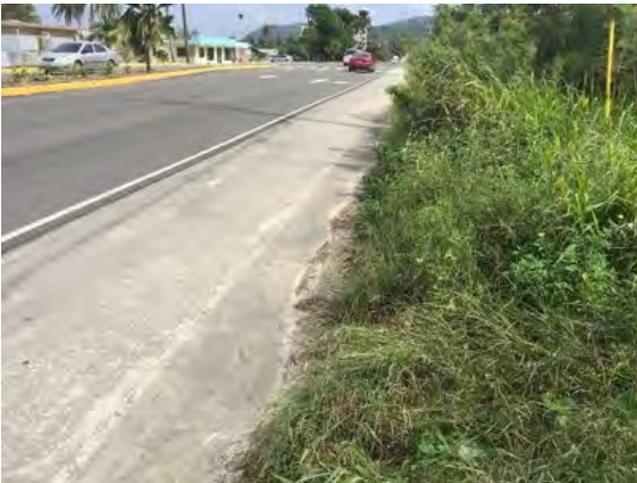
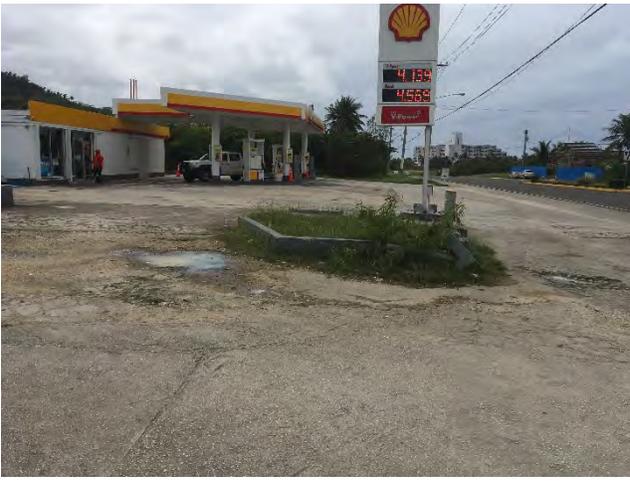
<p>Site ID: AN328</p>	<p>Watershed: Achugao North</p>
<p>Crew: JI</p>	<p>Date/Time: 01/20/2020 9:54 PM</p>
<p>Project Type:</p> <ul style="list-style-type: none"> Stormwater Retrofit

<p>Enforcement Needed: No</p>	
<p>Severity Rating: 3</p>	
<p>Implementation Priority: It's OK (Med)</p>	
<p>Descriptions of Existing Conditions: Sediment. At San Roque Market flows from parking to concrete swale at edge of Route 30. Minimal pitch in either direction. Sediment build up in channel along roadside. Vacant/wooded lot to north of low point. Potential GSI practice. Shell gas station also located in the contributing drainage area.</p>	
<p>Description of Proposed Opportunity: Erosion control. Install a vegetated sand filter to help with oil/grease and other water quality issues at site?</p>	
<p>Challenges/Constraints: property ownership?</p>	
<p>Additional Notes:</p>	
<p>Site Photo</p>	
<div style="display: flex; justify-content: space-around;">

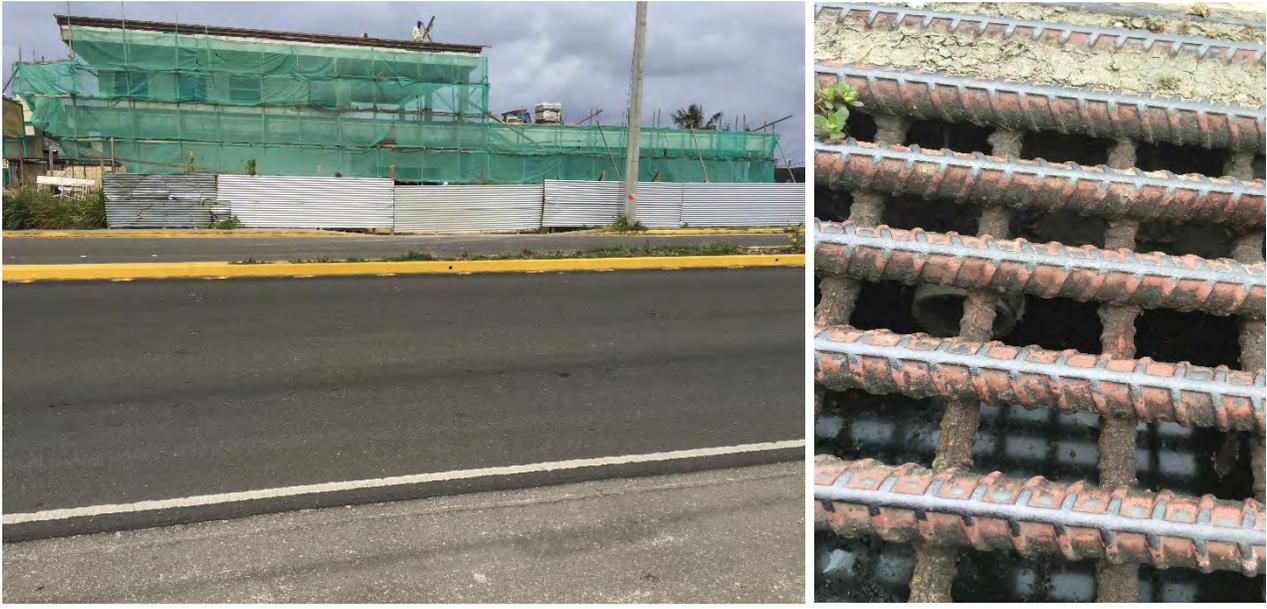
<p>Site ID: AN330</p>	<p>Watershed: Achugao North</p>
<p>Crew: JI</p>	<p>Date/Time: 01/20/2020 9:59 PM</p>
<p>Project Type:</p> <ul style="list-style-type: none"> Stormwater Retrofit

<p>USGS The National Map: National Boun... Powered by Esri</p>
<p>Enforcement Needed: No</p>	
<p>Severity Rating: 3</p>	
<p>Implementation Priority: It's OK (Med)</p>	
<p>Descriptions of Existing Conditions: Across from shell gas station - road is flat and sediment accumulates on street – low point is wooded. Near new condo construction - lease line unknown</p>	
<p>Description of Proposed Opportunity: Install bioretention in linear outlet swale</p>	
<p>Challenges/Constraints: land ownership</p>	
<p>Additional Notes:</p>	
<p>Site Photo</p>

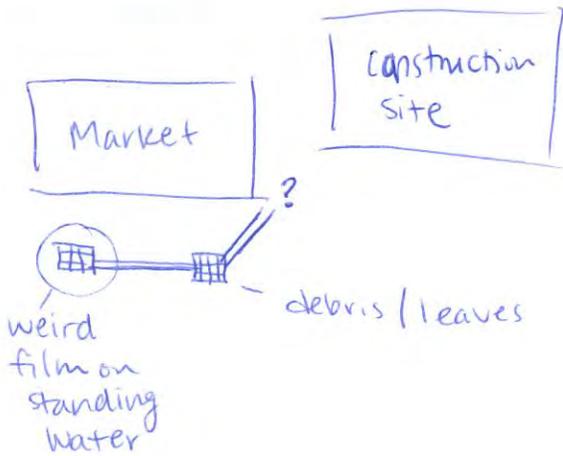
CBS in parking lot are connected. Sheen / film was observed on Western CB. May be from stop sink located inside market.

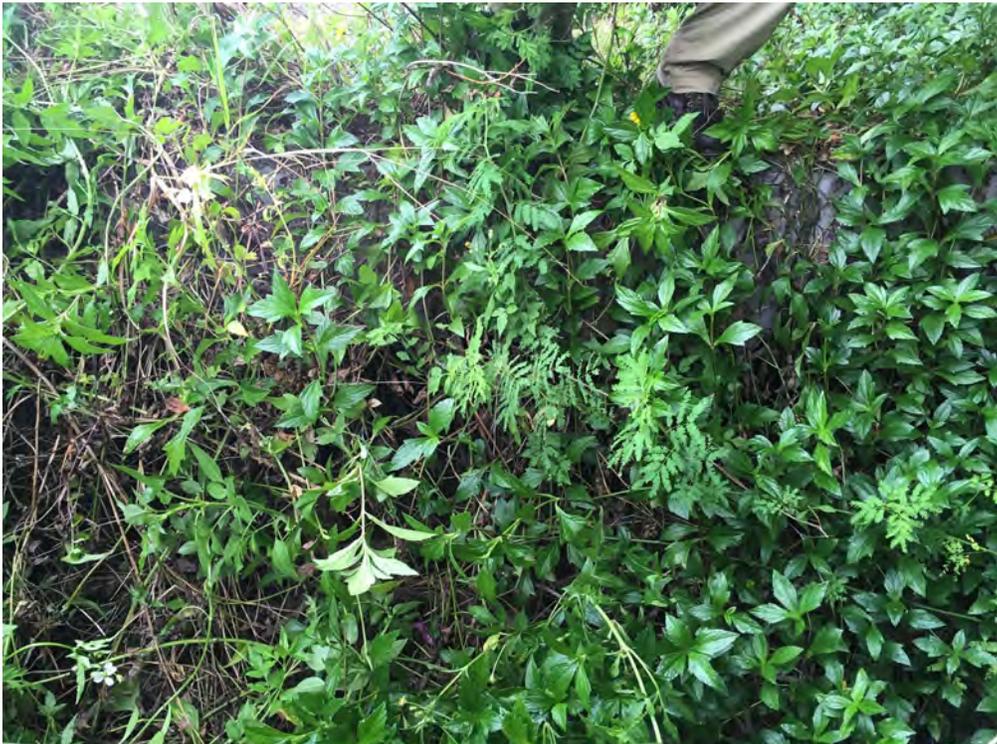
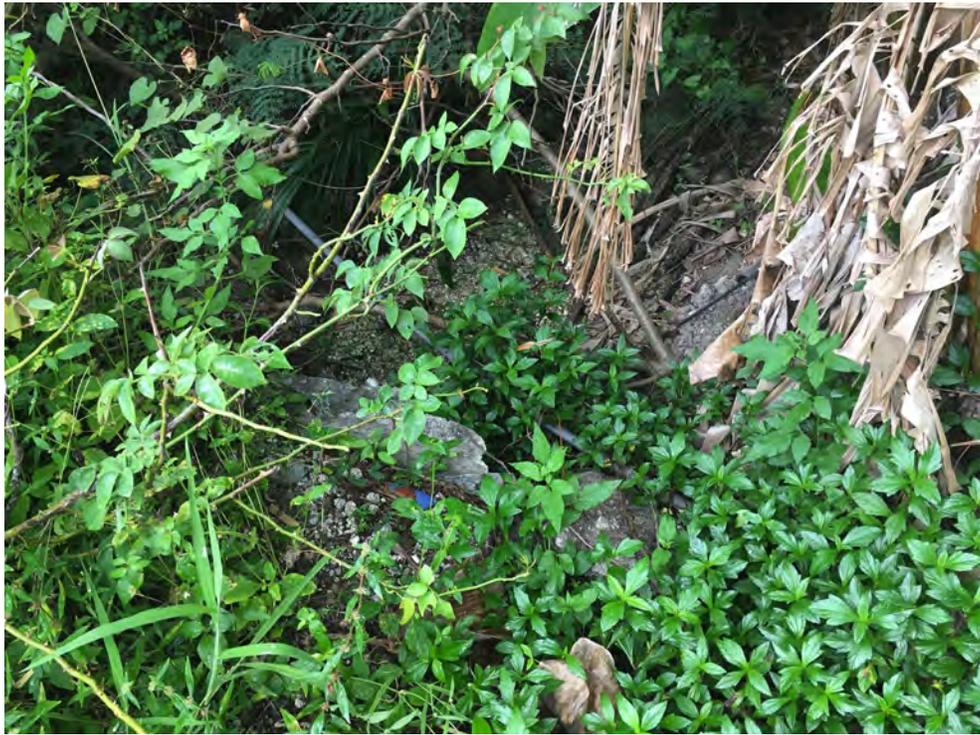
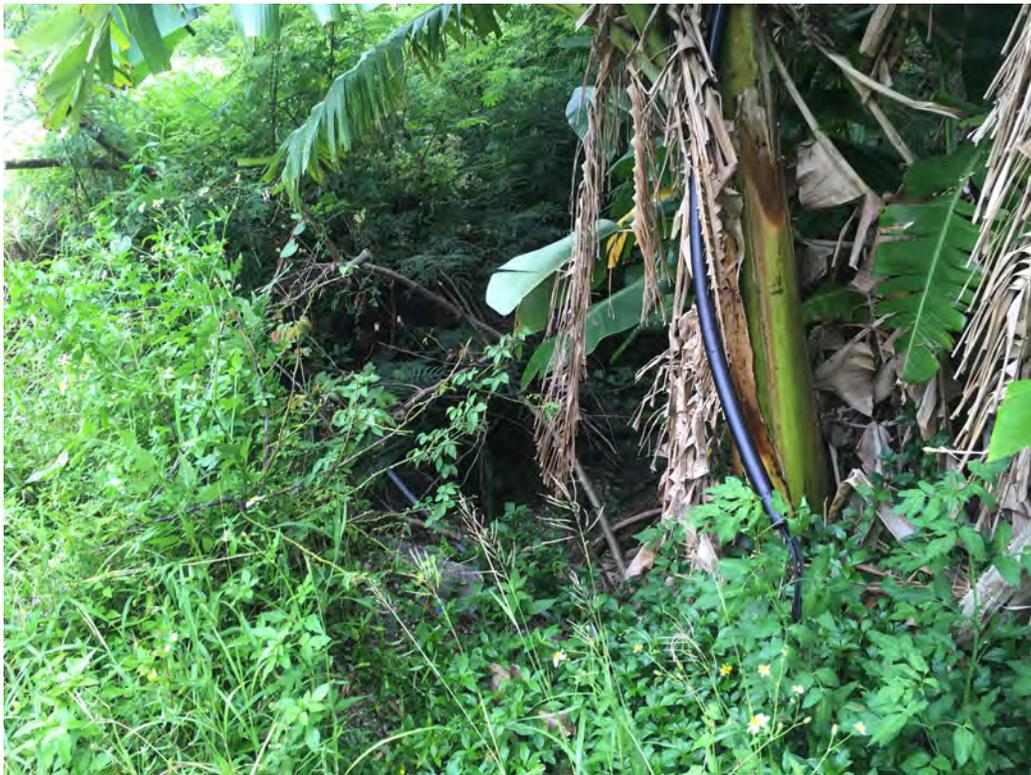
<p>Site ID: AN342</p>	<p>Watershed: Achugao North</p>
<p>Crew: JI</p>	<p>Date/Time:</p>
<p>Project Type:</p> <ul style="list-style-type: none"> • Drainage Infrastr., Maint. & Repair

<p>USGS The National Map: National Boun... Powered by Esri</p>
<p>Enforcement Needed: Yes</p>	
<p>Severity Rating: 4</p>	
<p>Implementation Priority: It's OK (Med)</p>	
<p>Descriptions of Existing Conditions: Overgrown vegetation in trench. Power/telephone line down in trench. Serious damage to structure.</p>	
<p>Description of Proposed Opportunity: Remove excess vegetation, repair structure, and repair/remove damaged utility line</p>	
<p>Challenges/Constraints:</p>	
<p>Additional Notes:</p>	
<p>Site Photo</p>

Overgrown vegetation in trench. serious damage to drainage structure. Power or telephone line is down in trench.

Remove excess vegetation, repair structure, and repair/remove damaged utility line

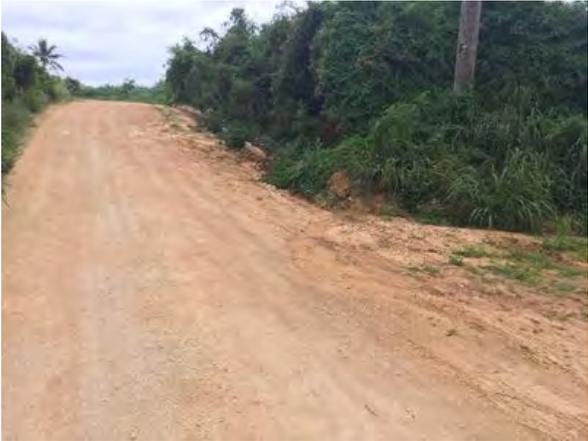
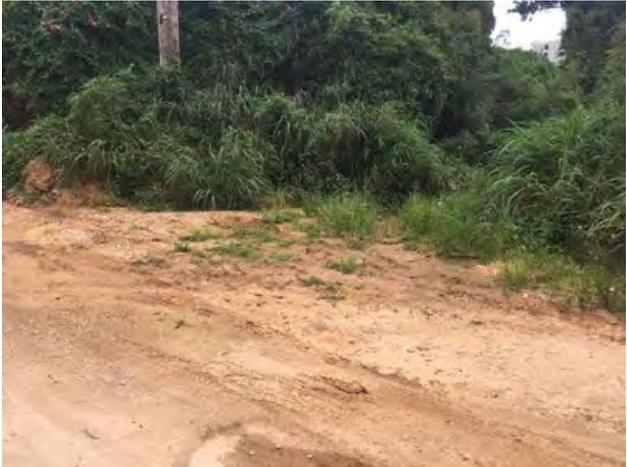
<p>Site ID: AN344</p>	<p>Watershed: Achugao North</p>
<p>Crew: JI</p>	<p>Date/Time: 01/21/2020 1:31 AM</p>
<p>Project Type:</p> <ul style="list-style-type: none"> Unpaved Road Stabilization

<p>Enforcement Needed: No</p>	
<p>Severity Rating: 4</p>	
<p>Implementation Priority: It's OK (Med)</p>	
<p>Descriptions of Existing Conditions: Old mall dirt road. where dirt turns and meets back of the mall (Magazine Drive). Gulling and wash/sediment accumulation at low point. Road also seems much wider (20') than needed.</p>	
<p>Description of Proposed Opportunity: Road stabilization - suggest paved to top of turn/construction site - or water bars/cross drains and collection swale with check dams. Need a place to collect runoff/turn out.</p>	
<p>Challenges/Constraints: Construction site nearby. Steep unpaved road.</p>	
<p>Additional Notes:</p>	
<p>Site Photo</p>	
<div style="display: flex; justify-content: space-around;">

Challenges/Constraints: Steep Unpaved Road

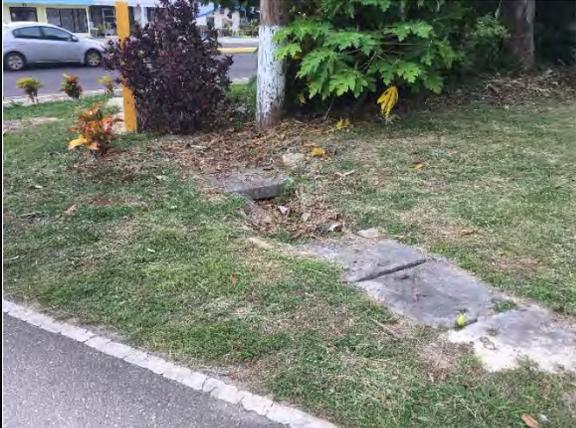
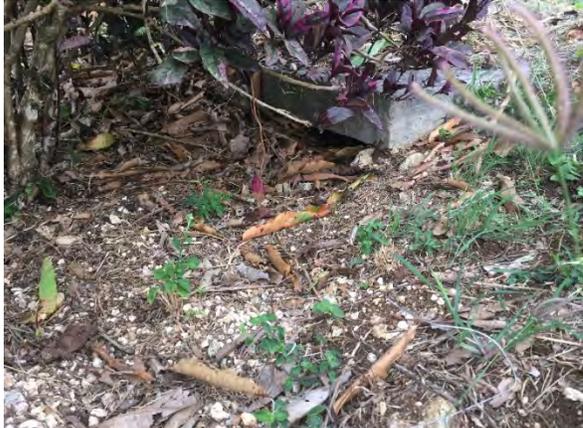
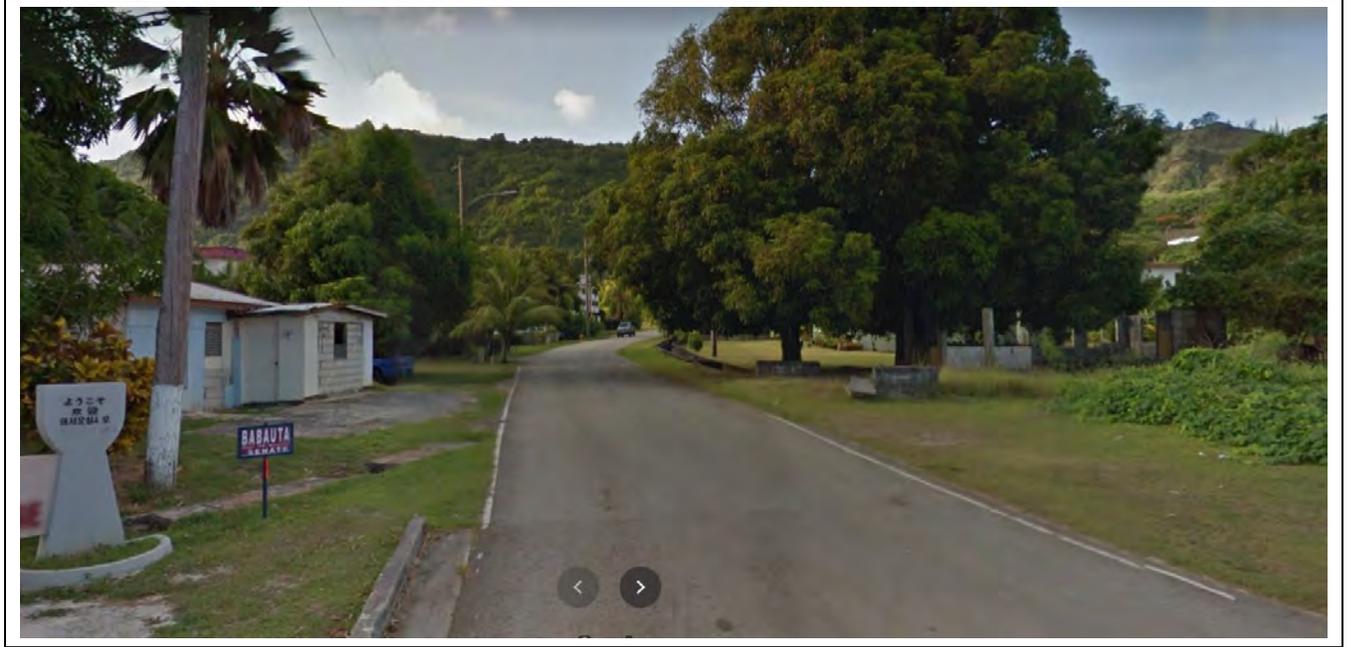
<p>Site ID: AN346</p>	<p>Watershed: Achugao North</p>
<p>Crew: JI + BAL</p>	<p>Date/Time:</p>
<p>Project Type:</p> <ul style="list-style-type: none"> • Drainage Infrastructure Maintenance and Repairs • Pavement Reduction • Retrofit

<p>Enforcement Needed: Yes</p>	
<p>Severity Rating: 2</p>	
<p>Implementation Priority: It's OK (Med)</p>	
<p>Descriptions of Existing Conditions: Full of leaves. Broken section of concrete structure. Lack of pretreatment.</p>	
<p>Description of Proposed Opportunity: Clean out leaves and repair concrete structure. Reduce existing road widths within San Roque and install linear bioswales to collect and treat road runoff.</p>	
<p>Challenges/Constraints: Large drainage area, must be divided into smaller subcatchments to properly manage. Stormwater conveyance of natural stream is directed into concrete trench and conveyed adjacent to road. Treatment opportunities within the developed San Roque Village will need to accommodate vehicular and pedestrian circulation patterns. Capacity/sizing of concrete trench and proposed BMPs should be analyzed prior to continued development within the Village for future impervious cover and associated retrofits.</p>

full of leaves ; broken section of concrete structure

Clean out leaves and repair concrete structure

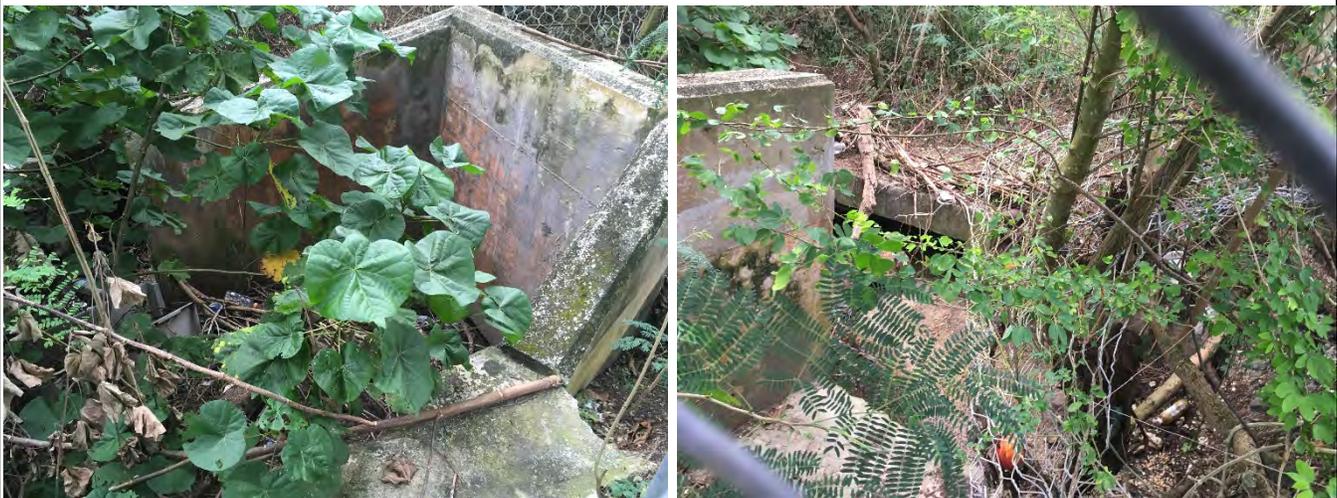
Channel and culvert full of trash and overgrown vegetation and stagnant water. Neighbors report having problems with trash and mosquitoes and complained about needing to clean up. Flood issues in past. Includes drainage points AN345 and AN350. Culverts on both ends of area have trash. Open channel is fenced off; on drive entrance to school. Hard to see condition of channel due to vegetation.

General maintenance – need to clean out vegetation and remove trash. Reevaluate channel to determine if stream/buffer restoration is appropriate. Important to re-establish positive drainage at this site to avoid mosquito breeding conditions. Could be opportunity to beautify area and provide education for school on drainage. Further investigate opportunities upstream for retrofits/volume reduction.

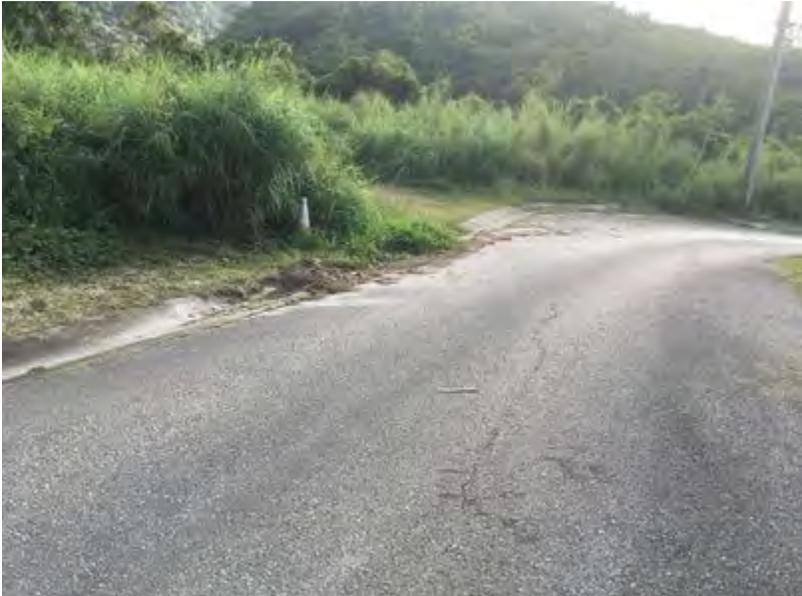
<p>Site ID: AN351</p>	<p>Watershed: Achugao North</p>
<p>Crew: JI</p>	<p>Date/Time: 01/20/2020 2:23 AM</p>
<p>Project Type:</p> <ul style="list-style-type: none"> • Drainage Infrastr., Maint. & Repair

<p>USGS The National Map: National Boun... Powered by Esri</p>
<p>Enforcement Needed: Yes</p>	
<p>Severity Rating: 3</p>	
<p>Implementation Priority: Not that important (Low)</p>	
<p>Descriptions of Existing Conditions: Significant sediment accumulation in swale</p>	
<p>Description of Proposed Opportunity: Clean out swale to allow for appropriate drainage.</p>	
<p>Challenges/Constraints: none</p>	
<p>Additional Notes:</p>	
<p>Site Photo</p>

Inspect & remove accumulated
debris to prevent channel
from clogging.
