Saipan Watershed Assessment 2020

<p>Site ID: AS102</p>	<p>Watershed: Achugao South</p>
<p>Crew: EH</p>	<p>Date/Time: 01/19/2020 8:33 PM</p>
<p>Project Type:</p> <ul style="list-style-type: none"> • Drainage Infrastr., Maint. & Repair

2020 SAIPAN WATERSHED FIELD NOTES

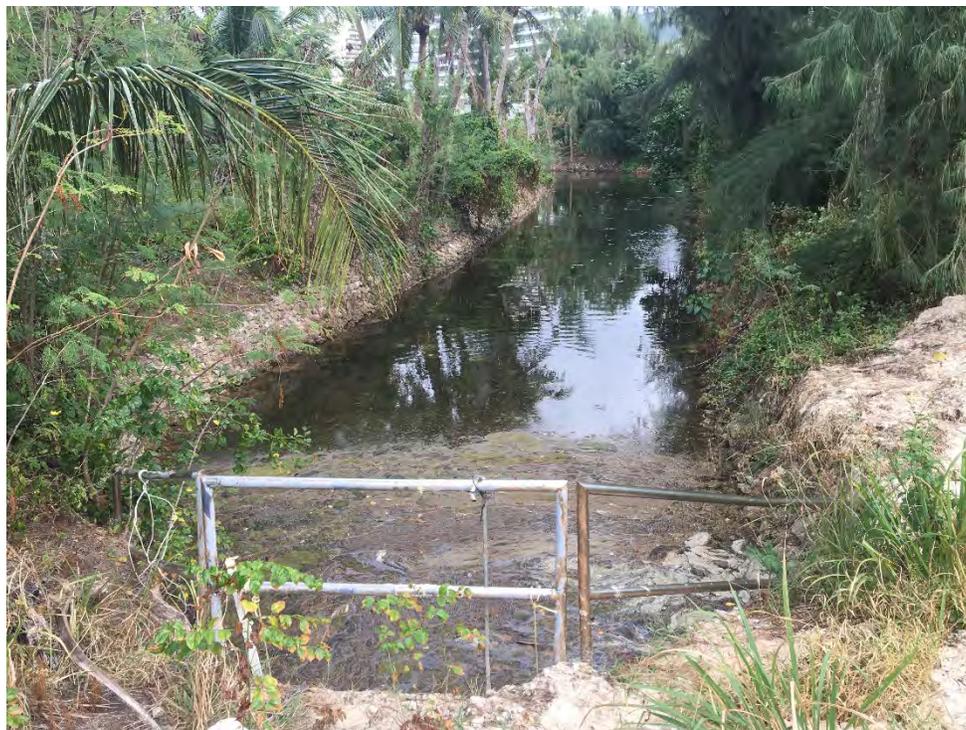
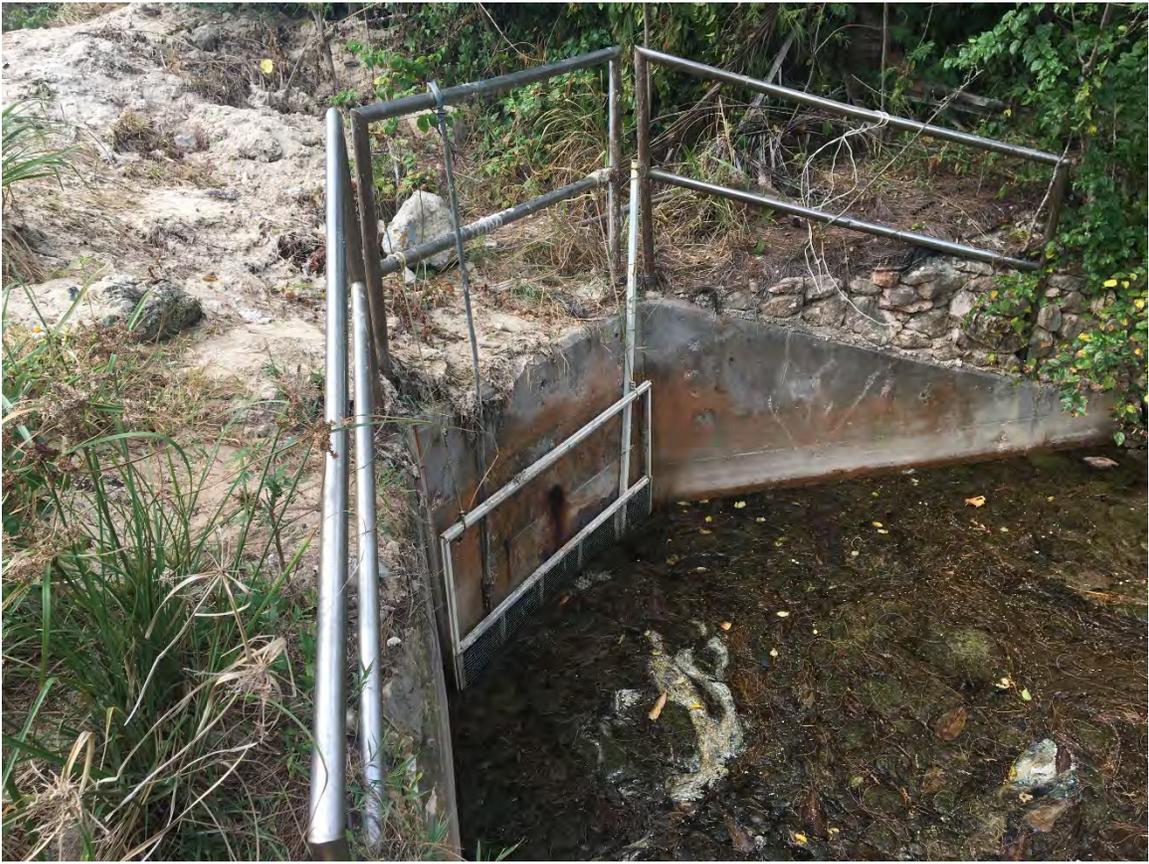
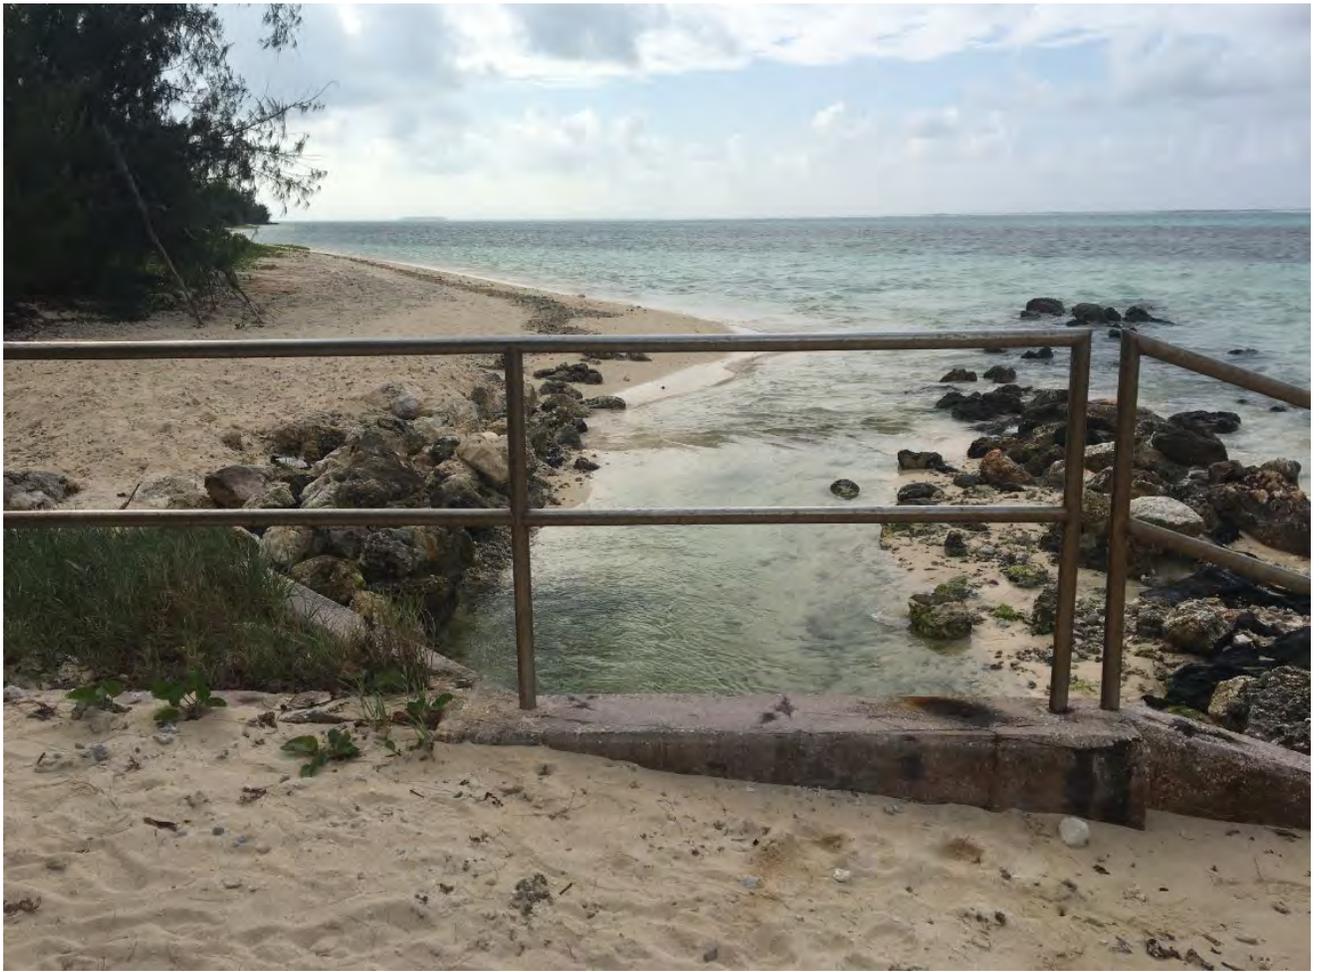
Descriptions of Existing Conditions:
 Existing ponds at Kensington, full of algae and possibly dead jellyfish. Smells. Discharges onto beach. See drainage form

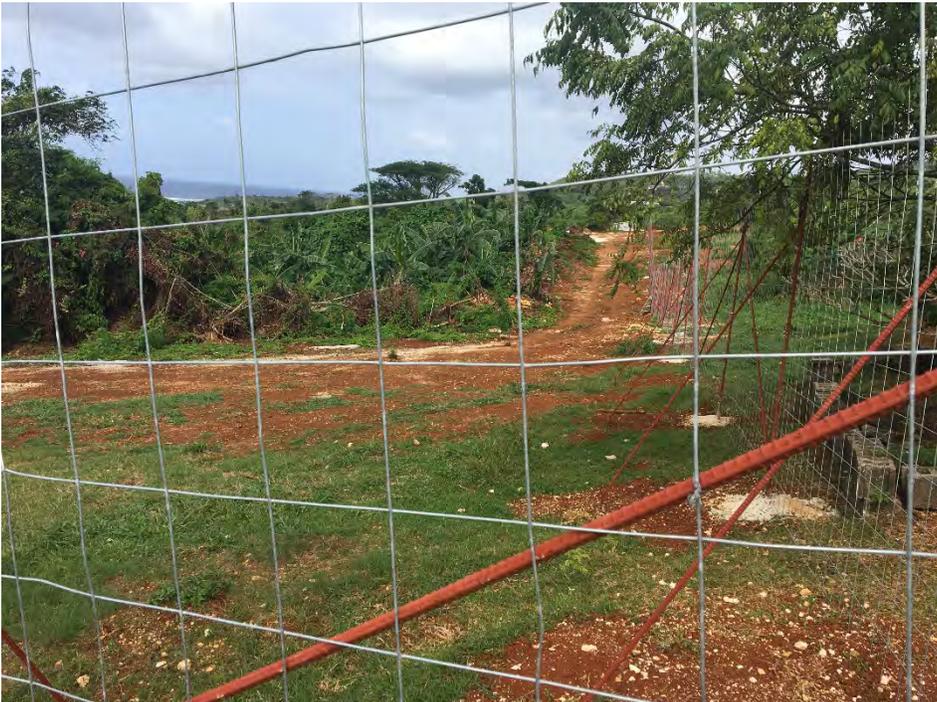
<p>Site ID: AN-502</p>	<p>Watershed: Achugao North</p>
<p>Crew: AK</p>	<p>Date/Time: 01/20/2020 6:19 AM</p>
<p>Project Type:</p> <ul style="list-style-type: none"> Construction Site ESC

<p>USGS The National Map: National Boun... Powered by Esri</p>
<p>Enforcement Needed: No</p>	
<p>Severity Rating: 2</p>	
<p>Implementation Priority: It's OK (Med)</p>	
<p>Descriptions of Existing Conditions: Beverly construction site. No evidence of issues yet, but also not able to observe ESC practices, including perimeter controls.</p>	
<p>Description of Proposed Opportunity: Recently started clearing, active work on site. Need to get out to inspect to ensure proper ESC.</p>	
<p>Challenges/Constraints:</p>	
<p>Additional Notes:</p>	
<p>Site Photo</p>

<p>Site Overview Caption: photo from perimeter of site.</p>

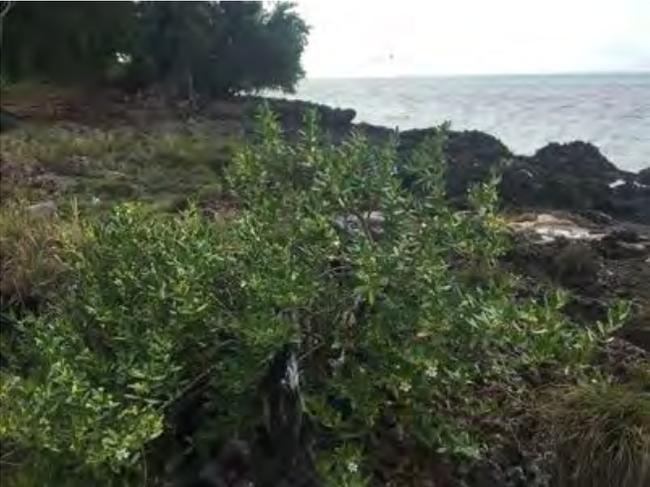
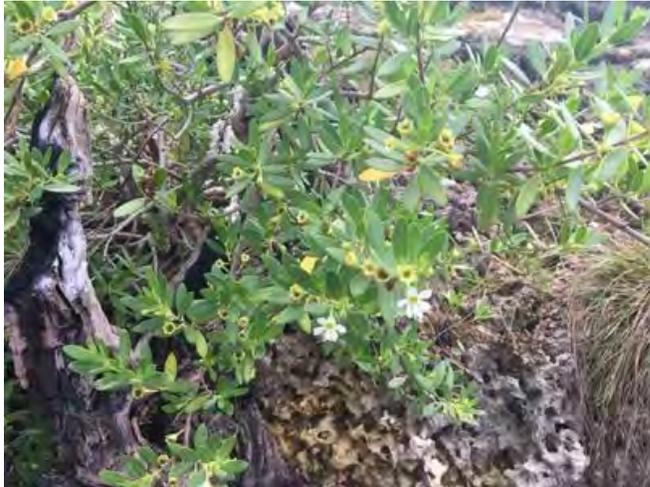
<p>The map shows the coastal area of Achugao, Saipan. A blue location pin is placed on the shoreline. Labels include 'PACIFIC OCEAN', 'Achugao', 'San Roque', 'CHALAI', and 'TANKO DR'. The map is credited to 'USGS The National Map: National Boun...' and 'Powered by Esri'.</p>
<p>Enforcement Needed: No</p>	
<p>Severity Rating: 3</p>	
<p>Implementation Priority: It's OK (Med)</p>	
<p>Descriptions of Existing Conditions: Zachary Williams identified potential Bonsai Mangrove species growing out of karst shoreline at Saipan Global construction. There is potential application from hotel to build a boardwalk along karst shoreline to give guests access to water (there is no sandy beach at this site).</p>	
<p>Description of Proposed Opportunity: Protect bonsai mangrove—need to confirm species. Need to review beach access plans to ensure protection of mangrove</p>

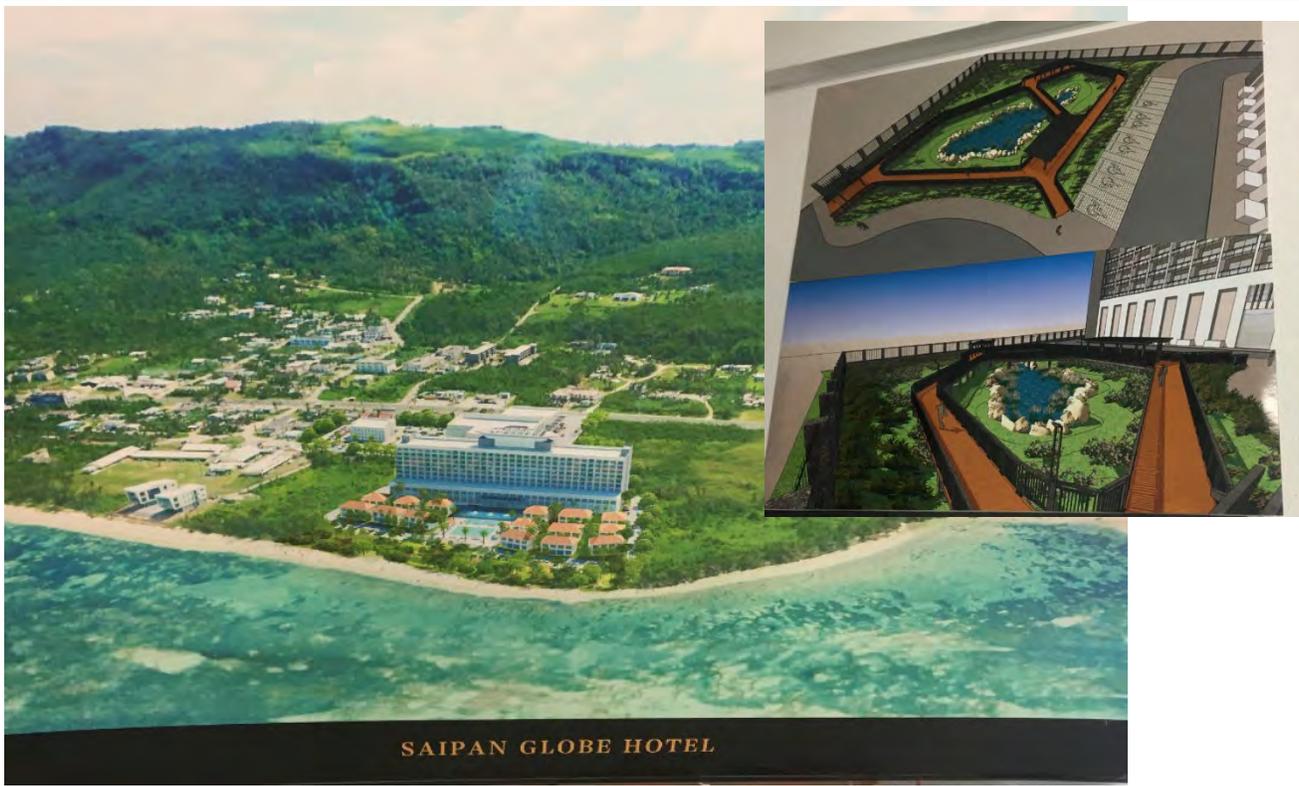
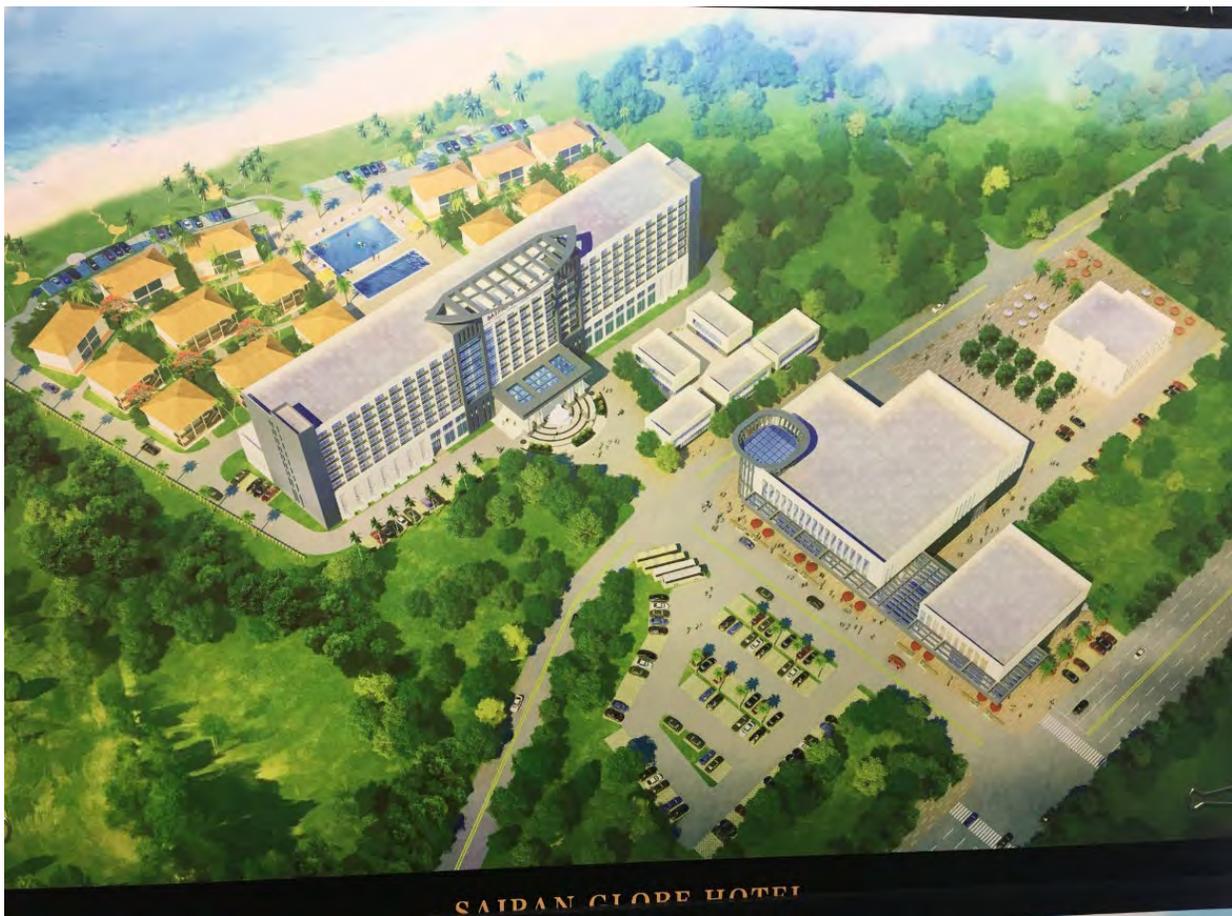
</div>	
<p>Site Overview Caption: Wall constructed to separate section of wetland to be used for stormwater management. Soil stockpiles in wetland area.</p>

Caption: Renderings of resort design showing “stormwater wetland” amenity with boardwalk, sandy beach, and other elements of site (no other stormwater BMPs shown).

<p>USGS The National Map: National Boun... Powered by Esri</p>
<p>Enforcement Needed: Yes</p>	
<p>Severity Rating: 4</p>	
<p>Implementation Priority: Love it! (High)</p>	
<p>Descriptions of Existing Conditions: Global Saipan walled off section of existing wetland to be used as stormwater practice for resort and convention center. From renderings, the facility does not appear to be sized to manage the full development, but no other stormwater management BMPs are shown.</p>	
<p>Description of Proposed Opportunity: Revisit permit to ensure compliance with stormwater standards. Require mitigation or make them restore wetland and redesign stormwater plan.</p>

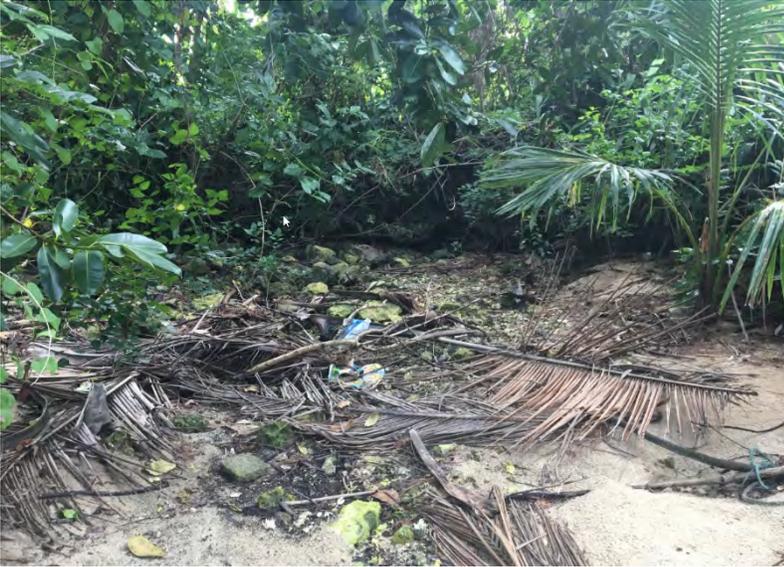
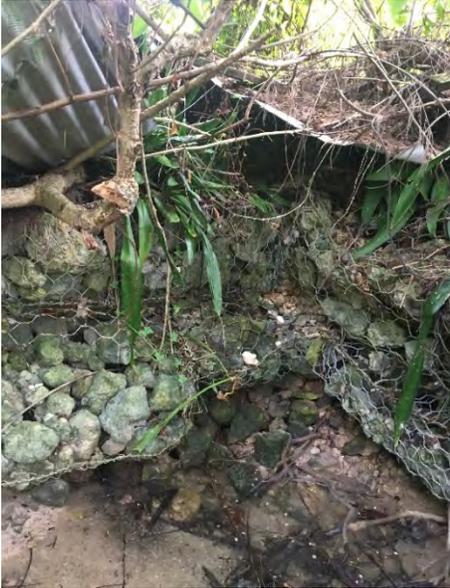
<p>USGS The National Map: National Boun... Powered by Esri</p>
<p>Enforcement Needed: No</p>	
<p>Severity Rating: 3</p>	
<p>Implementation Priority: It's OK (Med)</p>	
<p>Descriptions of Existing Conditions: Channel outlet draining San Roque and potentially the Kensington parking lot. Gabion baskets being undermined; trash and debris. This outlet is adjacent to the outfall on the beach from ponds at Kensington.</p>	
<p>Description of Proposed Opportunity: Further investigation of the flow paths and the gabion structure is needed to evaluate the site for any restoration activity. Track down the site plans from Kensington that may show this feature. Could be a good location for cleanup and debris removal.</p>
