Laolao Bay Watershed Existing Conditions and Opportunities Interim Report

September 2020 DRAFT

CNMI Bureau of Environmental and Coastal Quality
Division of Coastal Resource Management

Horsley Witten Group, Inc.
KOA Consulting, Inc.
Sea Change Consulting

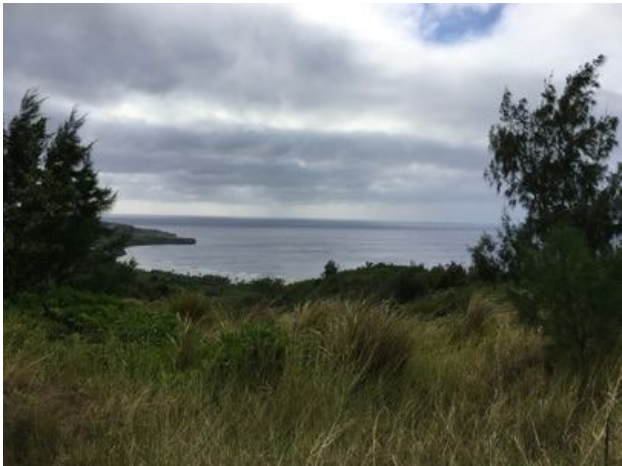
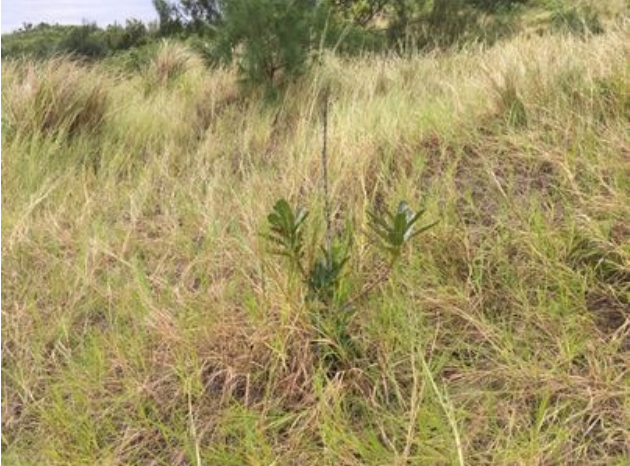
<p>Site ID: LL100</p>	<p>Watershed: Laolao</p>
<p>Crew: EH</p>	<p>Date/Time: 01/21/2020 7:09 PM</p>
<p>Project Type:</p> <ul style="list-style-type: none"> • Revegetation site

<p>USGS The National Map: National Boun... Powered by Esri</p>
<p>Enforcement Needed: No</p>	
<p>Severity Rating: 0 (Not significant)</p>	
<p>Implementation Priority: Unsure</p>	
<p>Descriptions of Existing Conditions: Ongoing revegetation efforts by MINA. Met with Wayne and Dan onsite on 1/20/20. See LL101 as well.</p>	
<p>Description of Proposed Opportunity: Nothing proposed. Currently maintained and monitored by MINA.</p>	
<p>Challenges/Constraints: Accessibility</p>	
<p>Additional Notes:</p>	
<p>Site Photo</p>

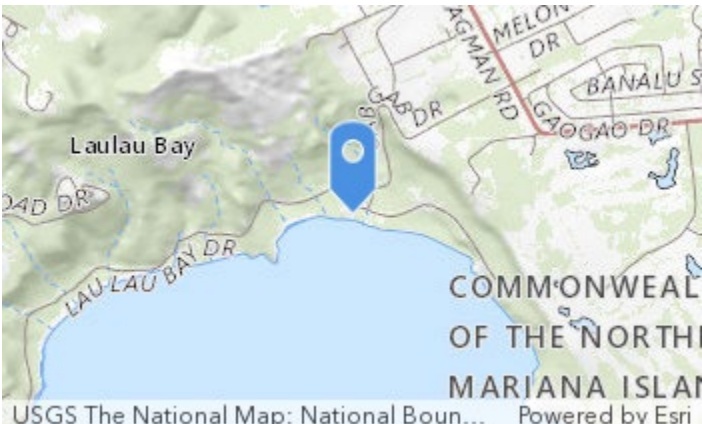
<p>Site ID: LL103</p>	<p>Watershed: Laolao</p>
<p>Crew: EH</p>	<p>Date/Time: 01/21/2020 8:44 PM</p>
<p>Project Type:</p> <ul style="list-style-type: none"> • Shoreline Stabilization • Watershed Education/Signage

<p>Enforcement Needed: No</p>	
<p>Severity Rating: 3</p>	
<p>Implementation Priority: Love it! (High)</p>	
<p>Descriptions of Existing Conditions: Uncontrolled pedestrian circulation eroding shoreline. Multiple access points to beach.</p>	
<p>Description of Proposed Opportunity: Organize circulation. Limit access points to 2. Stabilize path, add boardwalk? Part of dive site improvement/organization. Educational opportunity with signage etc.</p>	
<p>Challenges/Constraints: Heavy use, storms, hard to change user habits.</p>	
<p>Additional Notes: See previous dive site concept.</p>	
<p>Site Photo</p>

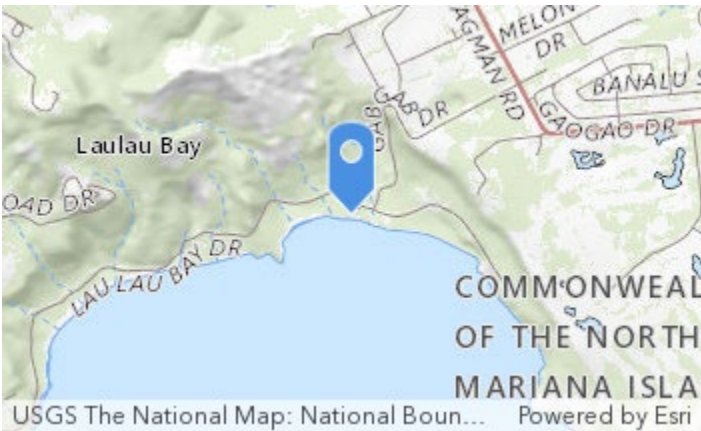
<p>Site ID: LL104</p>	<p>Watershed: Laolao</p>
<p>Crew: EH</p>	<p>Date/Time: 01/21/2020 8:48 PM</p>
<p>Project Type:</p> <ul style="list-style-type: none"> • Stormwater Retrofit • Shoreline Stabilization • Watershed Education/Signage

<p>Enforcement Needed: No</p>	
<p>Severity Rating: 4</p>	
<p>Implementation Priority: Love it! (High)</p>	
<p>Descriptions of Existing Conditions: Parking lot runoff eroding shoreline along pedestrian path.</p>	
<p>Description of Proposed Opportunity: Parking lot reorganization. Control drainage. Stabilization and reorganization of circulation. Stabilize path.</p>	
<p>Challenges/Constraints: Heavy use, hard to change user habits.</p>	
<p>Additional Notes: See previous dive site concept and new sketch.</p>	
<p>Site Photo</p>

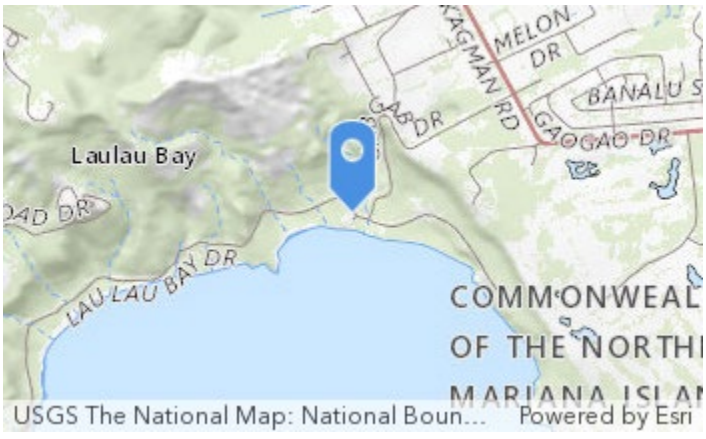
<p>Site ID: LL108</p>	<p>Watershed: Laolao</p>
<p>Crew: EH</p>	<p>Date/Time: 01/21/2020 9:22 PM</p>
<p>Project Type:</p> <ul style="list-style-type: none"> • Drainage Infrastr., Maint. & Repair • Stormwater Retrofit • Unpaved Road Stabilization • Shoreline Stabilization

<p>Enforcement Needed: No</p>	
<p>Severity Rating: 3</p>	
<p>Implementation Priority: Love it! (High)</p>	
<p>Descriptions of Existing Conditions: Runoff from Laolao Bay Rd eroding entrance to parking area and shoreline. Uncontrolled runoff.</p>	
<p>Description of Proposed Opportunity: Intercept runoff before entering dive site. Water bars with stormwater infiltration. Improve drainage along the road.</p>	
<p>Challenges/Constraints: Amount and velocity of runoff. Soils and infiltration capacity may be limited?</p>	
<p>Additional Notes:</p>	
<p>Site Photo</p>

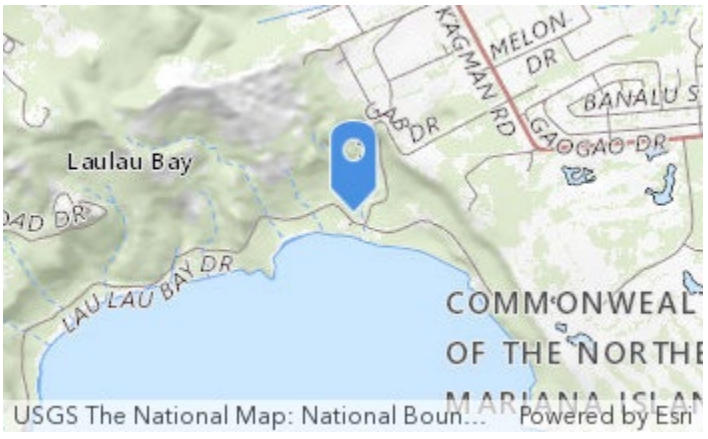
<p>Site ID: LL109</p>	<p>Watershed: Laolao</p>
<p>Crew: EH</p>	<p>Date/Time: 01/21/2020 9:35 PM</p>
<p>Project Type:</p> <ul style="list-style-type: none"> • Stormwater Retrofit • Unpaved Road Stabilization

<p>Enforcement Needed: No</p>	
<p>Severity Rating: 3</p>	
<p>Implementation Priority: Love it! (High)</p>	
<p>Descriptions of Existing Conditions: Entrance to parking. See LL108.</p>	
<p>Description of Proposed Opportunity: See LL108.</p>	
<p>Challenges/Constraints:</p>	
<p>Additional Notes:</p>	
<p>Site Photo</p>

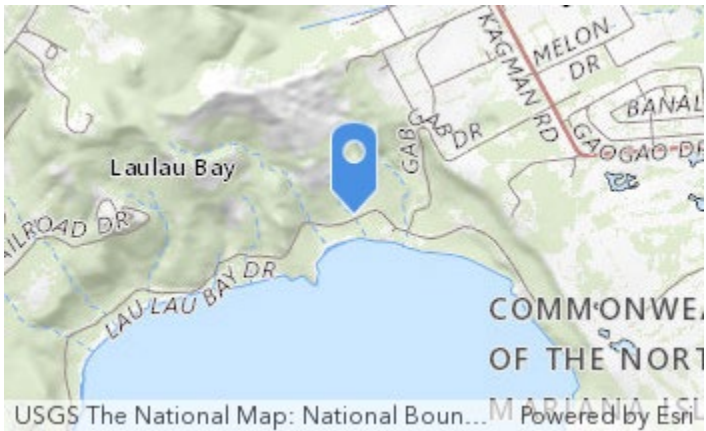
<p>Site ID: LL112</p>	<p>Watershed: Laolao</p>
<p>Crew: EH</p>	<p>Date/Time: 01/21/2020 9:45 PM</p>
<p>Project Type:</p> <ul style="list-style-type: none"> • Drainage Infrastr., Maint. & Repair • Stormwater Retrofit • Unpaved Road Stabilization

Lau Lau Bay Dr. LL112	Culvert concentrates flow into narrow channel. Road grading is rough mounds and dips. <i>Replace and widen culvert (convert to a large box culvert). Construct broad dip or other diversion at low point to direct road runoff into ditch.</i>	4	H	\$\$	●				
Lau Lau Bay Dr. LL113	Runoff discharges off road at uncontrolled location causing scouring and erosion down to very deep pool. 9' down to 3' wide plunge pool. Inflow to east comes onto road ~100 ft uphill and runs along road contributing to runoff at shoreline. <i>Create broad dip and formalize overflow. Upstream drainage: pitch discharges to road. Runs along eastern edge to informal drainage overflow.</i>	5	H	\$	●		●		
Gap Gap Rd. LL124/ 125/ 126	Washout and erosion of steep, unpaved road surface. <i>See PIWI conceptual plans. Proposed improvements to drainage were confirmed and remain valid.</i>	5	H	\$\$	●				
LL127	Swales on both side of paved road are filled with vegetation preventing runoff from entering. Runoff remains on paved surface and drains down Gap Gap Rd. Clean and cut back vegetation & reestablish/clean road swales. <i>Construct broad dip or waterbar (speed bump) at top of Gap Gap Rd. to keep runoff off Gap Gap. Possibly use bioretention, but may not have space and would require a lot of earthwork.</i>	4	H	\$	●	●

<p>Enforcement Needed: No</p>	
<p>Severity Rating: 4</p>	
<p>Implementation Priority: Love it! (High)</p>	
<p>Descriptions of Existing Conditions: Culvert at road concentrates flow into narrow channel. Road grading is rough mounds and dips.</p>	
<p>Description of Proposed Opportunity: Replace and widen culvert (convert to a large box culvert). Construct broad dip or other diversion at low point to direct road runoff into ditch.</p>	
<p>Challenges/Constraints: Road traffic and frequency of use. Subsurface material? Depth of culvert (very deep from road surface).</p>	
<p>Additional Notes:</p>	
<p>Site Photo</p>

REPLACE / WIDEN CULVERT - SAME LARGE BOX CULVERT
CONSTRUCT BROAD DIP OR OTHER DIVERSION @ LOW POINT
TO DIRECT ROAD RUNOFF INTO DITCH

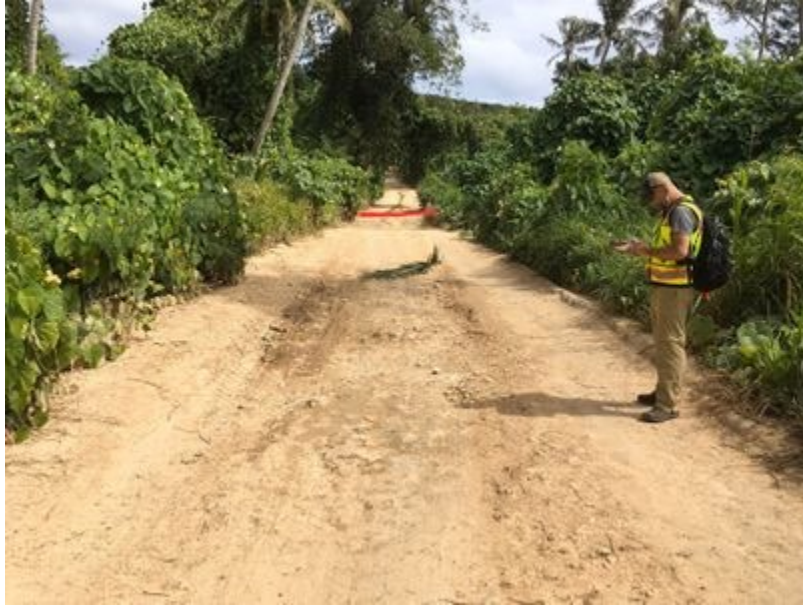
Additional Photo Caption: culvert crossing in red

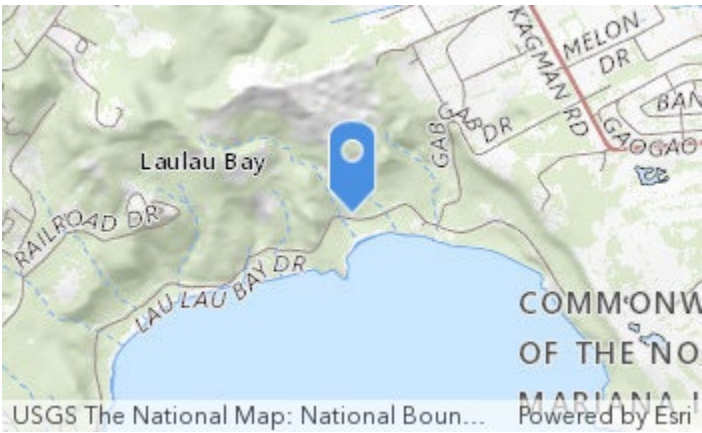
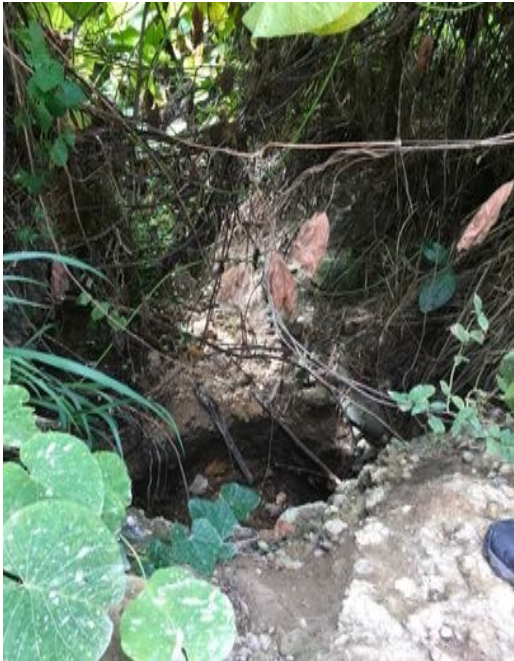
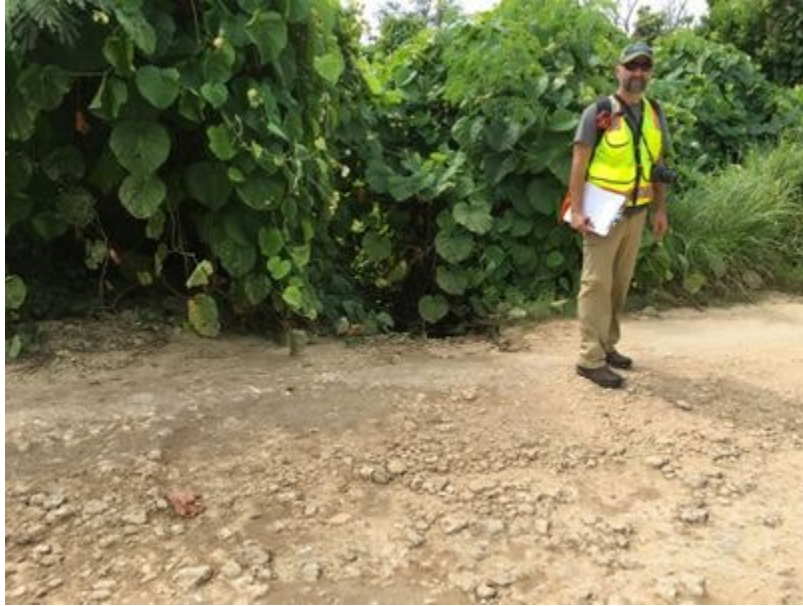
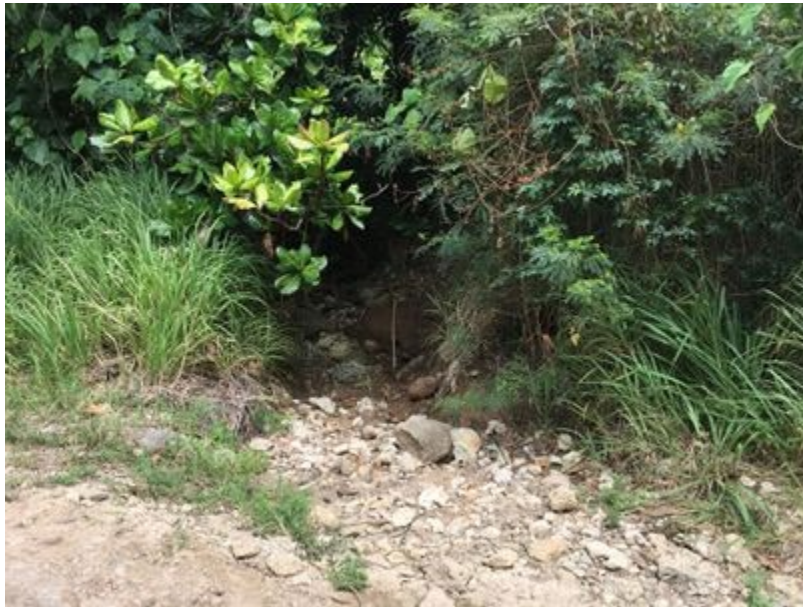
<p>Site ID: LL113</p>	<p>Watershed: Laolao</p>
<p>Crew: EH</p>	<p>Date/Time: 01/21/2020 9:57 PM</p>
<p>Project Type:</p> <ul style="list-style-type: none"> • Drainage Infrastr., Maint. & Repair • Unpaved Road Stabilization

<p>Enforcement Needed: No</p>	
<p>Severity Rating: 5 (Severe)</p>	
<p>Implementation Priority: Love it! (High)</p>	
<p>Descriptions of Existing Conditions: Runoff discharges off road at uncontrolled location causing scouring and erosion down to very deep pool. 9' down to plunge pool. 3' wide. Inflow to east comes onto road ~100 ft uphill and runs along road. Contributing</p>	
<p>Description of Proposed Opportunity: Create broad dip and formalize overflow. Upstream drainage: pitch discharges to road. Runs along eastern edge to informal drainage overflow.</p>	
<p>Challenges/Constraints: Large volume and high velocity of runoff discharge onto road. No culvert crossing.</p>	
<p>Additional Notes:</p>

LARGE VOLUME / HIGH VELOCITY RUN OFF DISCHARGE
ONTO ROAD - NO CULVERT CROSSING

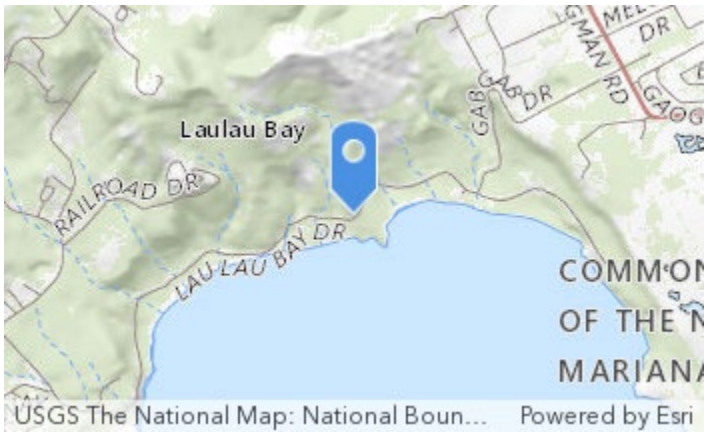
<p>Site ID: LL117</p>	<p>Watershed: Laolao</p>
<p>Crew: EH</p>	<p>Date/Time: 01/21/2020 10:21 PM</p>
<p>Project Type:</p>

<p>Enforcement Needed: No</p>	
<p>Severity Rating: 1</p>	
<p>Implementation Priority: Not that important (Low)</p>	
<p>Descriptions of Existing Conditions: Grass track, possibly to homestead or lookout?</p>	
<p>Description of Proposed Opportunity: Monitor for possible issues.</p>	
<p>Challenges/Constraints:</p>	
<p>Additional Notes:</p>	
<p>Site Photo</p>

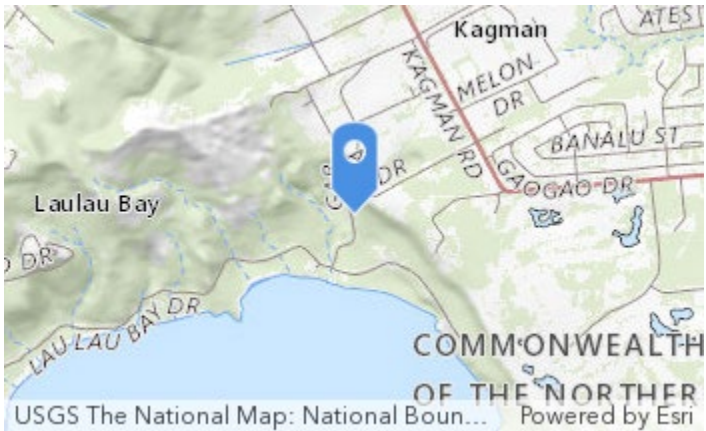
<p>Site ID: LL124</p>	<p>Watershed: Laolao</p>
<p>Crew: EH</p>	<p>Date/Time: 01/21/2020 11:06 PM</p>
<p>Project Type:</p> <ul style="list-style-type: none"> • Stormwater Retrofit • Unpaved Road Stabilization

<p>Enforcement Needed: No</p>	
<p>Severity Rating: 5 (Severe)</p>	
<p>Implementation Priority: Love it! (High)</p>	
<p>Descriptions of Existing Conditions: Washout and erosion along Gap Gap Road. See previous conceptual plans</p>	
<p>Description of Proposed Opportunity: See previous plans. Proposed improvements to drainage were confirmed and remain valid.</p>	
<p>Challenges/Constraints: Very steep road, accessibility and long-term maintenance.</p>	
<p>Additional Notes:</p>	
<p>Site Photo</p>	
<div style="display: flex; justify-content: space-around;">

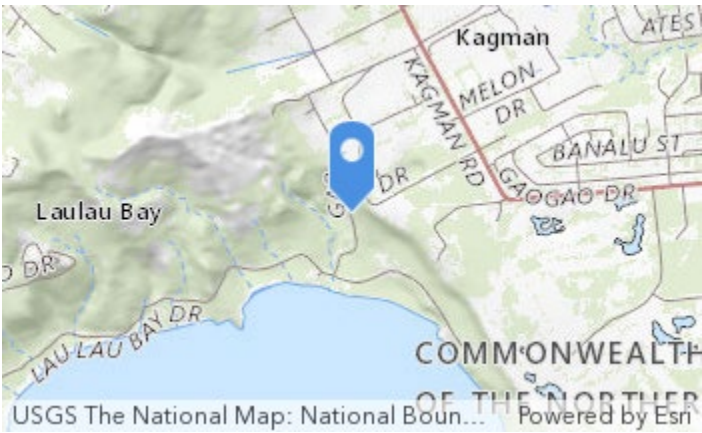
<p>Site ID: LL125</p>	<p>Watershed: Laolao</p>
<p>Crew: BK</p>	<p>Date/Time: 01/21/2020 11:08 PM</p>
<p>Project Type:</p> <ul style="list-style-type: none"> Unpaved Road Stabilization

<p>Enforcement Needed: No</p>	
<p>Severity Rating: 5 (Severe)</p>	
<p>Implementation Priority: Love it! (High)</p>	
<p>Descriptions of Existing Conditions: Washout and erosion along Gap Gap Road. See previous conceptual plans</p>	
<p>Description of Proposed Opportunity: See previous plans. Proposed improvements to drainage were confirmed and remain valid.</p>	
<p>Challenges/Constraints: Very steep road, accessibility and long-term maintenance.</p>	
<p>Additional Notes:</p>	
<p>Site Photo</p>

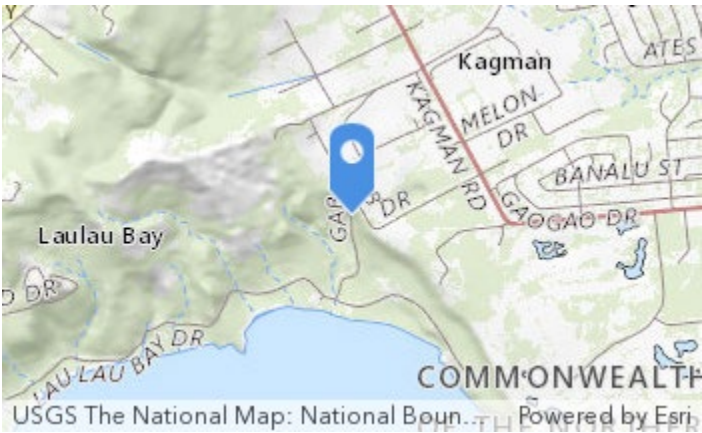
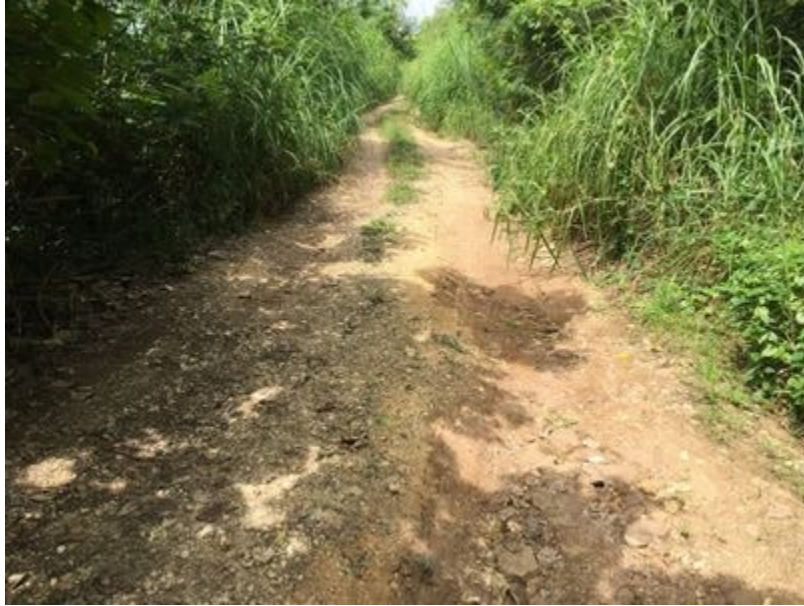
<p>Site ID: LL126</p>	<p>Watershed: Laolao</p>
<p>Crew: BK</p>	<p>Date/Time: 01/21/2020 11:14 PM</p>
<p>Project Type:</p> <ul style="list-style-type: none"> • Unpaved Road Stabilization

<p>Enforcement Needed: No</p>	
<p>Severity Rating: 5 (Severe)</p>	
<p>Implementation Priority: Love it! (High)</p>	
<p>Descriptions of Existing Conditions: Washout and erosion along Gap Gap Road. See previous conceptual plans</p>	
<p>Description of Proposed Opportunity: See previous plans. Proposed improvements to drainage were confirmed and remain valid.</p>	
<p>Challenges/Constraints: Very steep road, accessibility and long-term maintenance.</p>	
<p>Additional Notes:</p>	
<p>Site Photo</p>

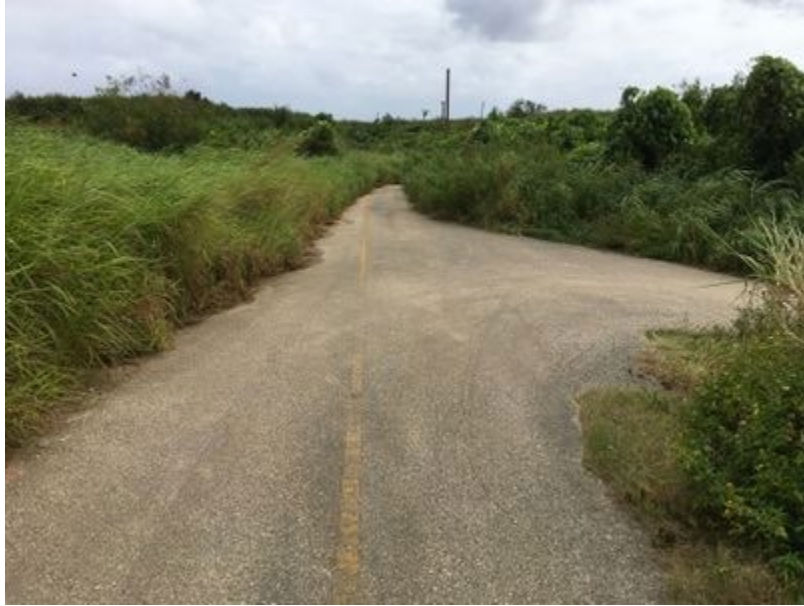
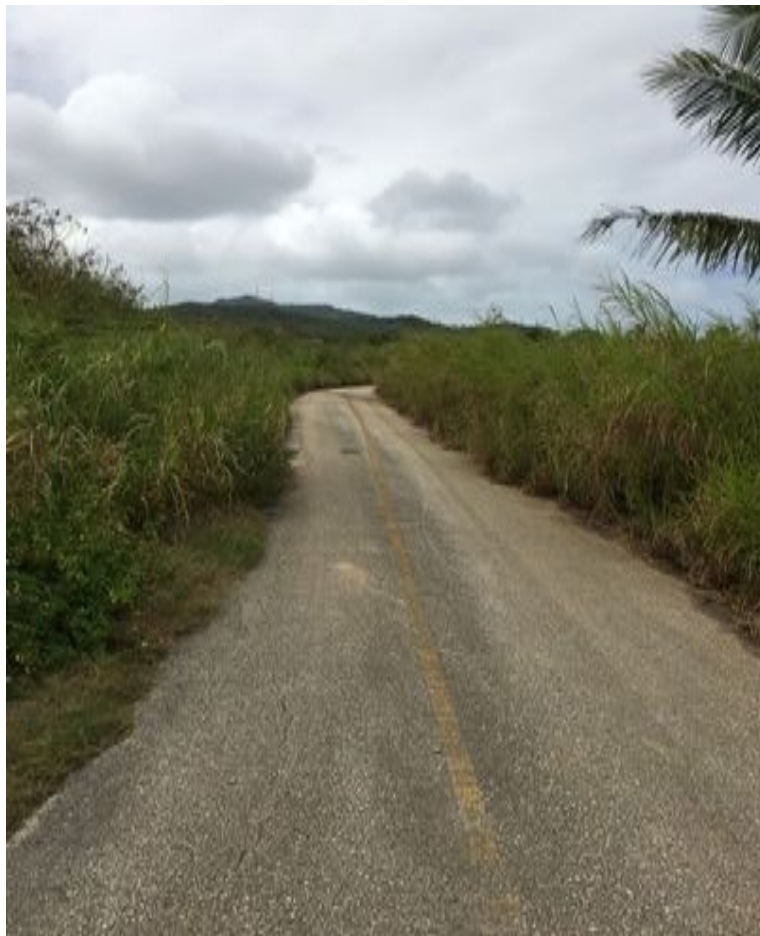
<p>Site ID: LL127</p>	<p>Watershed: Laolao</p>
<p>Crew: BK</p>	<p>Date/Time: 01/21/2020 11:25 PM</p>
<p>Project Type:</p> <ul style="list-style-type: none"> • Drainage Infrastr., Maint. & Repair • Unpaved Road Stabilization

<p>Enforcement Needed: No</p>	
<p>Severity Rating: 4</p>	
<p>Implementation Priority: Love it! (High)</p>	
<p>Descriptions of Existing Conditions: Swales on both side of paved road are filled with vegetation and runoff cannot get into swales. Runoff remains on paved surface and drains down Gap Gap Road.</p>	
<p>Description of Proposed Opportunity: Clean and cut back vegetation & reestablish/clean road swales. Construct broad dip or waterbar (speed bump) at top of Gap Gap Road to keep runoff on pavement/off Gap Gap. Possibly use bioretention, but may</p>	
<p>Challenges/Constraints: Swale maintenance. Has been difficult to get anything implemented at this site, which has been identified several times. Bioretention would have slope/grading changes.</p>

BIORETENTION WOULD HAVE SLOPE / GRADING CHALLENGES

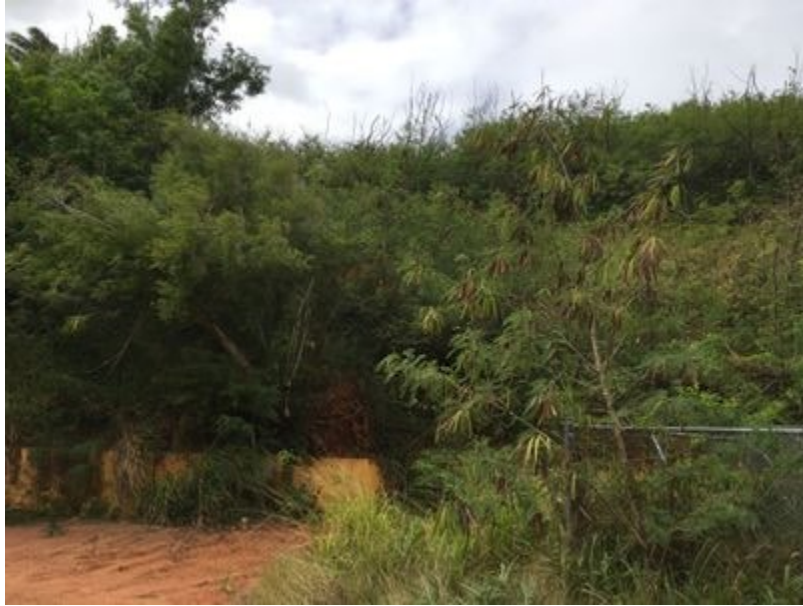
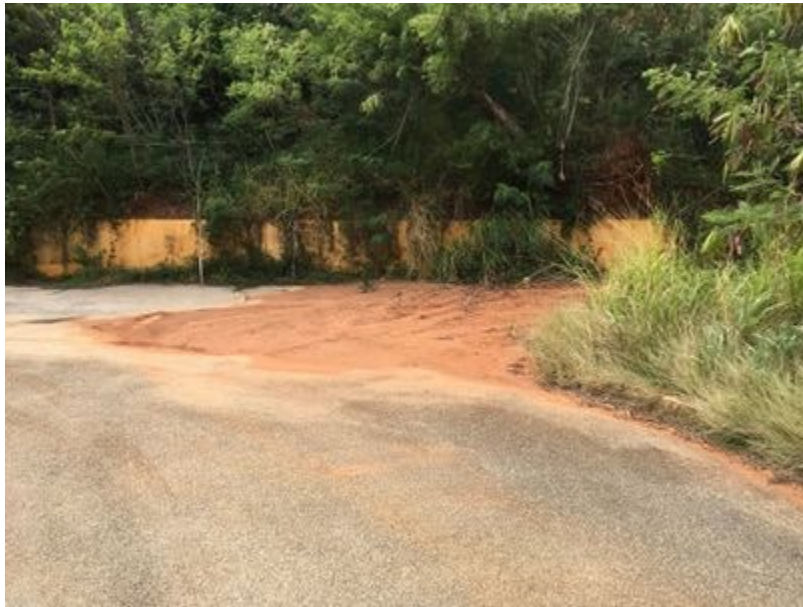
<p>Site ID: LL132</p>	<p>Watershed: Laolao</p>
<p>Crew: EH</p>	<p>Date/Time: 01/21/2020 11:51 PM</p>
<p>Project Type:</p> <ul style="list-style-type: none"> Upland Revegetation/Restoration

<p>Enforcement Needed: Yes</p>	
<p>Severity Rating: 5 (Severe)</p>	
<p>Implementation Priority: It's OK (Med)</p>	
<p>Descriptions of Existing Conditions: Tree blown down over retaining wall with root destabilization. Excessively steep slope above retaining wall (which appears too short). Bare dirt/mudslide on steep slope. Sediment source to parking lot/rain garden and</p>	
<p>Description of Proposed Opportunity: Clean up sediment and slope. Extend wall and stabilize slope.</p>	
<p>Challenges/Constraints: Very steep slopes. Detention center may be abandoned so may only be feasible if detention center is in use.</p>	
<p>Additional Notes:</p>	
<p>Site Photo</p>

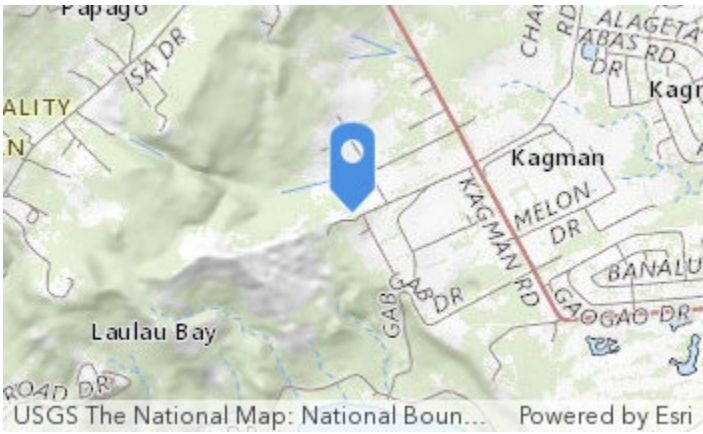
<p>Site ID: LL133</p>	<p>Watershed: Laolao</p>
<p>Crew: EH</p>	<p>Date/Time: 01/22/2020 12:00 AM</p>
<p>Project Type:</p> <ul style="list-style-type: none"> Unpaved Road Stabilization

<p>Enforcement Needed: Yes</p>	
<p>Severity Rating: 4</p>	
<p>Implementation Priority: Not that important (Low)</p>	
<p>Descriptions of Existing Conditions: Eroded dirt road to water tank at top of watershed.</p>	
<p>Description of Proposed Opportunity: Stabilize and remove sediment source. Apply dirt road strategies, such as dips and water bars to shed runoff. Regrade & stabilize.</p>	
<p>Challenges/Constraints: Steep slopes.</p>	
<p>Additional Notes:</p>	
<p>Site Photo</p>

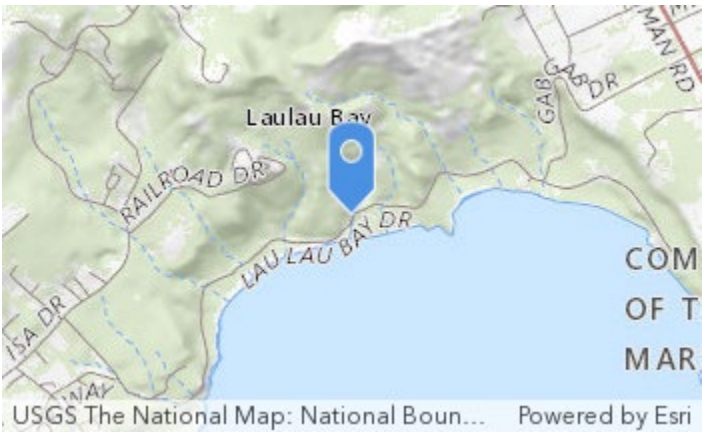
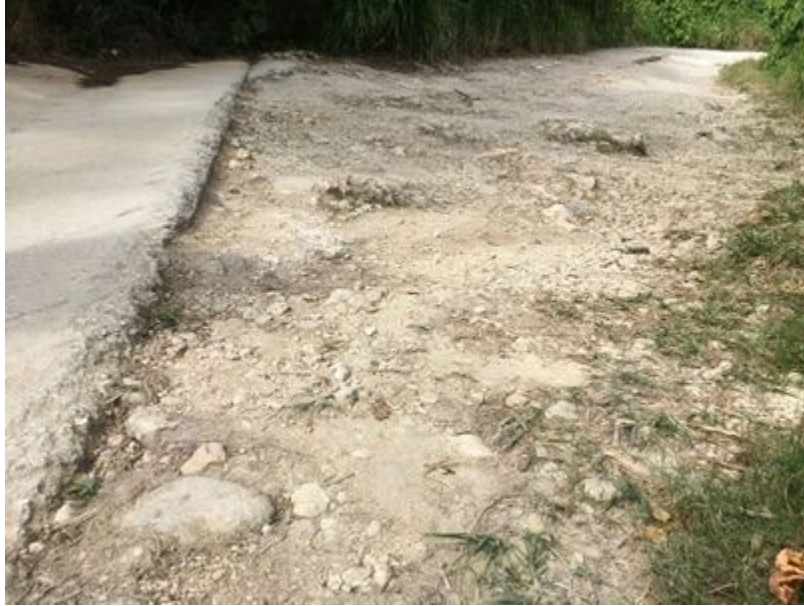
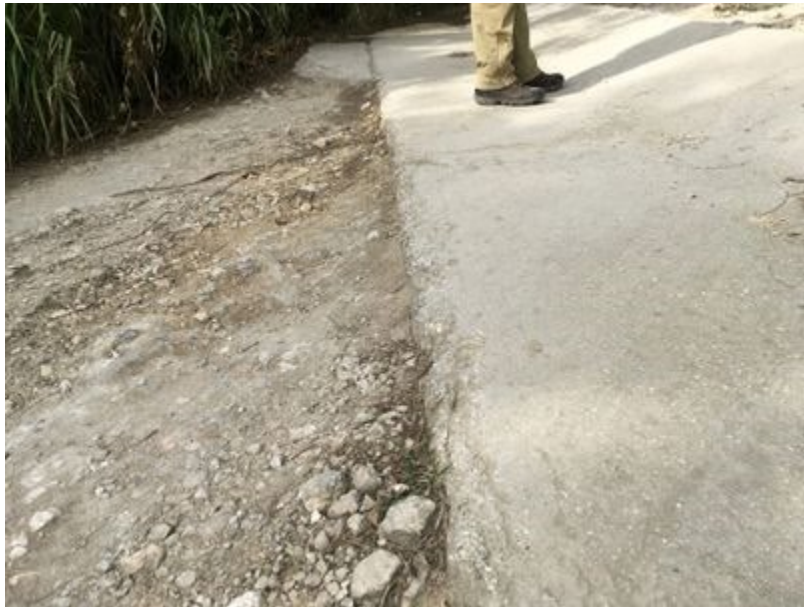
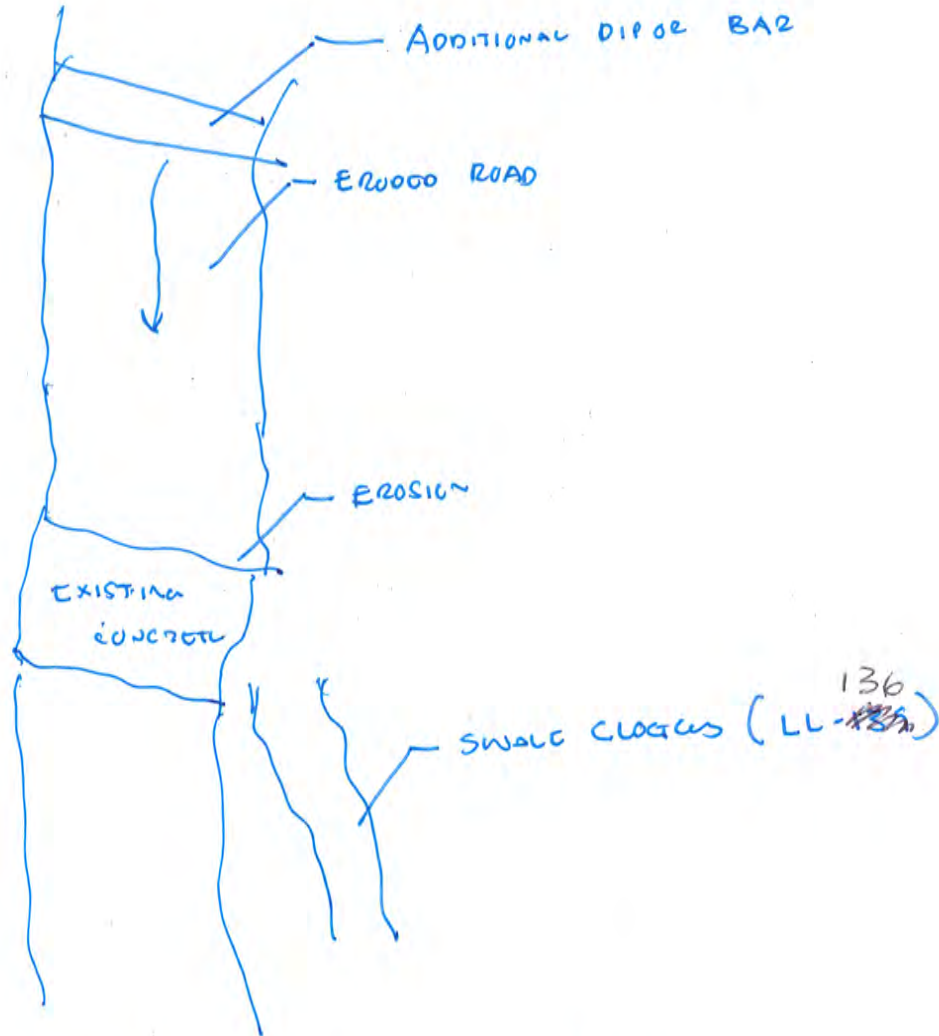
<p>Site ID: LL135</p>	<p>Watershed: Laolao</p>
<p>Crew: EH</p>	<p>Date/Time: 01/22/2020 12:45 AM</p>
<p>Project Type:</p> <ul style="list-style-type: none"> • Drainage Infrastr., Maint. & Repair • Unpaved Road Stabilization

<p>Enforcement Needed: No</p>	
<p>Severity Rating: 3</p>	
<p>Implementation Priority: It's OK (Med)</p>	
<p>Descriptions of Existing Conditions: Broad dip with swales (formalized downstream)</p>	
<p>Description of Proposed Opportunity: Clean swale, regrade road. Add second broad dip uphill.</p>	
<p>Challenges/Constraints: Steel slope, erosion at edge of conc. Ongoing maintenance and erosion at interface of concrete and dirt road.</p>	
<p>Additional Notes: Appears to be functional.</p>	
<p>Site Photo</p>

<p>Site Overview Caption: Clean.</p>

Additional Photo Caption: Uphill

Additional Photo Caption: Downhill

Challenges/Constraints: ON GOING MAINTENANCE AND DRAINAGE ALONG
INTERFACE OF CONCRETE & DIRT ROAD

SEE ALSO LOW WATER CROSSING DESIGN PLANS.

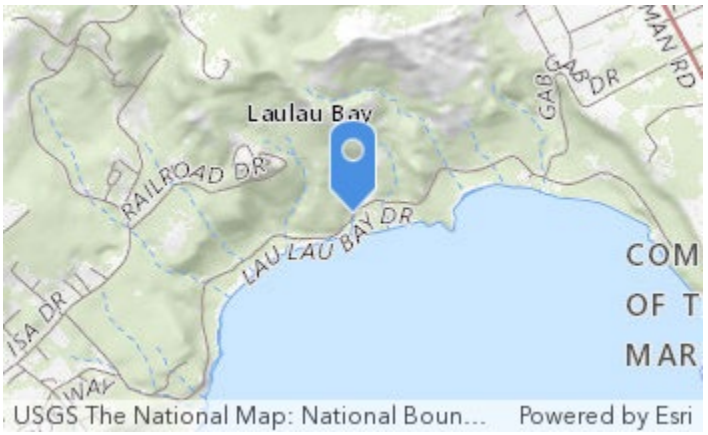
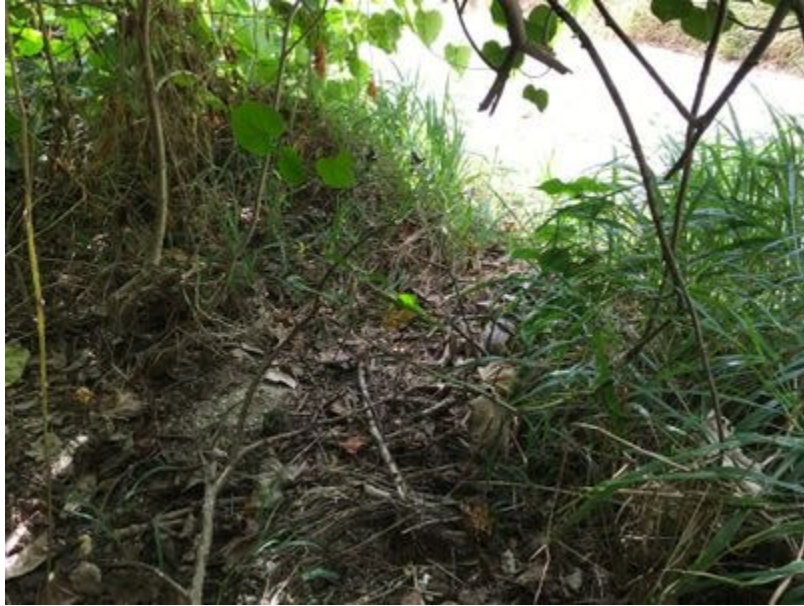
<p>Site ID: LL136</p>	<p>Watershed: Laolao</p>
<p>Crew: EH</p>	<p>Date/Time: 01/22/2020 12:51 AM</p>
<p>Project Type:</p> <ul style="list-style-type: none"> • Drainage Infrastr., Maint. & Repair • Unpaved Road Stabilization

<p>Enforcement Needed: Yes</p>	
<p>Severity Rating: 5 (Severe)</p>	
<p>Implementation Priority: Love it! (High)</p>	
<p>Descriptions of Existing Conditions: Clogged formalized swale. See LL135.</p>	
<p>Description of Proposed Opportunity: Clean and redirect to restore flow.</p>	
<p>Challenges/Constraints: Maintenance.</p>	
<p>Additional Notes:</p>	
<p>Site Photo</p>

<p>Site Overview Caption: Formalized channel to right. Current flow to left.</p>

Additional Photo Caption: Current flow path.

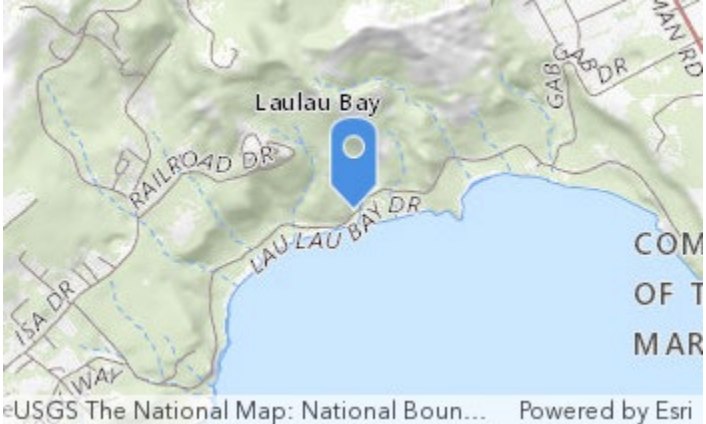
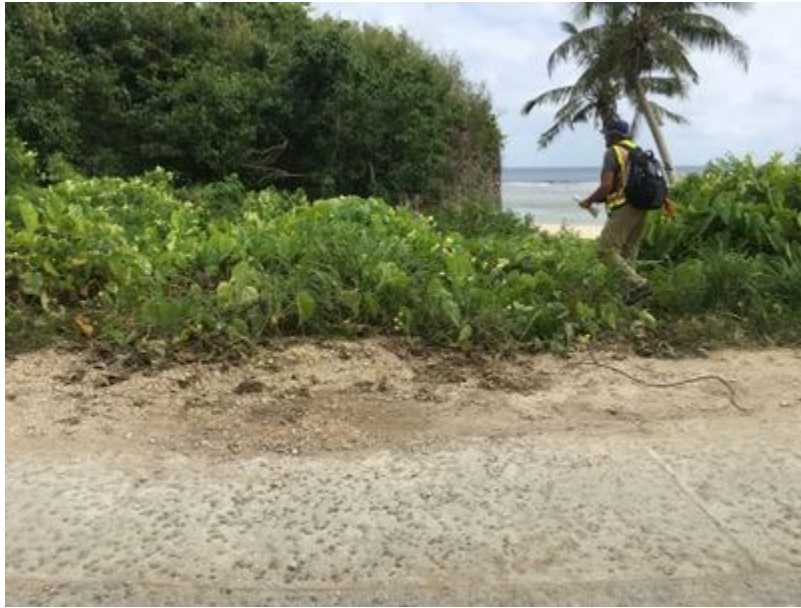
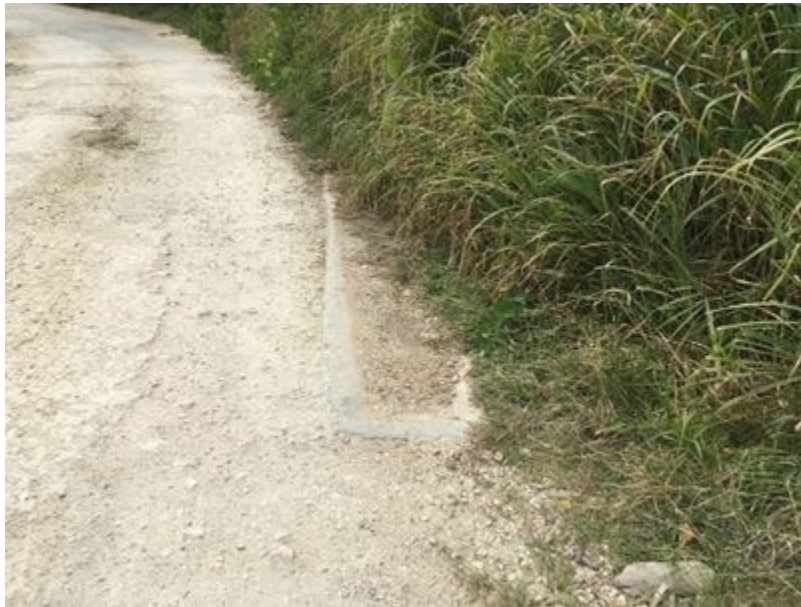
<p>Site ID: LL138</p>	<p>Watershed: Laolao</p>
<p>Crew: EH</p>	<p>Date/Time: 01/22/2020 1:02 AM</p>
<p>Project Type:</p> <ul style="list-style-type: none"> • Drainage Infrastr., Maint. & Repair • Stormwater Retrofit • Unpaved Road Stabilization

<p>Enforcement Needed: Yes</p>	
<p>Severity Rating: 5 (Severe)</p>	
<p>Implementation Priority: Love it! (High)</p>	
<p>Descriptions of Existing Conditions: Lots of sediment on broad dip and in swales.</p>	
<p>Description of Proposed Opportunity: Clean! Remove vegetation at outlet.</p>	
<p>Challenges/Constraints: Maintenance.</p>	
<p>Additional Notes:</p>	
<p>Site Photo</p>

Additional Photo Caption: intended flow path middle left (pile of dirt). Current flow path on right.

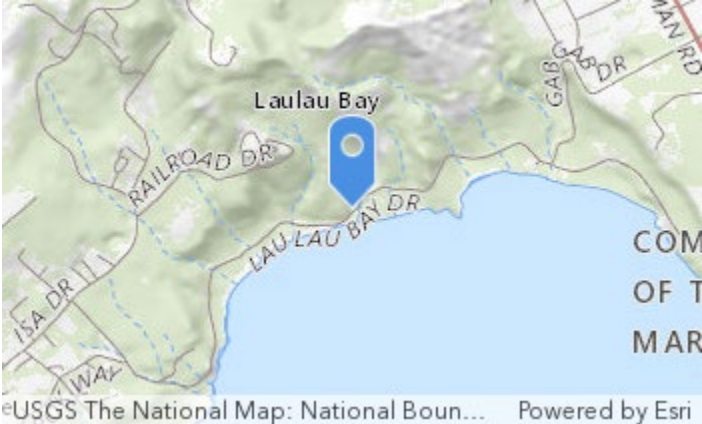
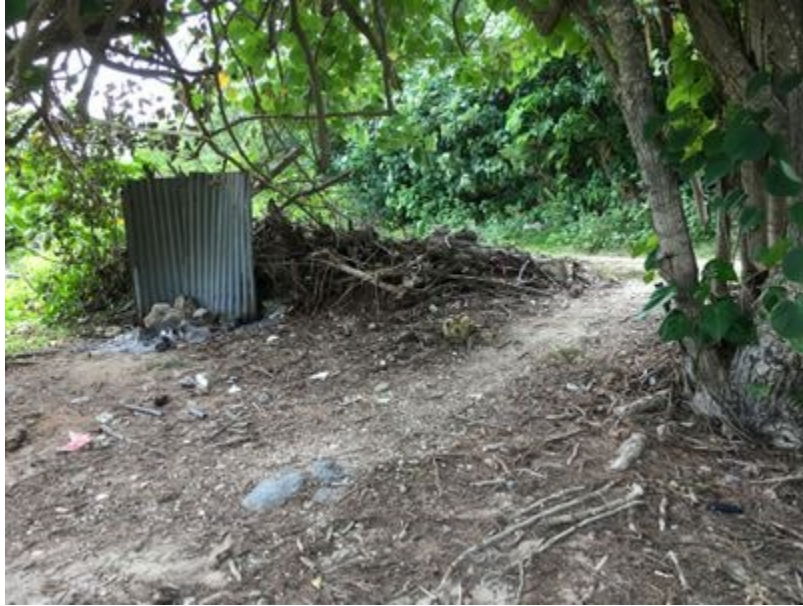
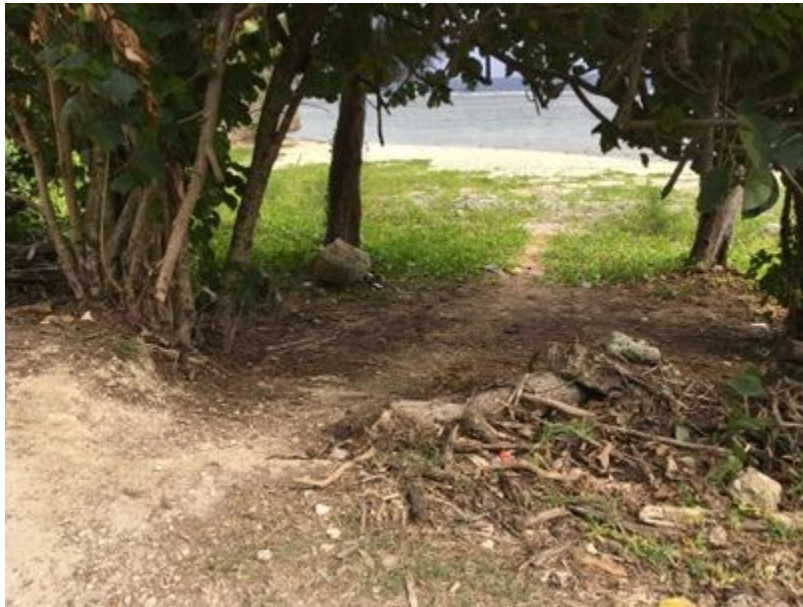
<p>Site ID: LL139</p>	<p>Watershed: Laolao</p>
<p>Crew: EH</p>	<p>Date/Time: 01/22/2020 1:08 AM</p>
<p>Project Type:</p> <ul style="list-style-type: none"> Shoreline Stabilization

<p>Enforcement Needed: No</p>	
<p>Severity Rating: 4</p>	
<p>Implementation Priority: It's OK (Med)</p>	
<p>Descriptions of Existing Conditions: Seaward edge of road. 3' drop at start. Guess low energy. Rocky sand. Trees present. (with LL143)</p>	
<p>Description of Proposed Opportunity: Start living shoreline. Use gabion walls or green walls.</p>	
<p>Challenges/Constraints: Road abuts top of shoreline, so limited space. High traffic, exposure to future storms.</p>	
<p>Additional Notes:</p>	
<p>Site Photo</p>

<p>Site Overview Caption: Start.</p>

Additional Photo Caption: From above

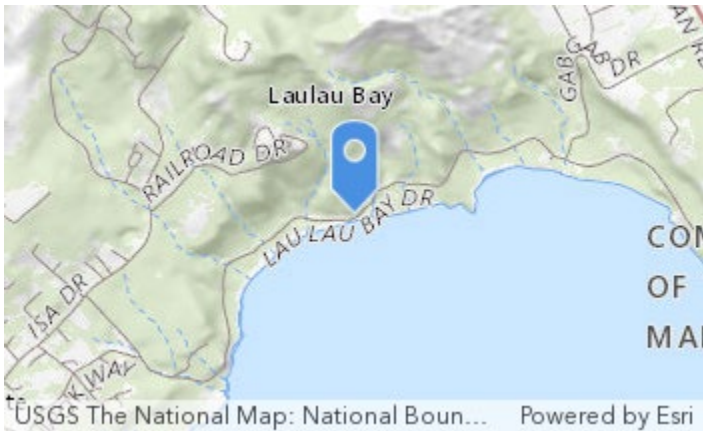
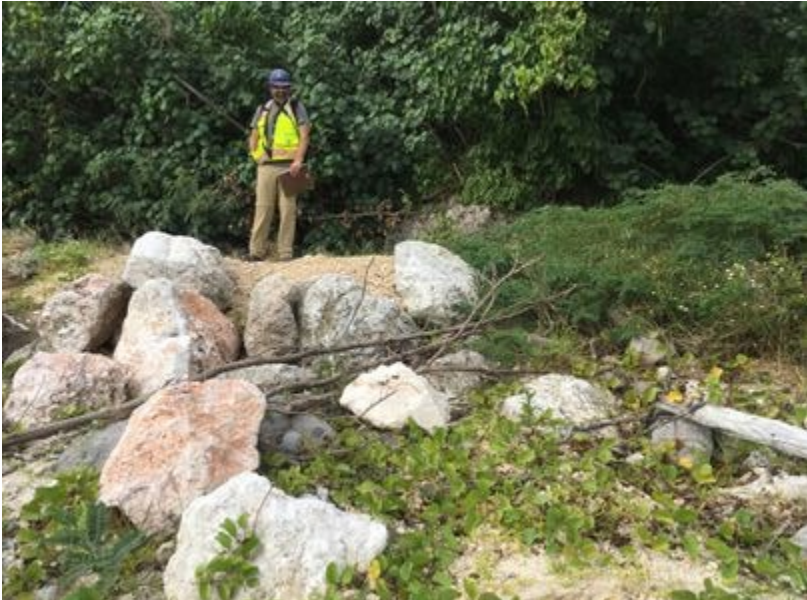
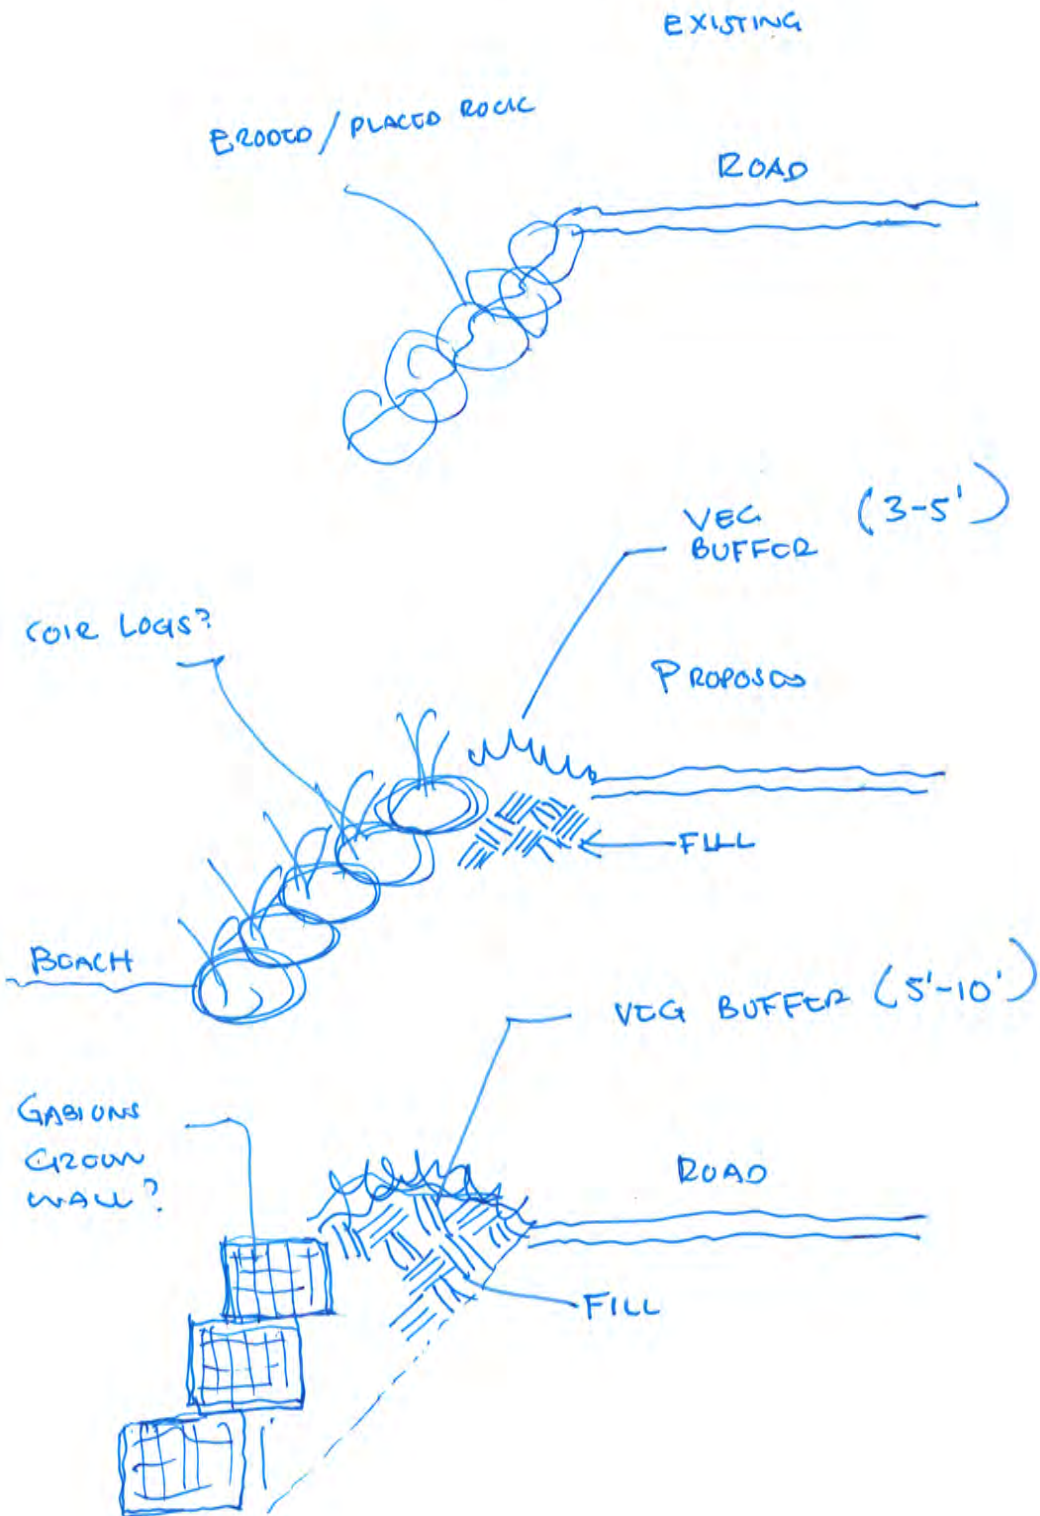
<p>Site ID: LL143</p>	<p>Watershed: Laolao</p>
<p>Crew: EH</p>	<p>Date/Time: 01/22/2020 1:24 AM</p>
<p>Project Type:</p> <ul style="list-style-type: none"> Shoreline Stabilization

<p>Enforcement Needed: No</p>	
<p>Severity Rating: 4</p>	
<p>Implementation Priority: It's OK (Med)</p>	
<p>Descriptions of Existing Conditions: End living shoreline/shoreline restoration. (with LL139)</p>	
<p>Description of Proposed Opportunity: See LL139.</p>	
<p>Challenges/Constraints: See LL139.</p>	
<p>Additional Notes:</p>	
<p>Site Photo</p>

REPAIRS UNSIGHTLY. LOCATION APPEARS TO BE LOW ENERGY AREA

EXPOSURE TO FUTURE STORMS

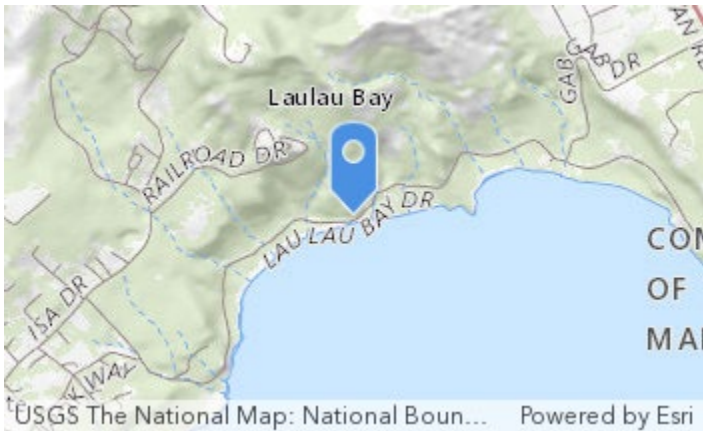
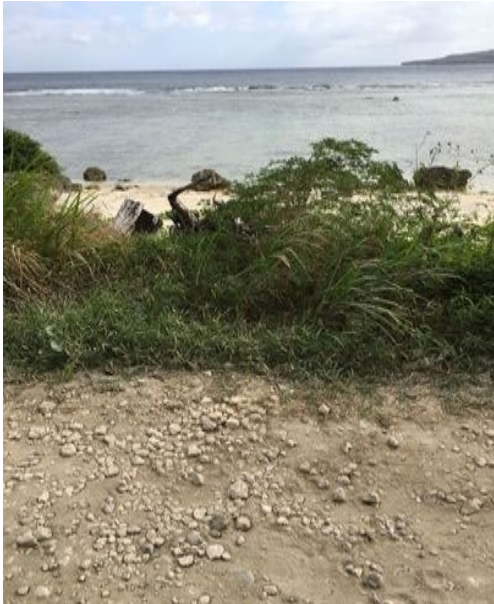
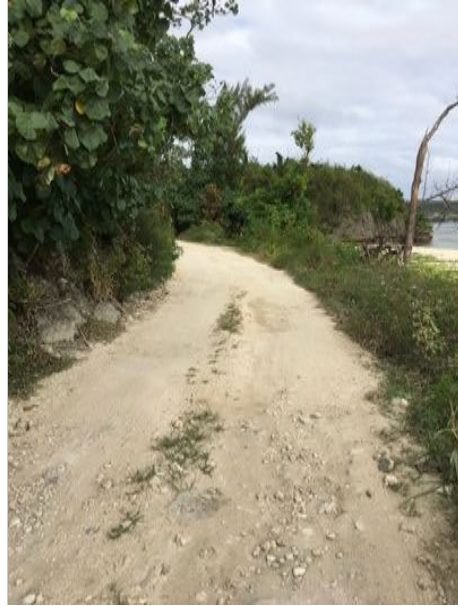
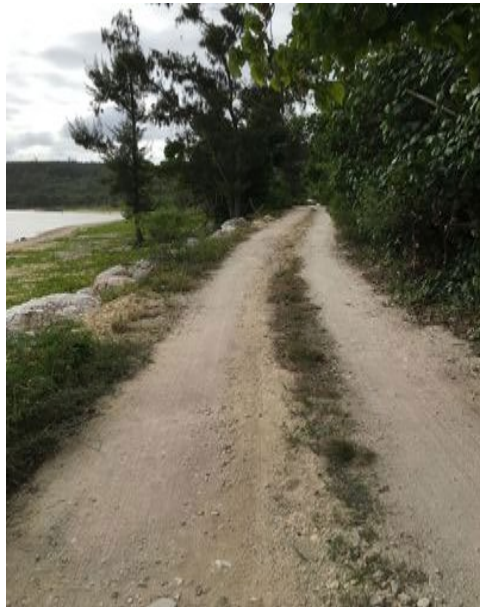
<p>Site ID: LL144</p>	<p>Watershed: Laolao</p>
<p>Crew: BK</p>	<p>Date/Time: 01/22/2020 1:25 AM</p>
<p>Project Type:</p> <ul style="list-style-type: none"> • Drainage Infrastr., Maint. & Repair • Shoreline Stabilization

<p>Enforcement Needed: No</p>	
<p>Severity Rating: 2</p>	
<p>Implementation Priority: It's OK (Med)</p>	
<p>Descriptions of Existing Conditions: Low point in rd. Discharges toward LL139 & LL143.</p>	
<p>Description of Proposed Opportunity: Address stormwater as part of shoreline restoration</p>	
<p>Challenges/Constraints: Erosion</p>	
<p>Additional Notes: None</p>	
<p>Site Photo</p>

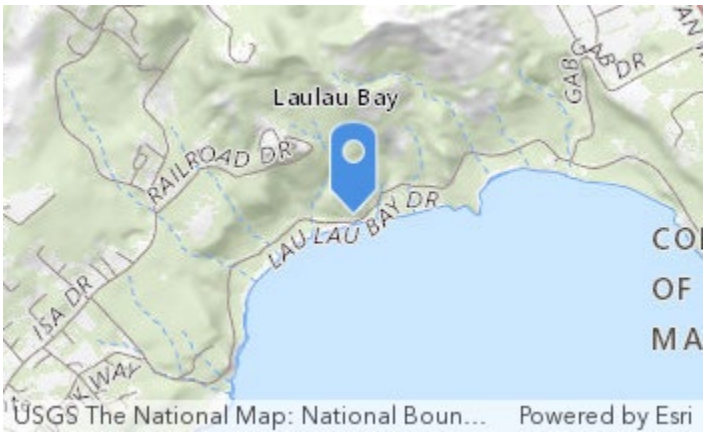
<p>Site ID: LL145</p>	<p>Watershed: Laolao</p>
<p>Crew: EH</p>	<p>Date/Time: 01/22/2020 1:30 AM</p>
<p>Project Type:</p> <ul style="list-style-type: none"> Shoreline Stabilization

<p>Enforcement Needed: No</p>	
<p>Severity Rating: 4</p>	
<p>Implementation Priority: It's OK (Med)</p>	
<p>Descriptions of Existing Conditions: Start shoreline restoration. (with LL146)</p>	
<p>Description of Proposed Opportunity: Living shoreline (see notes for LL139/LL143/LL144)</p>	
<p>Challenges/Constraints:</p>	
<p>Additional Notes:</p>	
<p>Site Photo</p>
