Laolao Bay Watershed Existing Conditions and Opportunities Interim Report

September 2020 DRAFT

CNMI Bureau of Environmental and Coastal Quality
Division of Coastal Resource Management

Horsley Witten Group, Inc.
KOA Consulting, Inc.
Sea Change Consulting

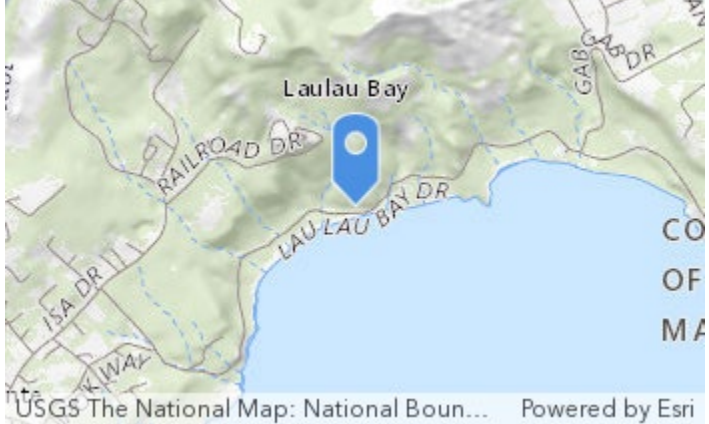
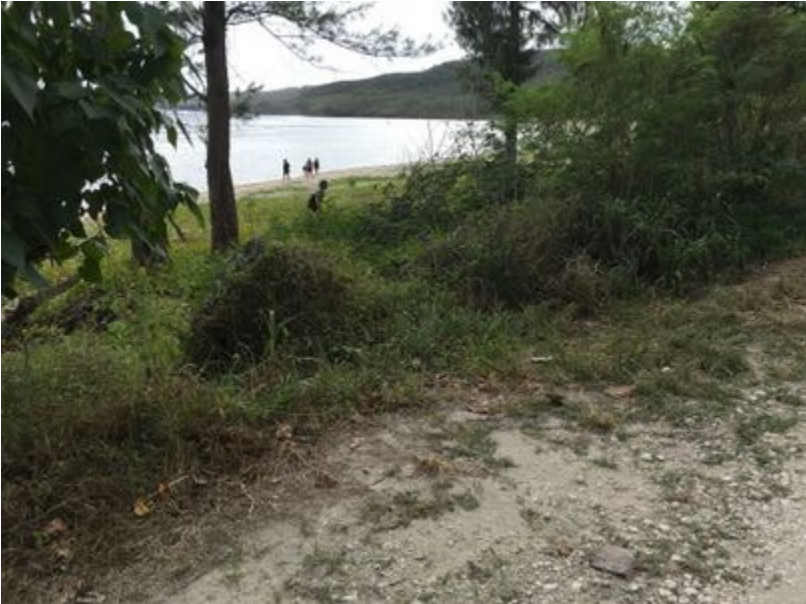
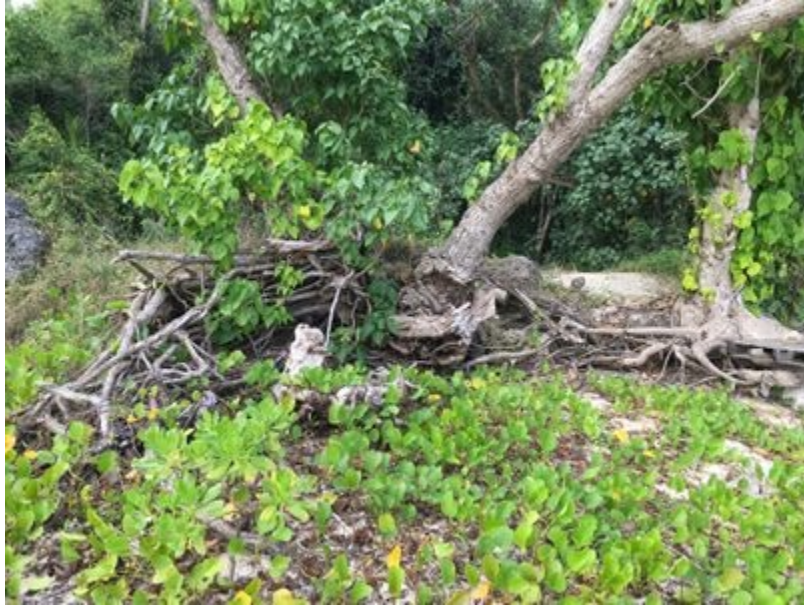
<p>Site ID: LL146</p>	<p>Watershed: Laolao</p>
<p>Crew: EH</p>	<p>Date/Time: 01/22/2020 1:31 AM</p>
<p>Project Type:</p> <ul style="list-style-type: none"> Shoreline Stabilization

<p>Enforcement Needed: No</p>	
<p>Severity Rating: 4</p>	
<p>Implementation Priority: It's OK (Med)</p>	
<p>Descriptions of Existing Conditions: End shoreline restoration. (with LL145)</p>	
<p>Description of Proposed Opportunity: Living shoreline (see notes for LL139/LL143/LL144)</p>	
<p>Challenges/Constraints:</p>	
<p>Additional Notes:</p>	
<p>Site Photo</p>

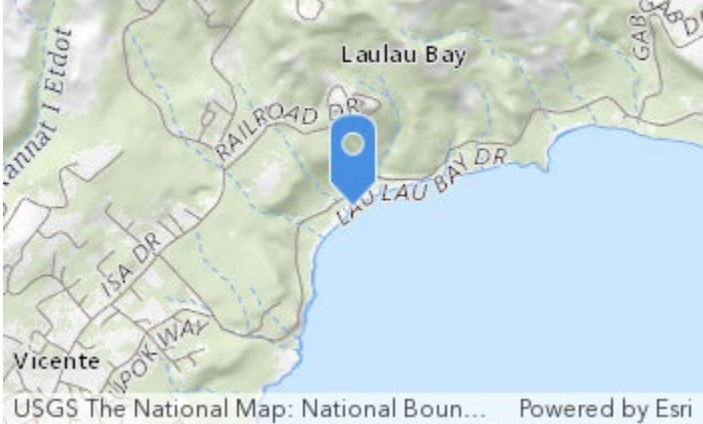
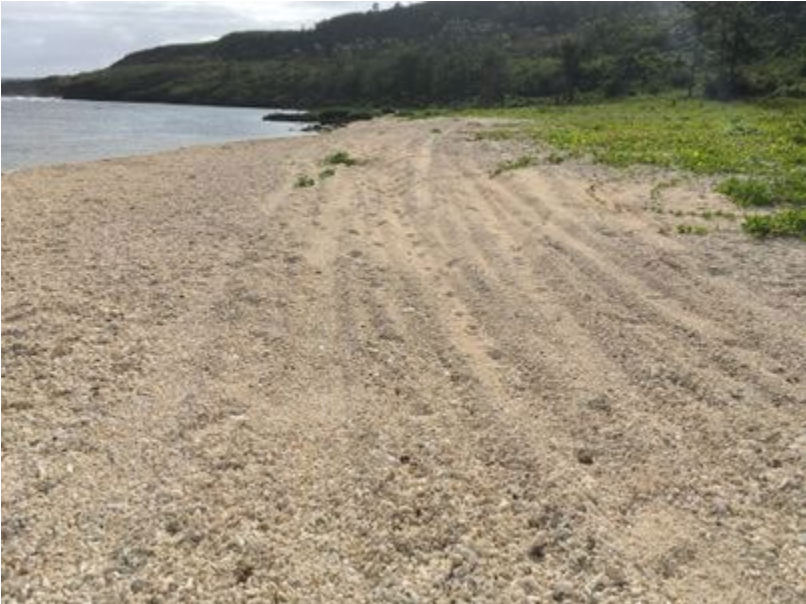
<p>Site ID: LL151</p>	<p>Watershed: Laolao</p>
<p>Crew: EH</p>	<p>Date/Time: 01/22/2020 1:57 AM</p>
<p>Project Type:</p> <ul style="list-style-type: none"> Residential Stewardship

<p>USGS The National Map: National Boun... Powered by Esri</p>
<p>Enforcement Needed: Yes</p>	
<p>Severity Rating: 3</p>	
<p>Implementation Priority: Unsure</p>	
<p>Descriptions of Existing Conditions: Driving on beach</p>	
<p>Description of Proposed Opportunity: Prevent driving on beach. Signage or physical barrier?</p>	
<p>Challenges/Constraints:</p>	
<p>Additional Notes:</p>	
<p>Site Photo</p>

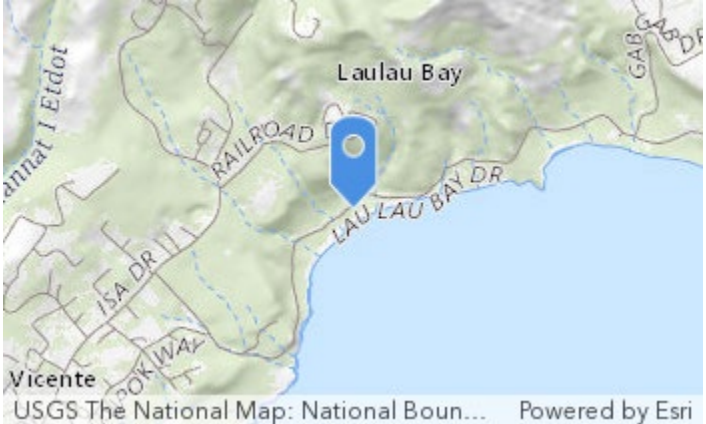
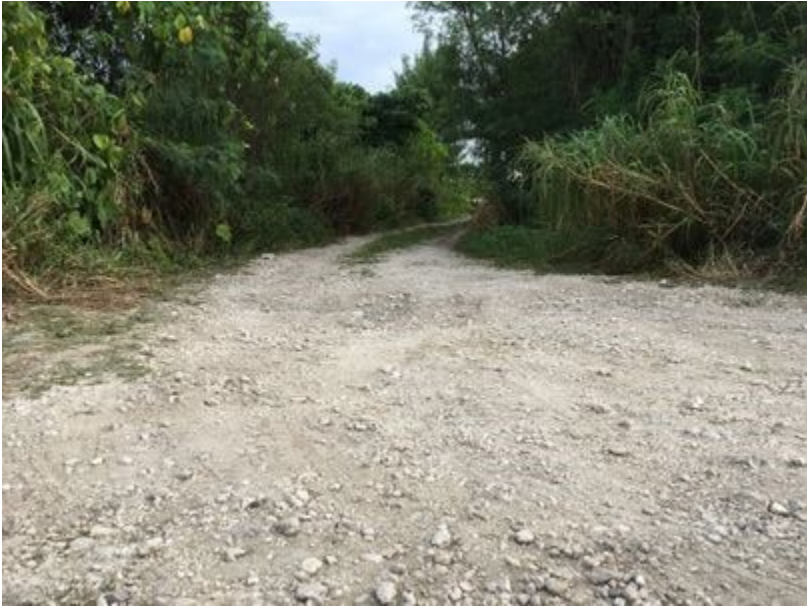
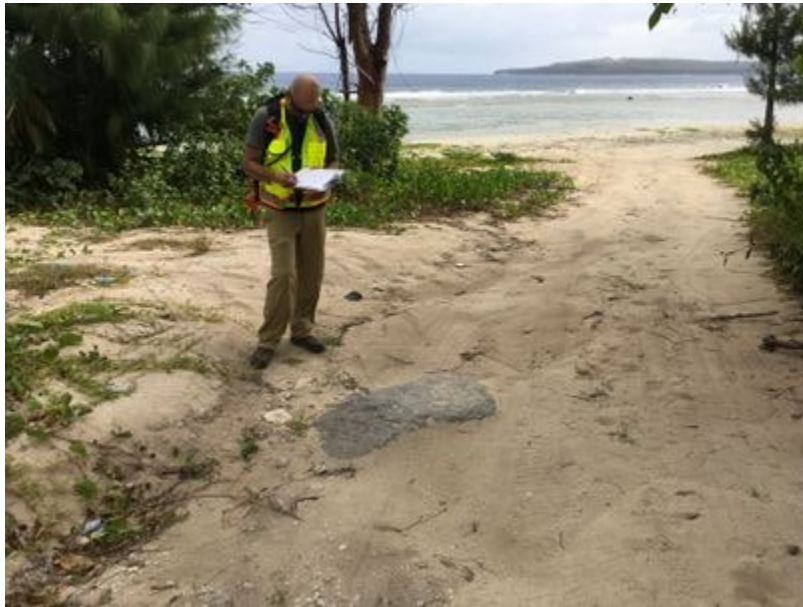
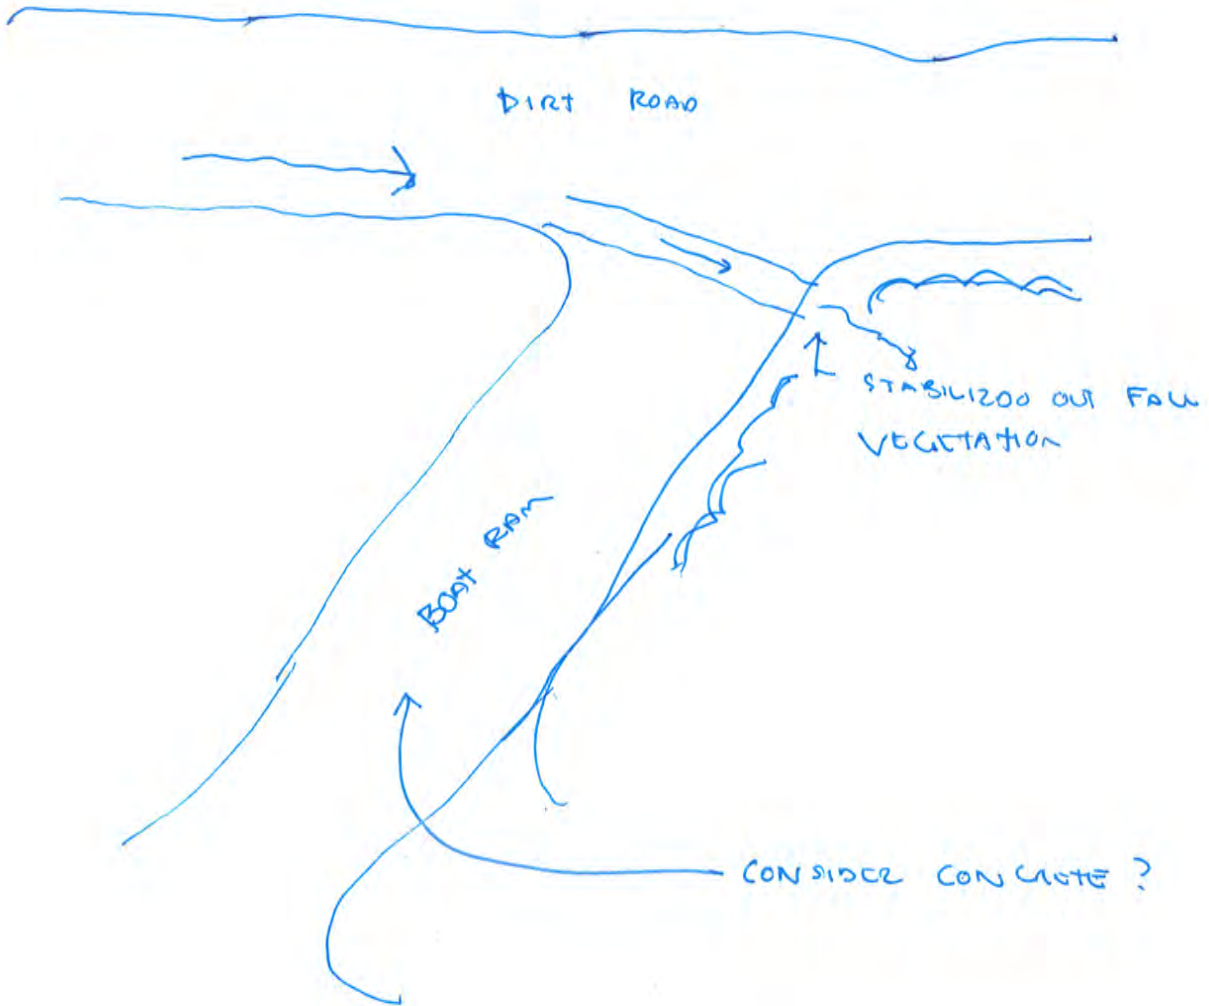
<p>Site ID: LL152</p>	<p>Watershed: Laolao</p>
<p>Crew: EH</p>	<p>Date/Time: 01/22/2020 2:00 AM</p>
<p>Project Type:</p> <ul style="list-style-type: none"> • Drainage Infrastr., Maint. & Repair • Unpaved Road Stabilization

<p>Enforcement Needed: No</p>	
<p>Severity Rating: 4</p>	
<p>Implementation Priority: It's OK (Med)</p>	
<p>Descriptions of Existing Conditions: Runoff drains down boat ramp access eroding and washing out onto beach.</p>	
<p>Description of Proposed Opportunity: Water bar or broad dip at top of access to direct runoff away from ramp and into vegetation.</p>	
<p>Challenges/Constraints: Heavy use, not a lot of space to discharge.</p>	
<p>Additional Notes:</p>	
<p>Site Photo</p>

<p>Site Overview Caption: Top of ramp</p>

HEAVY USE, SPACE TO PUCHONGE

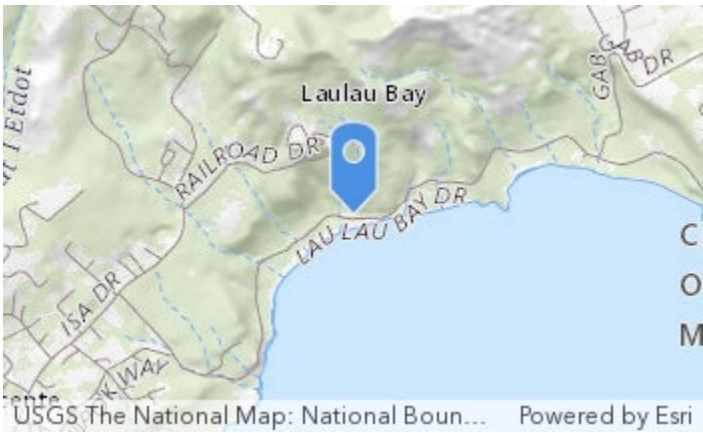
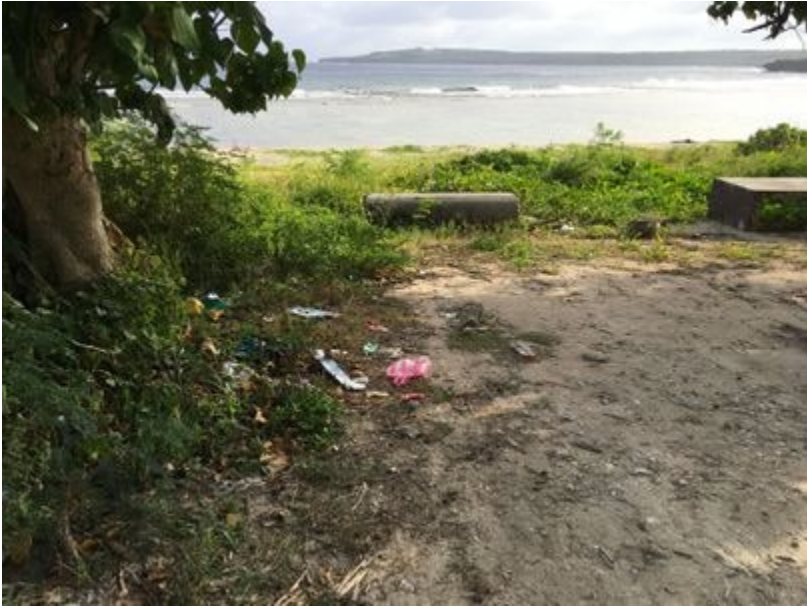
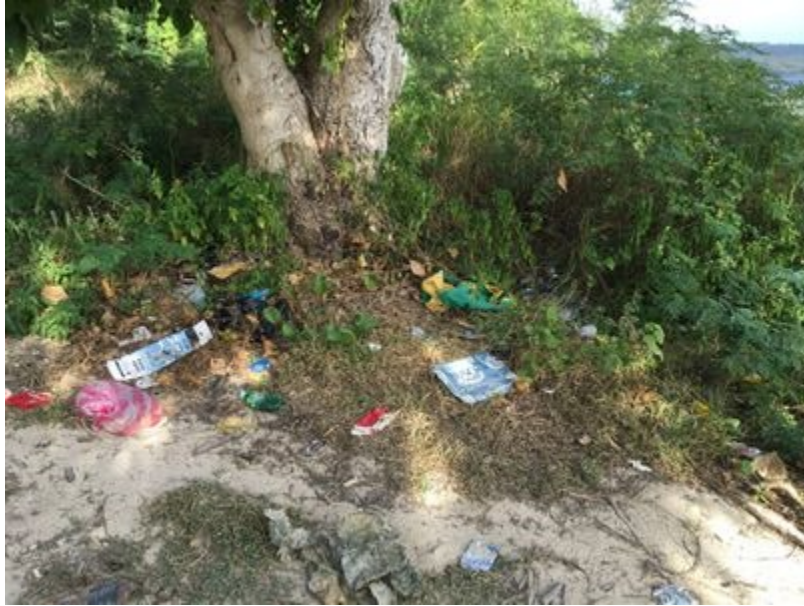
<p>Site ID: LL154</p>	<p>Watershed: Laolao</p>
<p>Crew: EH</p>	<p>Date/Time: 01/22/2020 2:19 AM</p>
<p>Project Type:</p> <ul style="list-style-type: none"> Residential Stewardship

<p>USGS The National Map: National Boun... Powered by Esri</p>
<p>Enforcement Needed: Yes</p>	
<p>Severity Rating: 5 (Severe)</p>	
<p>Implementation Priority: Love it! (High)</p>	
<p>Descriptions of Existing Conditions: Lots of trash</p>	
<p>Description of Proposed Opportunity: Trash pickup, educational signage.</p>	
<p>Challenges/Constraints:</p>	
<p>Additional Notes:</p>	
<p>Site Photo</p>

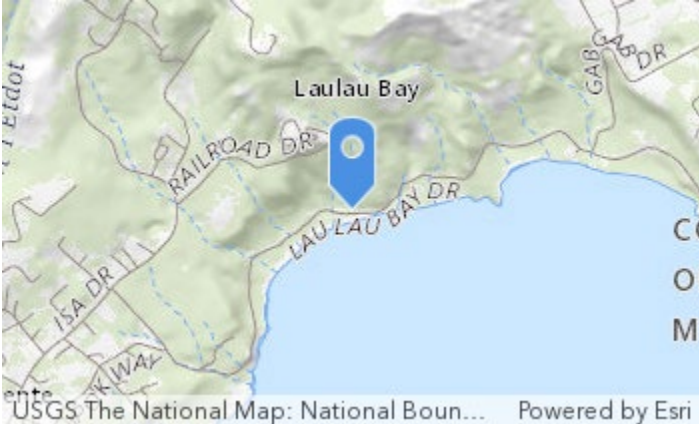
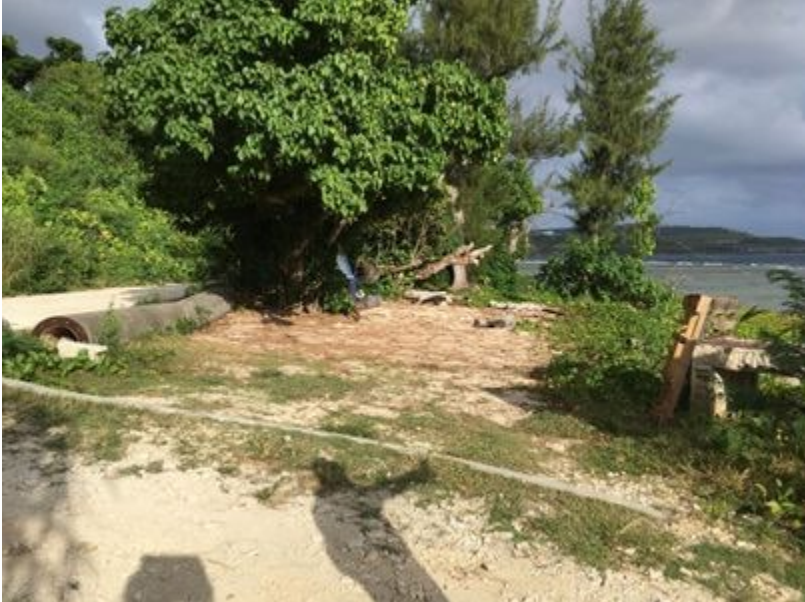
<p>Site ID: LL155</p>	<p>Watershed: Laolao</p>
<p>Crew: EH</p>	<p>Date/Time: 01/22/2020 2:23 AM</p>
<p>Project Type:</p> <ul style="list-style-type: none"> • Drainage Infrastr., Maint. & Repair • Unpaved Road Stabilization • Shoreline Stabilization • Watershed Education/Signage

<p>Enforcement Needed: No</p>	
<p>Severity Rating: 5 (Severe)</p>	
<p>Implementation Priority: Love it! (High)</p>	
<p>Descriptions of Existing Conditions: Former parking lot washed out during Yutu. Parking now uncontrolled and new areas east and west of former parking area now degraded.</p>	
<p>Description of Proposed Opportunity: Restore parking lot and shoreline. Living shoreline.</p>	
<p>Challenges/Constraints: Receding shoreline, heavy use, exposure to storms. Very little room.</p>	
<p>Additional Notes:</p>	
<p>Site Photo</p>

Now areas BOTH NORTH & SOUTH OF parking area
now degraded

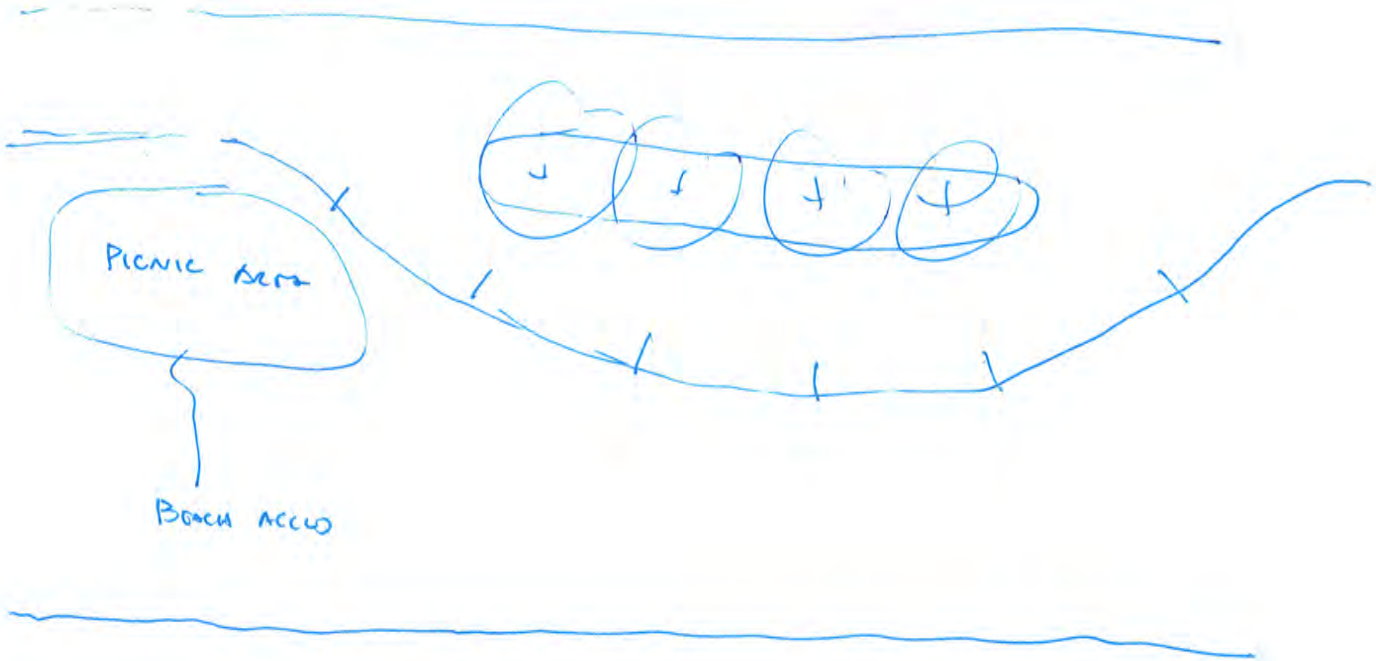
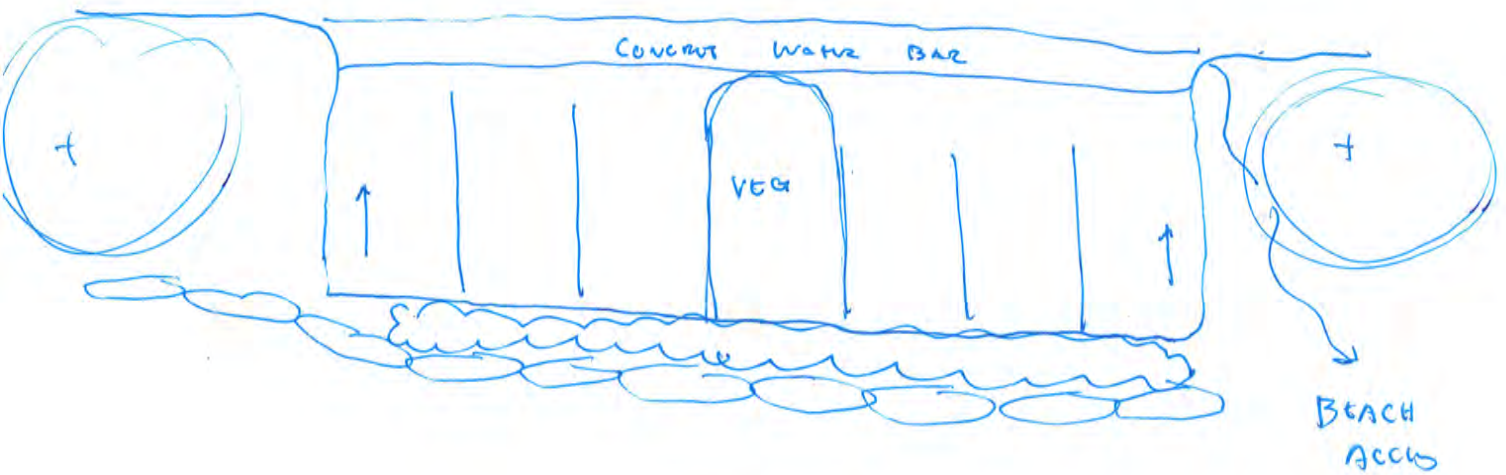
HEAVY USE, EXPOSED TO STORMS - HIGH SURFACE
NO ROOM TO RETREAT

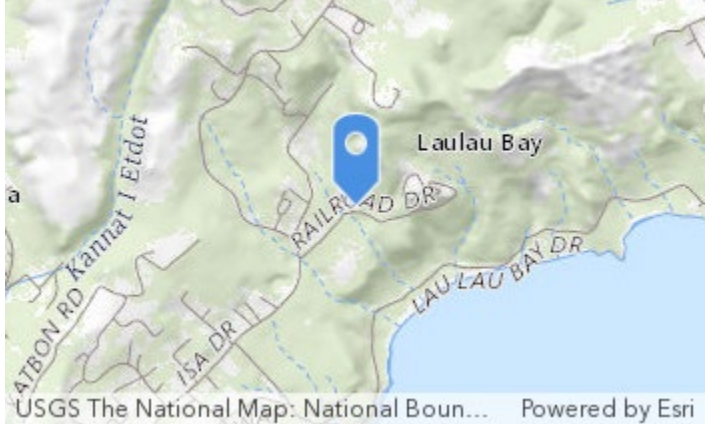
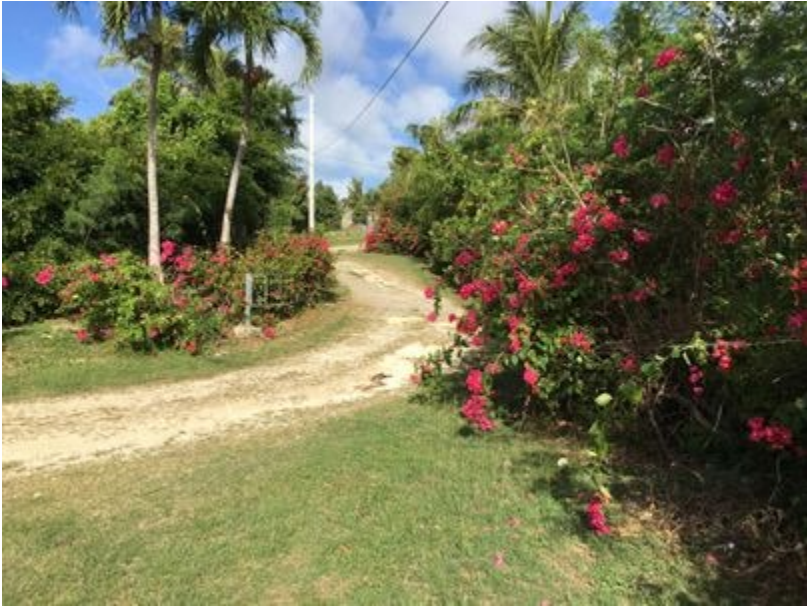
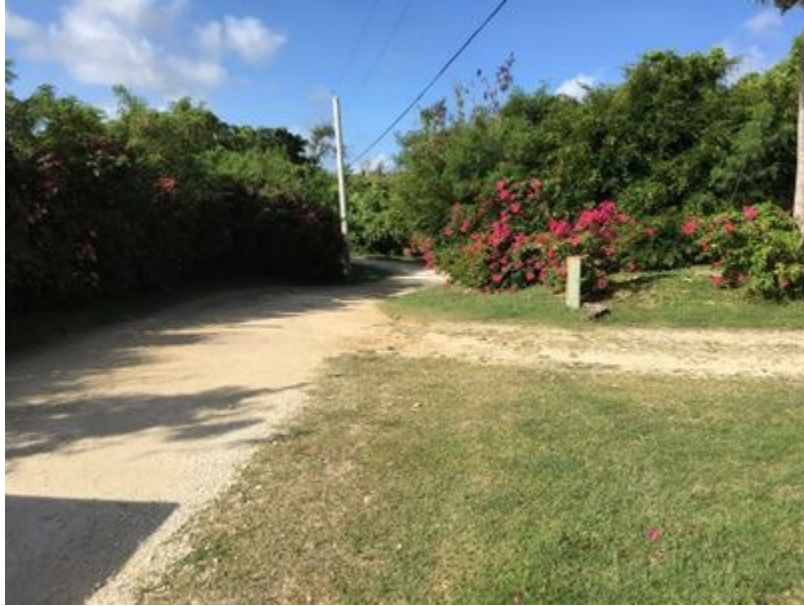
<p>Site ID: LL157</p>	<p>Watershed: Laolao</p>
<p>Crew: EH</p>	<p>Date/Time: 01/22/2020 7:16 PM</p>
<p>Project Type:</p> <ul style="list-style-type: none"> Residential Stewardship

<p>Enforcement Needed: No</p>	
<p>Severity Rating: 4</p>	
<p>Implementation Priority: It's OK (Med)</p>	
<p>Descriptions of Existing Conditions: Gravel driveway flows onto road. Sediment ends up in broad dip.</p>	
<p>Description of Proposed Opportunity: Waterbar on driveway. Intercept runoff before reaching road.</p>	
<p>Challenges/Constraints: On private land, would require landowner cooperation.</p>	
<p>Additional Notes:</p>	
<p>Site Photo</p>

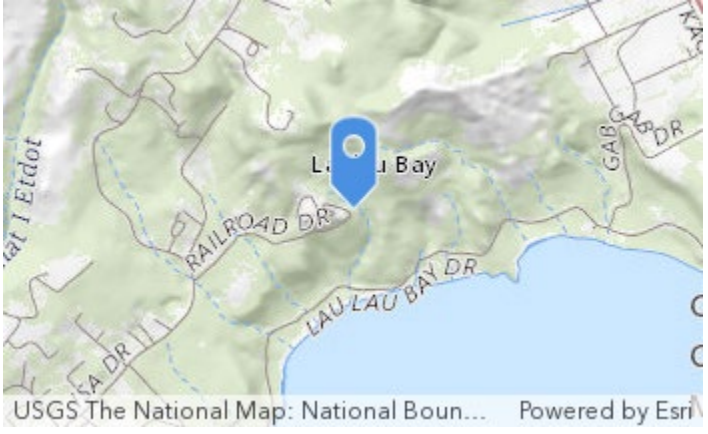
<p>Site ID: LL161</p>	<p>Watershed: Laolao</p>
<p>Crew: EH</p>	<p>Date/Time: 01/22/2020 7:52 PM</p>
<p>Project Type:</p> <ul style="list-style-type: none"> • Drainage Infrastr., Maint. & Repair • Stormwater Retrofit

<p>Enforcement Needed: No</p>	
<p>Severity Rating: 4</p>	
<p>Implementation Priority: It's OK (Med)</p>	
<p>Descriptions of Existing Conditions: Paved road runoff flows to informal discharge point.</p>	
<p>Description of Proposed Opportunity: Formalize drainage/control outfall.</p>	
<p>Challenges/Constraints: Very steep, not much room.</p>	
<p>Additional Notes:</p>	
<p>Site Photo</p>

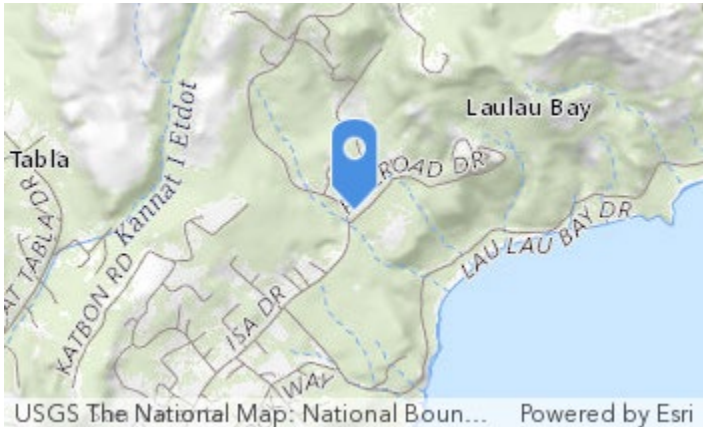
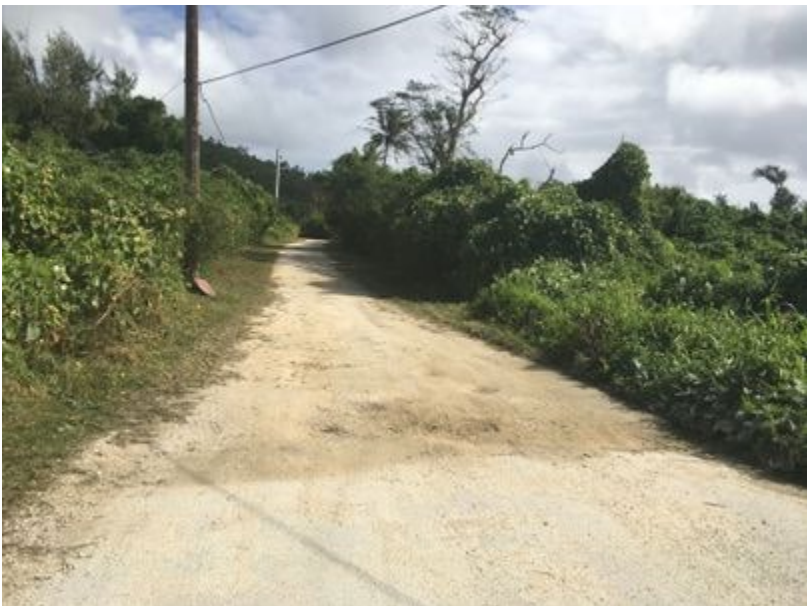
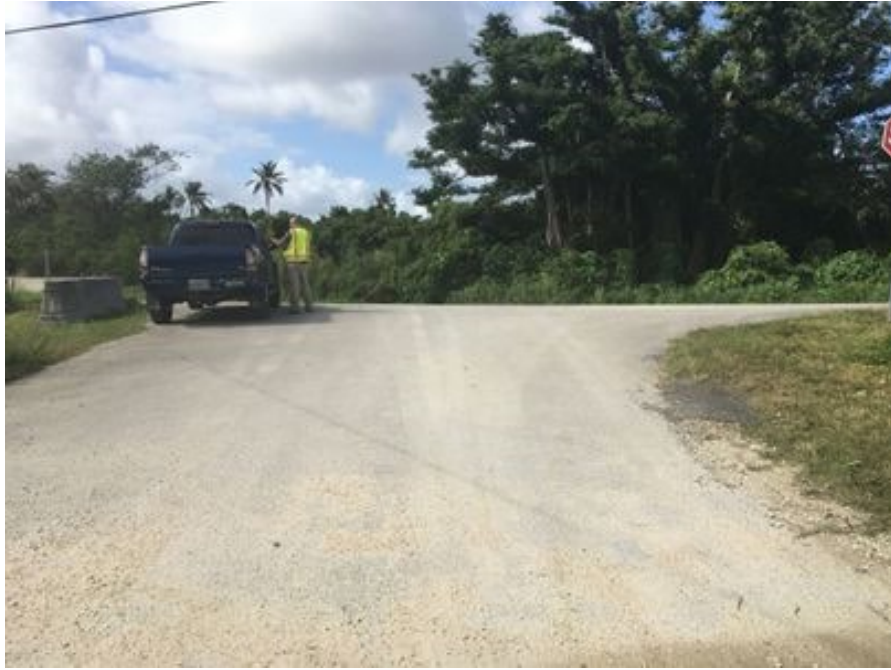
<p>Site ID: LL167</p>	<p>Watershed: Laolao</p>
<p>Crew: EH</p>	<p>Date/Time: 01/22/2020 8:22 PM</p>
<p>Project Type:</p> <ul style="list-style-type: none"> Stormwater Retrofit

<p>Enforcement Needed: No</p>	
<p>Severity Rating: 3</p>	
<p>Implementation Priority: It's OK (Med)</p>	
<p>Descriptions of Existing Conditions: Low point at at dirt/pavement transition. Runoff discharges off site.</p>	
<p>Description of Proposed Opportunity: Formalize/stabilize low point to reduce erosion. Could be built in conjunction with LL173.</p>	
<p>Challenges/Constraints: May cause erosion further up the road at new trnsition between stabilized low point and dirt road.</p>	
<p>Additional Notes:</p>	
<p>Site Photo</p>

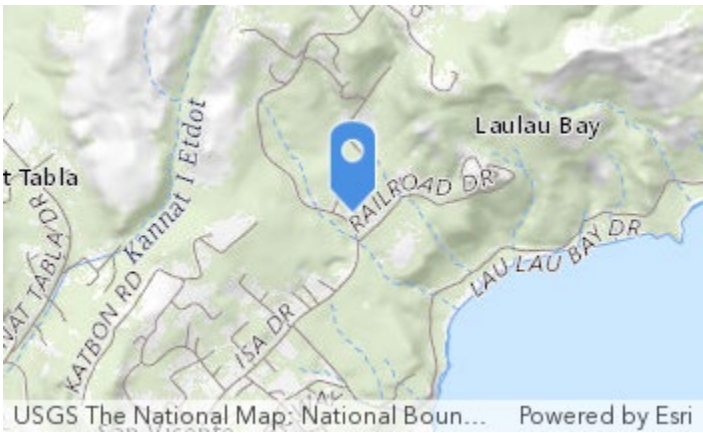
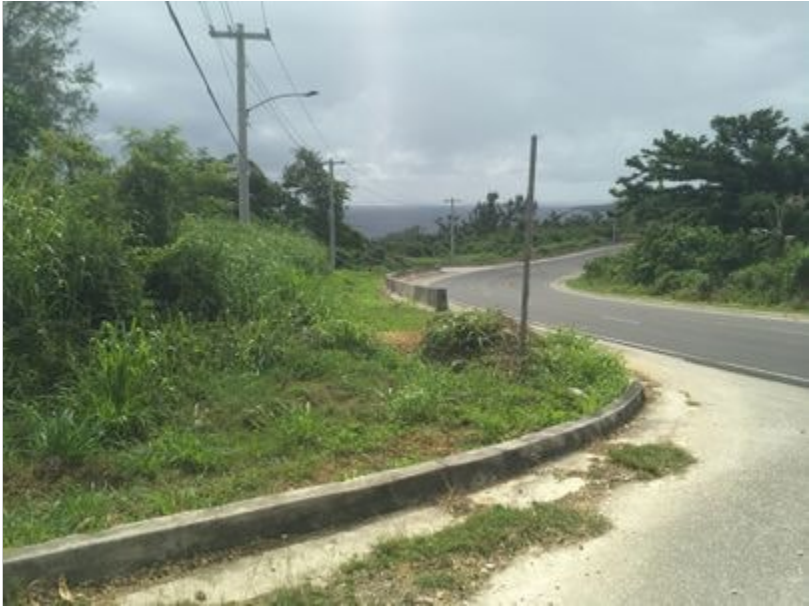
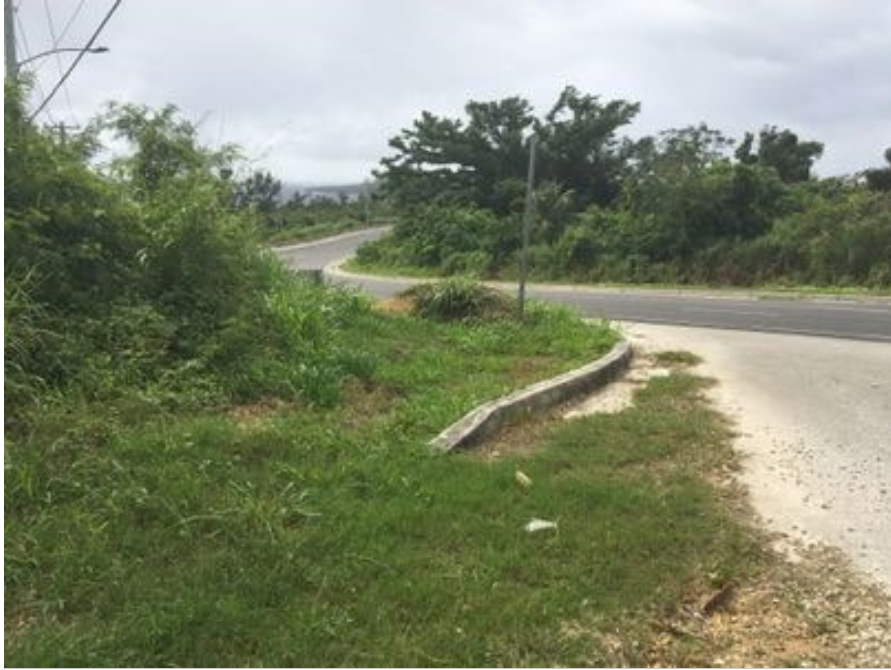
<p>Site ID: LL173</p>	<p>Watershed: Laolao</p>
<p>Crew: EH</p>	<p>Date/Time: 01/22/2020 8:54 PM</p>
<p>Project Type:</p> <ul style="list-style-type: none"> • Drainage Infrastr., Maint. & Repair

<p>Enforcement Needed: No</p>	
<p>Severity Rating: 4</p>	
<p>Implementation Priority: Love it! (High)</p>	
<p>Descriptions of Existing Conditions: Appears to be an existing vegetated swale with heavily clogged inlet. Runoff from dirt road bypasses swale and discharges to main road.</p>	
<p>Description of Proposed Opportunity: Clean and re-establish inlet. Consider broad dip to intercept runoff upgradient. See LL167-- can be same project.</p>	
<p>Challenges/Constraints: Future clogging from dirt road. Ongoing maintenance.</p>	
<p>Additional Notes:</p>	
<p>Site Photo</p>

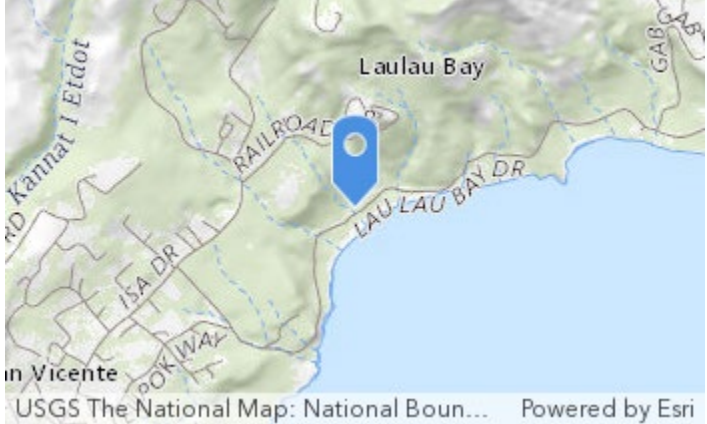
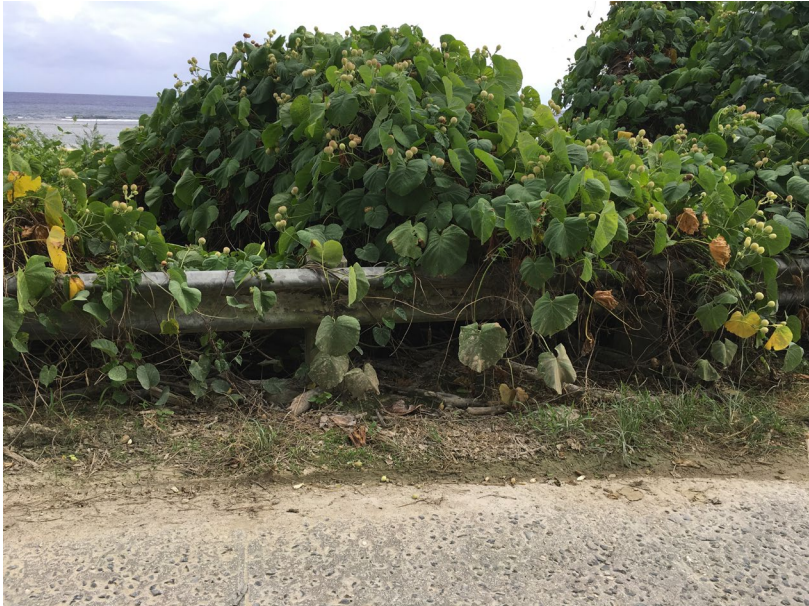
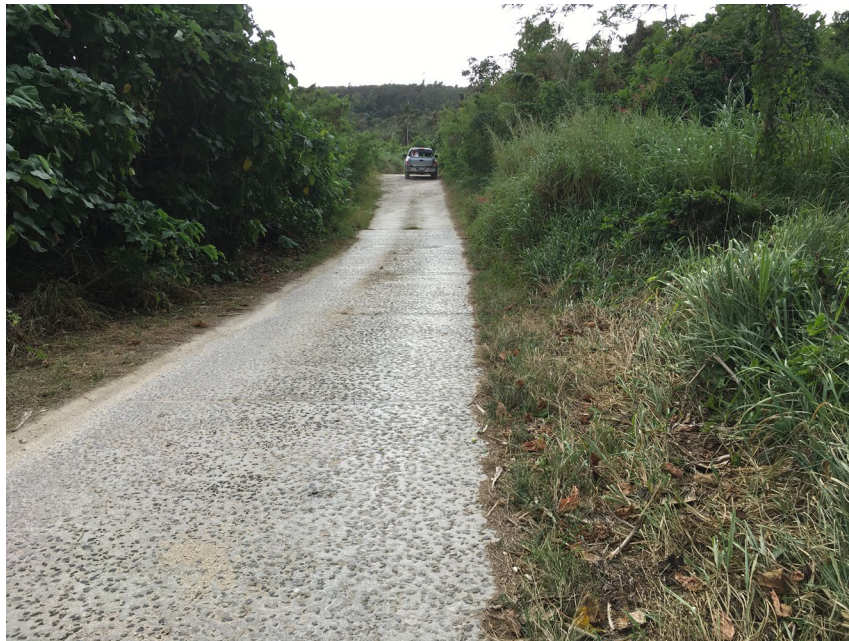
<p>Site ID: LL204</p>	<p>Watershed: Laolao</p>
<p>Crew: EH</p>	<p>Date/Time:</p>
<p>Project Type:</p> <ul style="list-style-type: none"> • Drainage Infrastr., Maint. & Repair

<p>Enforcement Needed: Yes</p>	
<p>Severity Rating: 2</p>	
<p>Implementation Priority: Love it! (High)</p>	
<p>Descriptions of Existing Conditions: Broad dip across road (see LL149) with branches and debris.</p>	
<p>Description of Proposed Opportunity: Clean and clear.</p>	
<p>Challenges/Constraints:</p>	
<p>Additional Notes:</p>	
<p>Site Photo</p>

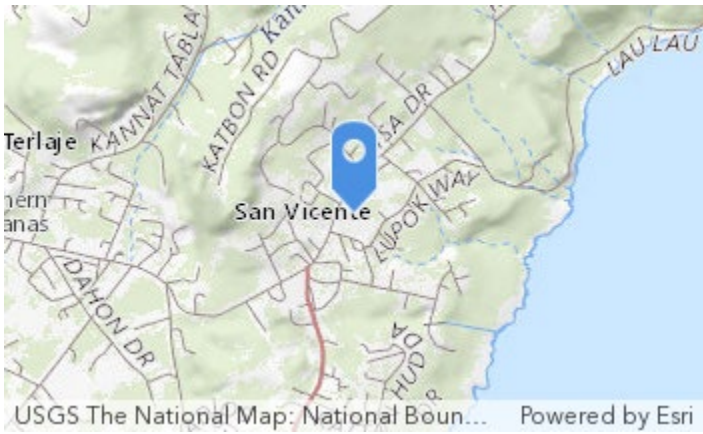
<p>Site ID: LL311</p>	<p>Watershed: Laolao</p>
<p>Crew: JI</p>	<p>Date/Time: 01/21/2020 11:31 PM</p>
<p>Project Type:</p> <ul style="list-style-type: none"> Bank stabilization

<p>Enforcement Needed: No</p>	
<p>Severity Rating: 2</p>	
<p>Implementation Priority: Not that important (Low)</p>	
<p>Descriptions of Existing Conditions: channel with 2:1 slope. Munch says grass erodes and soil slopes wash into swale.</p>	
<p>Description of Proposed Opportunity: ERSC blanket or drought tolerant vegetation. Gabion basket!</p>	
<p>Challenges/Constraints: Flex MSE wall? stone gabions? ground cover with ERSC blanket?</p>	
<p>Additional Notes:</p>	
<p>Site Photo</p>

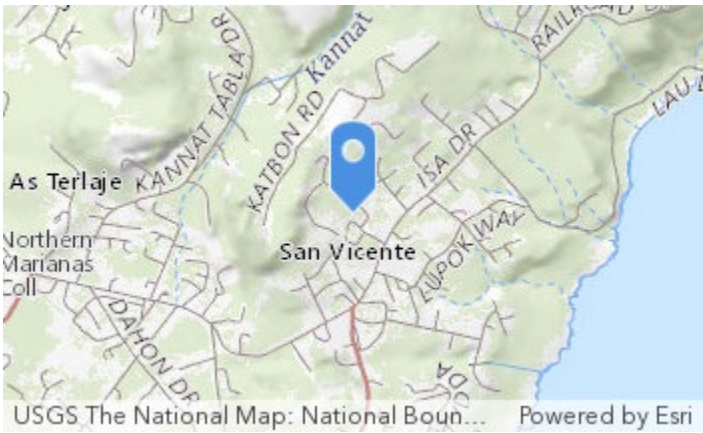
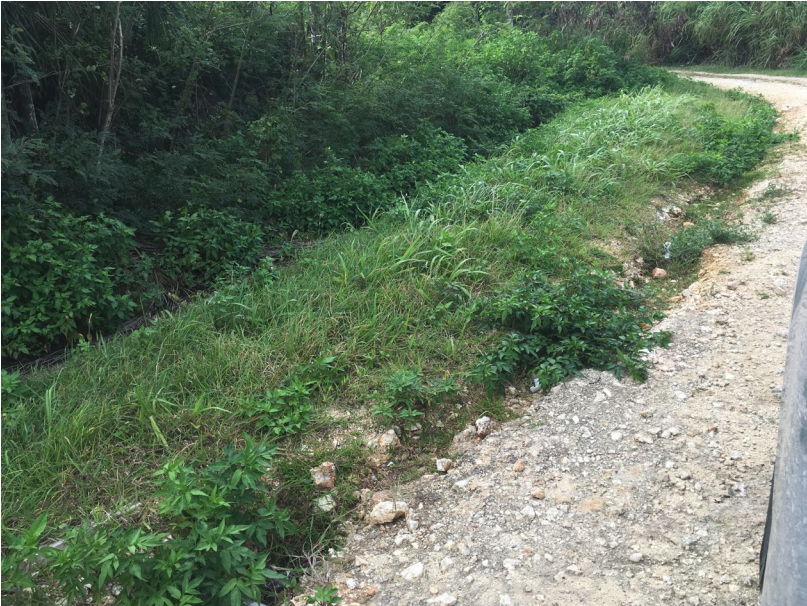
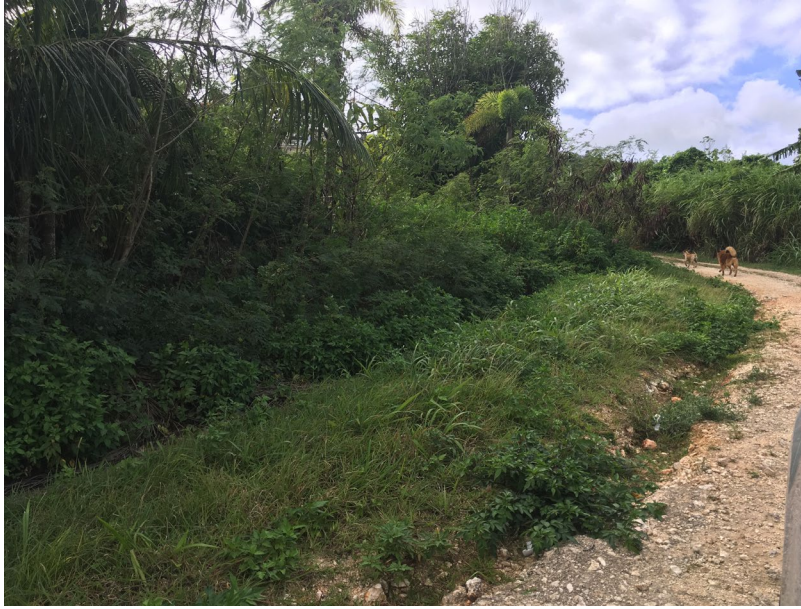
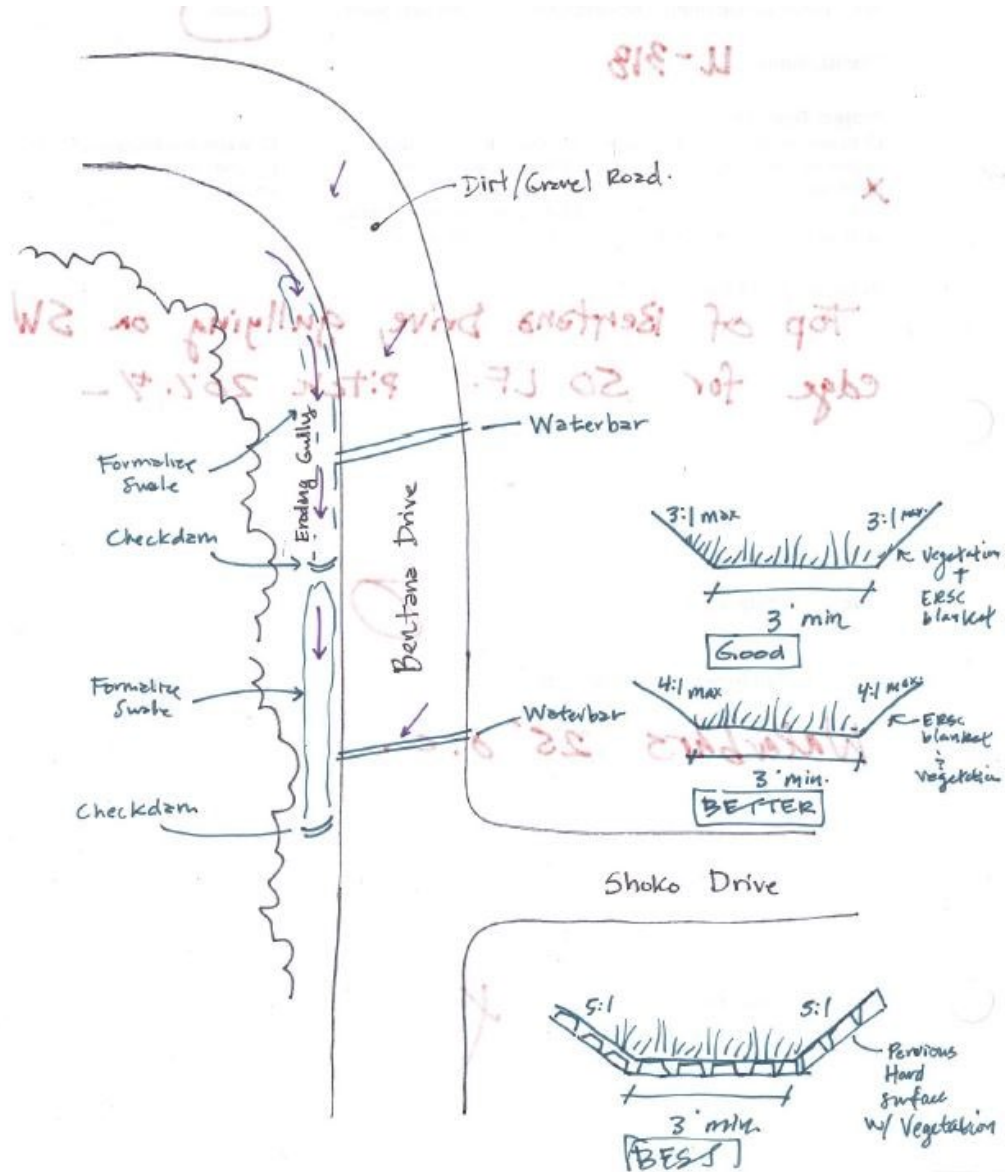
<p>Site ID: LL318</p>	<p>Watershed: Laolao</p>
<p>Crew: JI</p>	<p>Date/Time: 01/22/2020 1:27 AM</p>
<p>Project Type:</p> <ul style="list-style-type: none"> Unpaved Road Stabilization

<p>USGS The National Map: National Boun... Powered by Esri</p>
<p>Enforcement Needed: No</p>	
<p>Severity Rating: 3</p>	
<p>Implementation Priority: It's OK (Med)</p>	
<p>Descriptions of Existing Conditions: Dirt road gullyng. Top of Bentana Drive, gullyng on SW edge for 50 LF. pitch 20% +/-</p>	
<p>Description of Proposed Opportunity: Waterbars 25' O.C.</p>	
<p>Challenges/Constraints:</p>	
<p>Additional Notes:</p>	
<p>Site Photo</p>

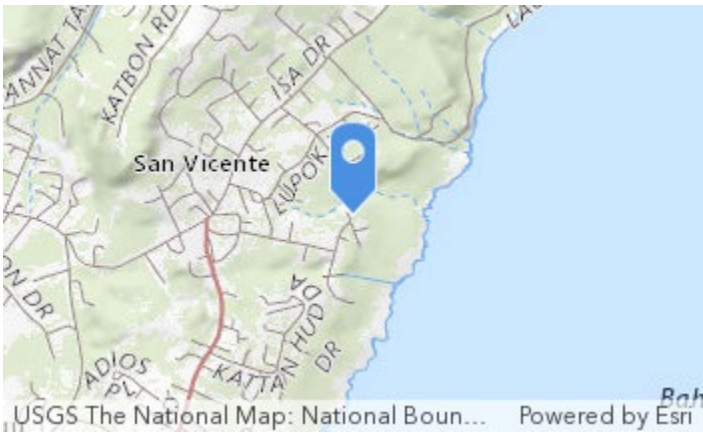
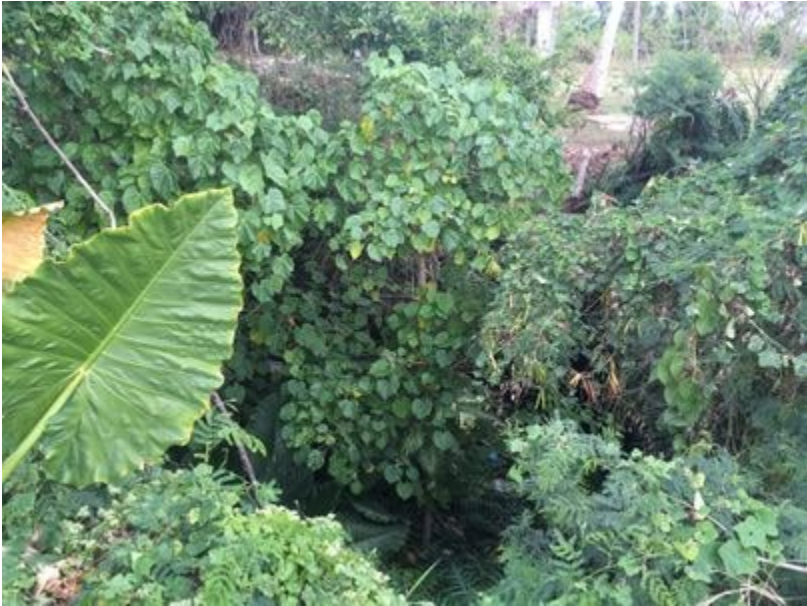
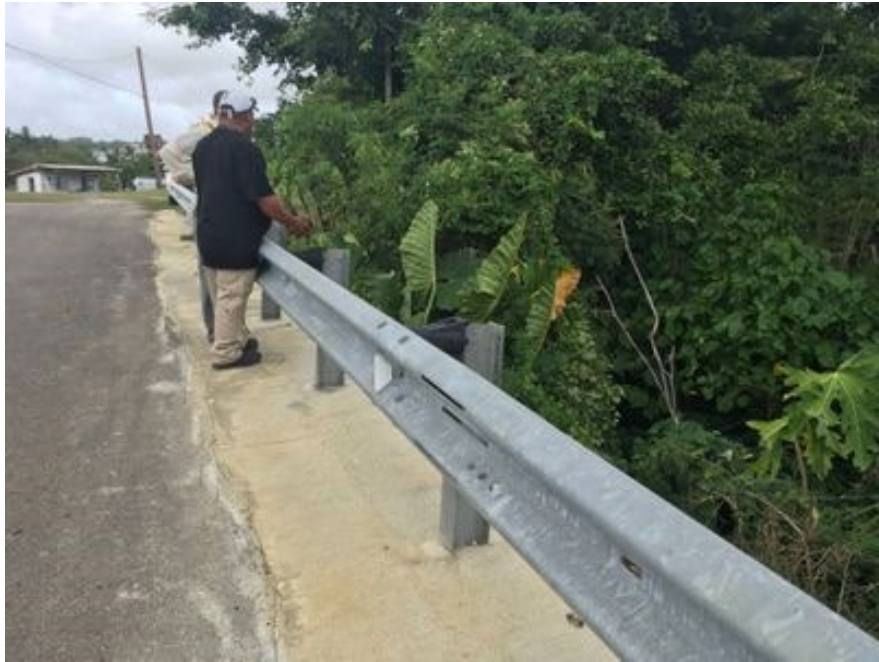
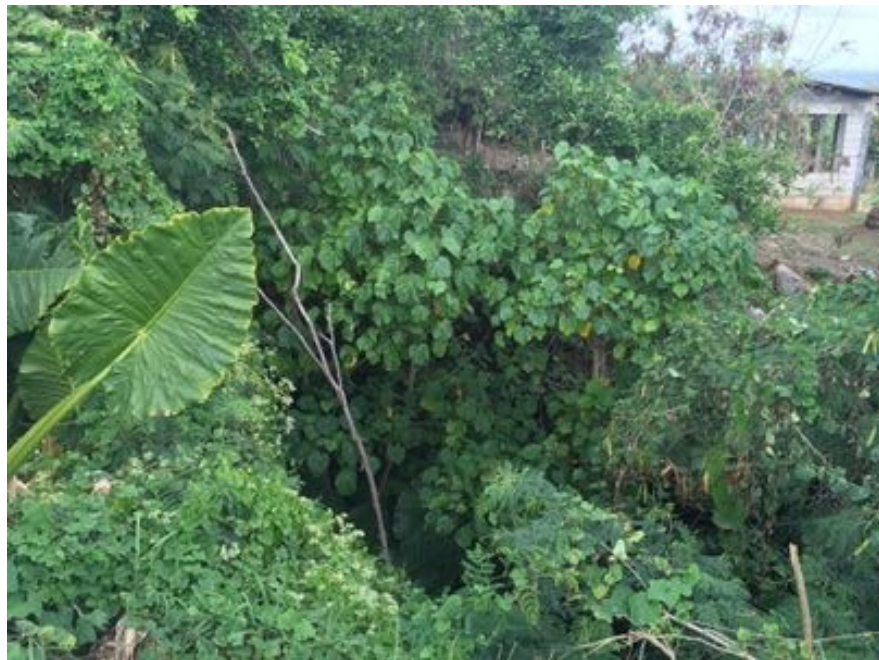
<p>Site ID: LL336</p>	<p>Watershed: Laolao</p>
<p>Crew: JI</p>	<p>Date/Time: 01/22/2020 12:04 AM</p>
<p>Project Type:</p> <ul style="list-style-type: none"> Watershed Education/Signage

<p>The map shows the San Vicente area with a blue location pin. Labeled roads include ANNAT TA, KATBON RD, ISA DR, LUPOK, ADIOS PL, KATTAN HUDD DR, and SAN VICENTE. The map is powered by Esri.</p>
<p>Enforcement Needed: Yes</p>	
<p>Severity Rating: 4</p>	
<p>Implementation Priority: It's OK (Med)</p>	
<p>Descriptions of Existing Conditions: Sinkhole on private property - connects to a stream and then directly to the ocean. It is currently an illegal trash dumping site.</p>	
<p>Description of Proposed Opportunity: Clean up trash. Create educational opportunity and tourist attraction for people to go into the hole and listen to the ocean.</p>	
<p>Challenges/Constraints: Private property</p>	
<p>Additional Notes:</p>
