Laolao Bay Watershed Existing Conditions and Opportunities Interim Report

September 2020 DRAFT

CNMI Bureau of Environmental and Coastal Quality
Division of Coastal Resource Management

Horsley Witten Group, Inc.
KOA Consulting, Inc.
Sea Change Consulting

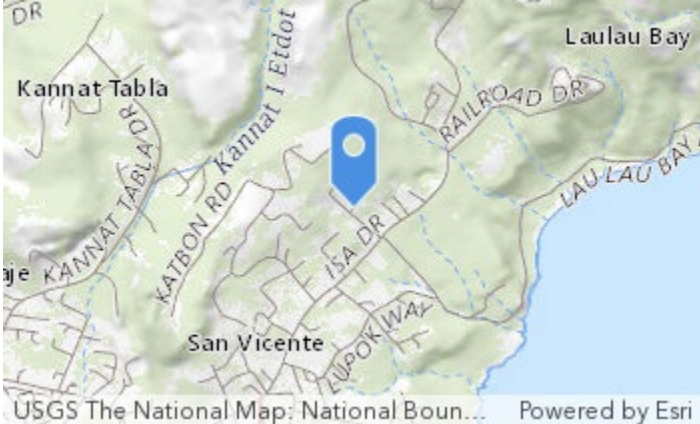
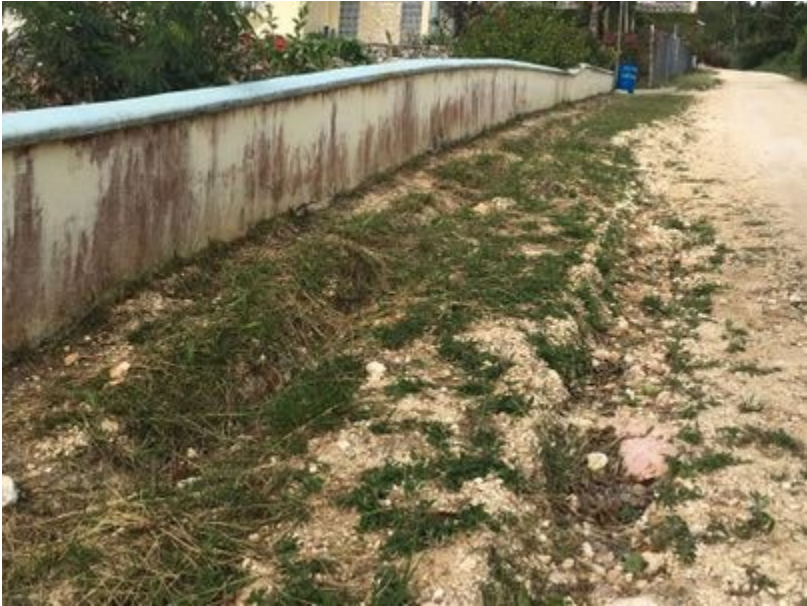
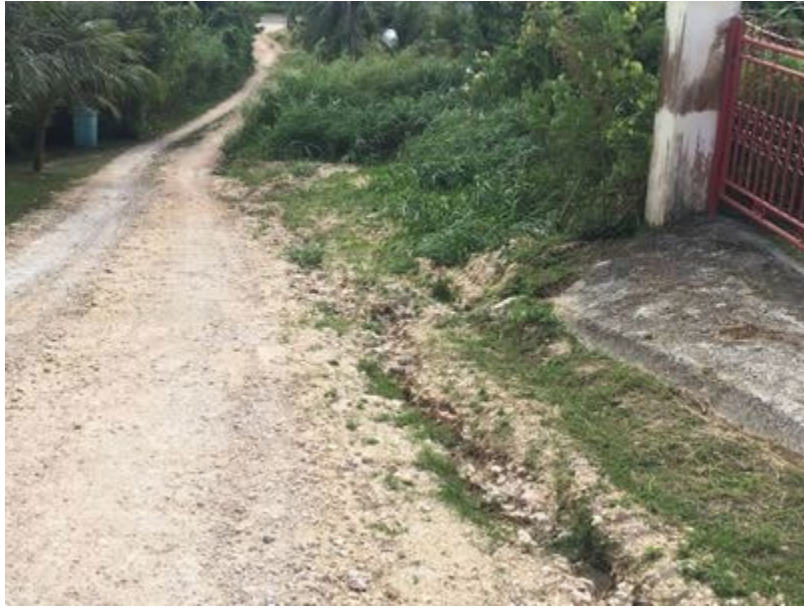
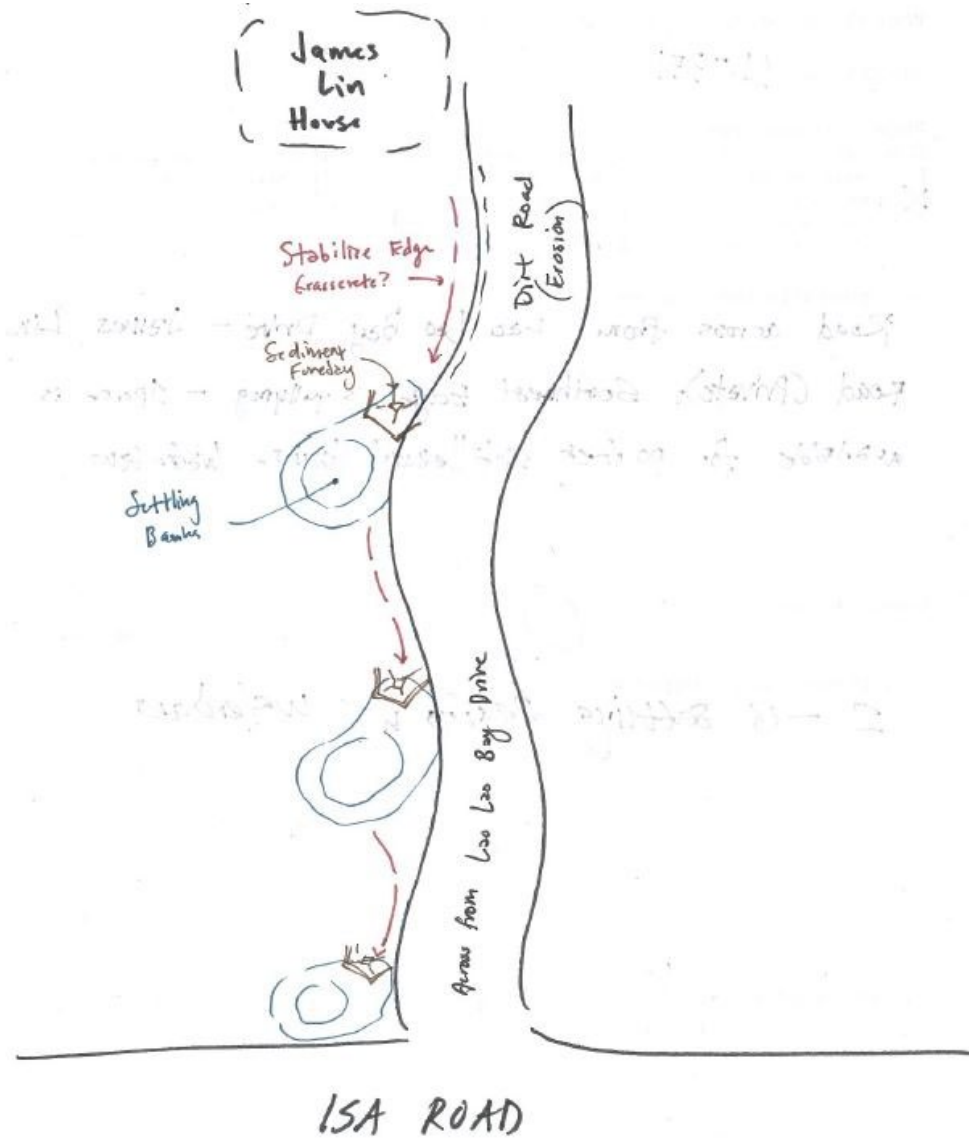
<p>Site ID: LL351</p>	<p>Watershed: Laolao</p>
<p>Crew: JI</p>	<p>Date/Time: 01/22/2020 8:25 PM</p>
<p>Project Type:</p> <ul style="list-style-type: none"> Unpaved Road Stabilization

<p>Enforcement Needed: No</p>	
<p>Severity Rating: 4</p>	
<p>Implementation Priority: Love it! (High)</p>	
<p>Descriptions of Existing Conditions: Serious erosion on one side of the road/ Road across from Lao Lao Bay Drive - James Lin road (private) - southwest edge is gullyng. space is available for pocket settlement basins. waterbars.</p>	
<p>Description of Proposed Opportunity: 2-3 settling basins with waterbars</p>	
<p>Challenges/Constraints: Private road, need to go to dpw or mayor</p>	
<p>Additional Notes: Contributing to Lao Lao Bay settling basin (target source not symptom)</p>	
<p>Site Photo</p>

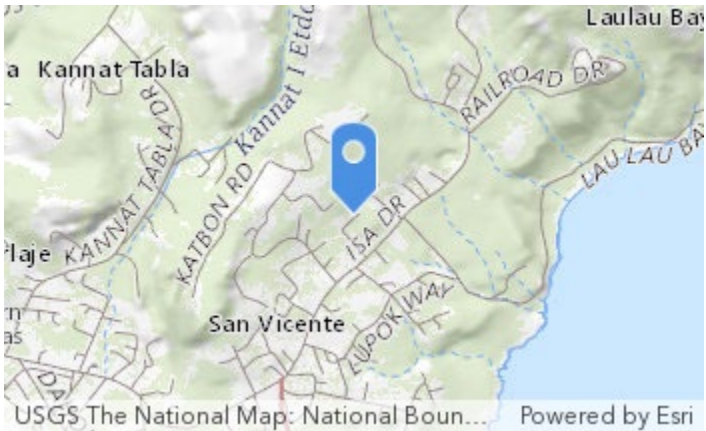
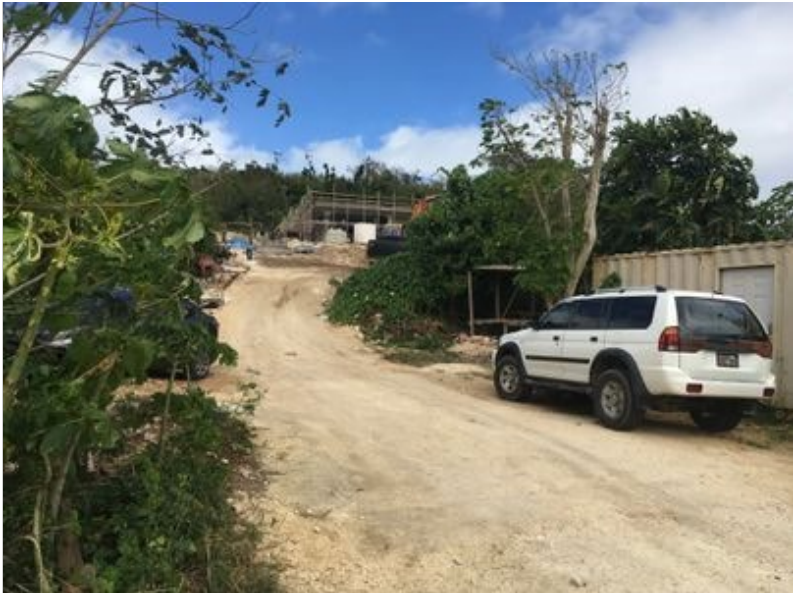
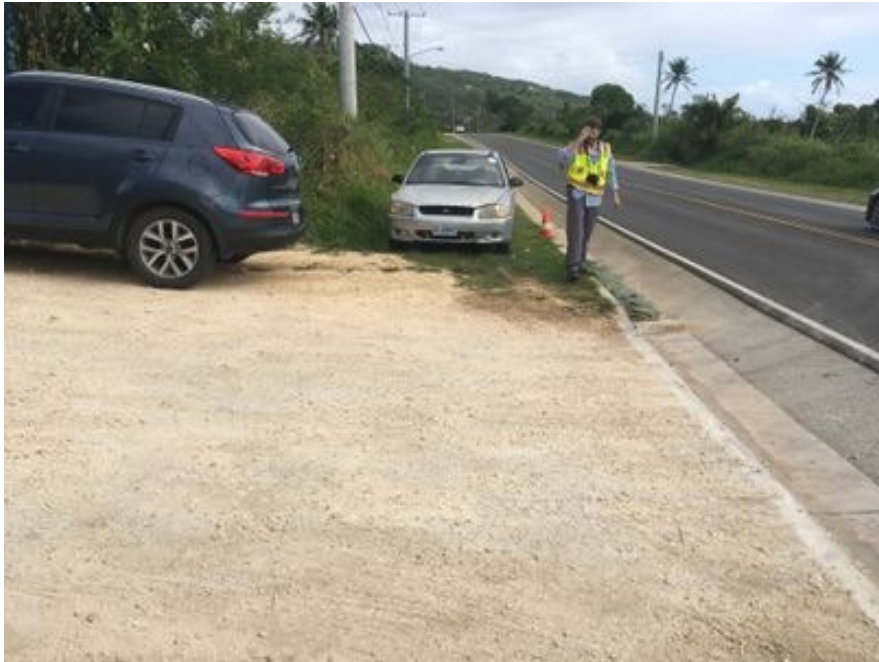
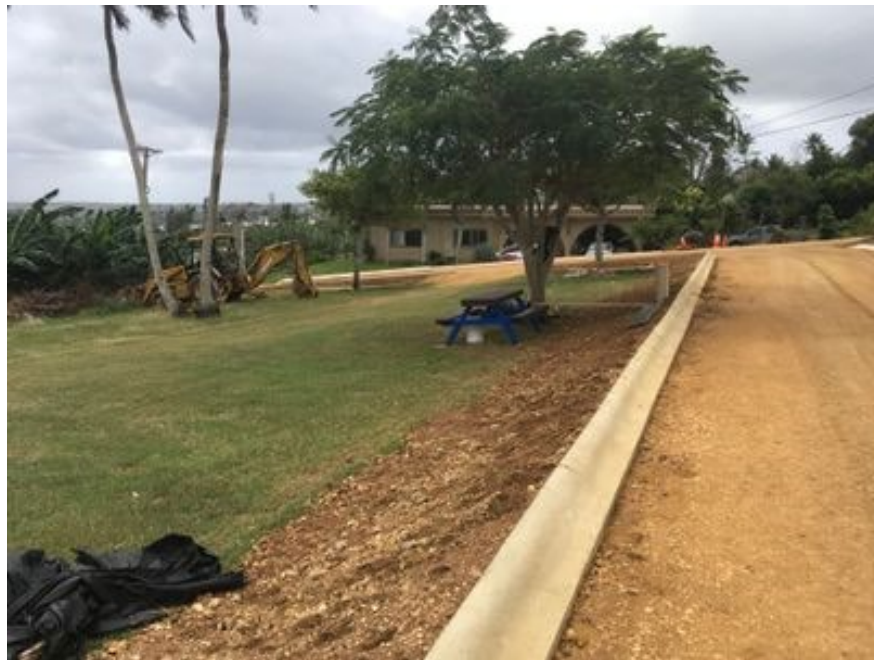
<p>Site ID: LL352</p>	<p>Watershed: Laolao</p>
<p>Crew: JI</p>	<p>Date/Time: 01/22/2020 8:46 PM</p>
<p>Project Type:</p> <ul style="list-style-type: none"> Construction Site ESC

<p>Enforcement Needed: Yes</p>	
<p>Severity Rating: 5 (Severe)</p>	
<p>Implementation Priority: Love it! (High)</p>	
<p>Descriptions of Existing Conditions: Palu Road construction. No ERSC - full catch basin at Isa Dr. No silt sack. No track pad. Staging area at top of hill with brush clear. Street next to Palu Road also has construction and not much ESC was observed.</p>	
<p>Description of Proposed Opportunity: Enforcement. ERSC - lack of awareness by DPW. Silt sack in ex. cbs. cover stockpiles, silt sock around stockpiles.</p>	
<p>Challenges/Constraints: Saw this too much at construction site. clearing before ERSC.</p>	
<p>Additional Notes: No erosion control measures from construction up above, staging area at top of hill but no ESC</p>

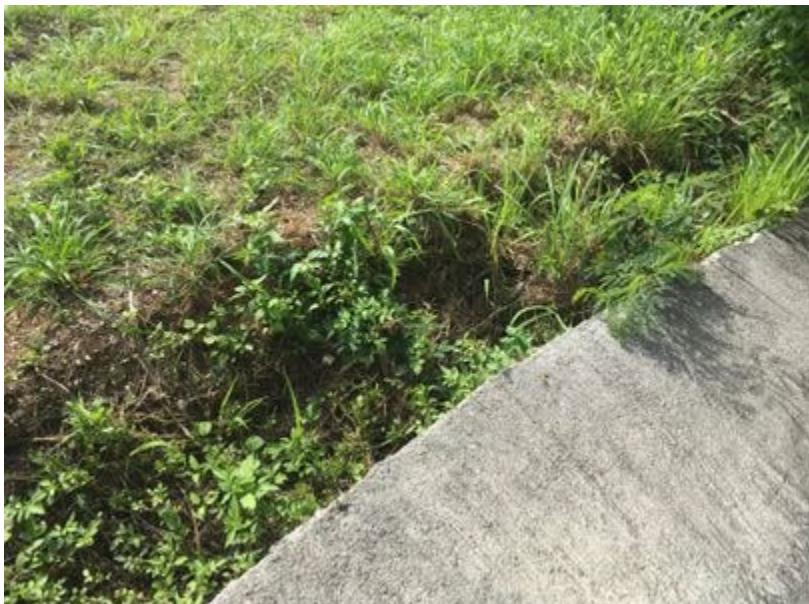
<p>Site ID: LL377</p>	<p>Watershed: Laolao</p>
<p>Crew: JI</p>	<p>Date/Time: 01/22/2020 11:56 PM</p>
<p>Project Type:</p> <ul style="list-style-type: none"> • Drainage Infrastr., Maint. & Repair

<p>Enforcement Needed: No</p>	
<p>Severity Rating: 3</p>	
<p>Implementation Priority: It's OK (Med)</p>	
<p>Descriptions of Existing Conditions: Washout along side of concrete swale into woods. Flume into wooded area is blown out on road side. runoff can't make turn.</p>	
<p>Description of Proposed Opportunity: Add berm or curb edge. simple and easy to avoid sediment input.</p>	
<p>Challenges/Constraints:</p>	
<p>Additional Notes:</p>	
<p>Site Photo</p>

Challenges/Constraints: SW is moving extremely fast downhill & doesn't want to make turn with Channel. Side slope is being eroded as result.

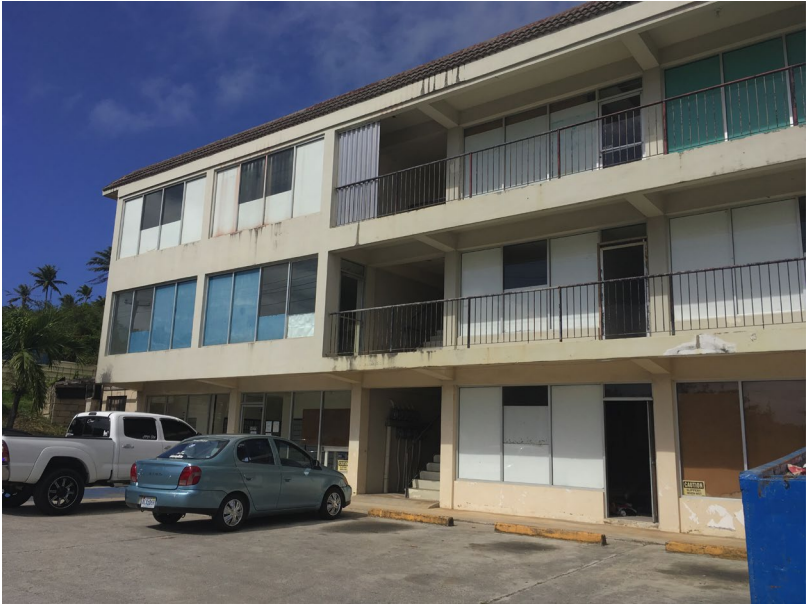
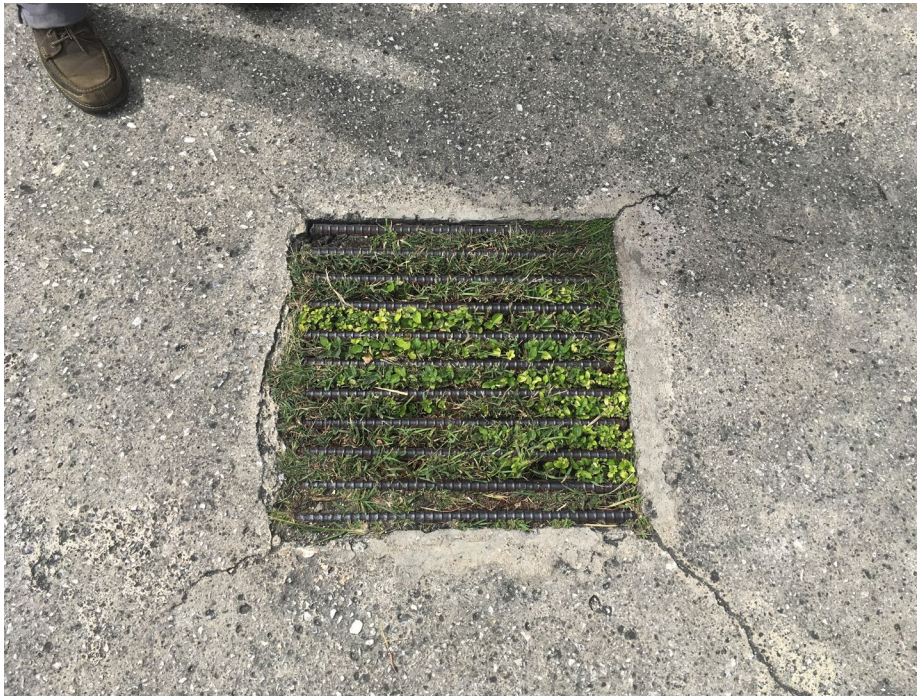
<p>Site ID: LL382</p>	<p>Watershed: Laolao</p>
<p>Crew: JI</p>	<p>Date/Time:</p>
<p>Project Type:</p> <ul style="list-style-type: none"> • Drainage Infrastr., Maint. & Repair

<p>Enforcement Needed: Yes</p>	
<p>Severity Rating: 5 (Severe)</p>	
<p>Implementation Priority: It's OK (Med)</p>	
<p>Descriptions of Existing Conditions: catch basin in post office parking lot is full of vegetation</p>	
<p>Description of Proposed Opportunity: clean out catch basin</p>	
<p>Challenges/Constraints:</p>	
<p>Additional Notes:</p>	
<p>Site Photo</p>
