**SOUTHGATE POND/CHENAY BAY  
AREA OF PARTICULAR CONCERN  
(APC)**

**AREA OF PRESERVATION AND RESTORATION  
(APR)**

*A COMPREHENSIVE ANALYTIC STUDY*

V.I. DEPARTMENT OF PLANNING AND NATURAL RESOURCES  
*Coastal Zone Management Program*

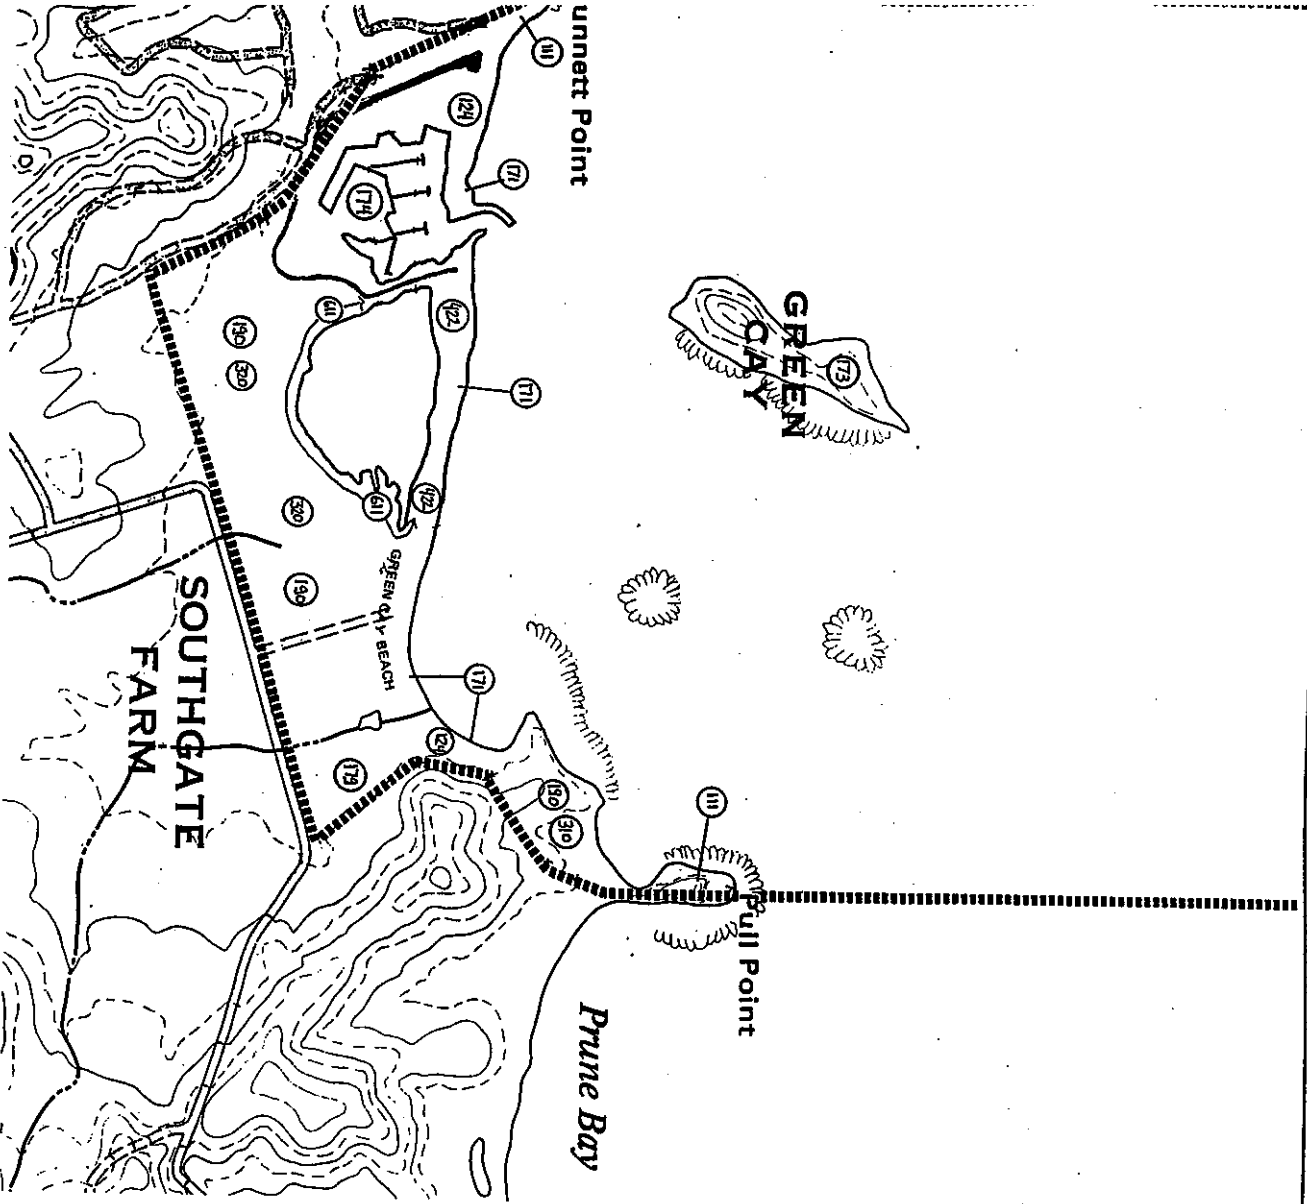
Figure 5  
 Land Use/Land Cover Map  
 Base map adapted from: BCK&E, 1979  
 Island Resources Foundation, 1993

LAND USE / LAND COVER
111 Residential (low density)
124 Hotel/Resort
171 Beach (recreation)
173 Park (Wildlife Refuge)
174 Marina
179 Recreation (Tennis Courts)
190 Undeveloped
310 Grassland
320 Scrub/Brushland
422 Beach Woodland
611 Mangrove complex

1. Parks/Recreation/Open Space - Green Cay Island is a National Wildlife Refuge and is entirely used for this purpose.
2. Residential (Low Density) - Pull Point and Punnett Point are zoned low density which allows a maximum of two structures per acre.
3. Waterfront/Marine - The areas around Southgate Pond are set aside for water-dependent uses. This includes the area surrounding Green Cay Marina located in the western portion of the Pond.
4. Hotel/Resort - Tamarind Reef Hotel is being reconstructed on its original foundation which is located adjacent to the opened western portion of the Southgate Pond. Chenay Bay Beach Resort is located on the eastern portion of Chenay Bay.
5. Undeveloped - The areas surrounding the eastern portion of Southgate Pond and Chenay Beach presently remain undeveloped.

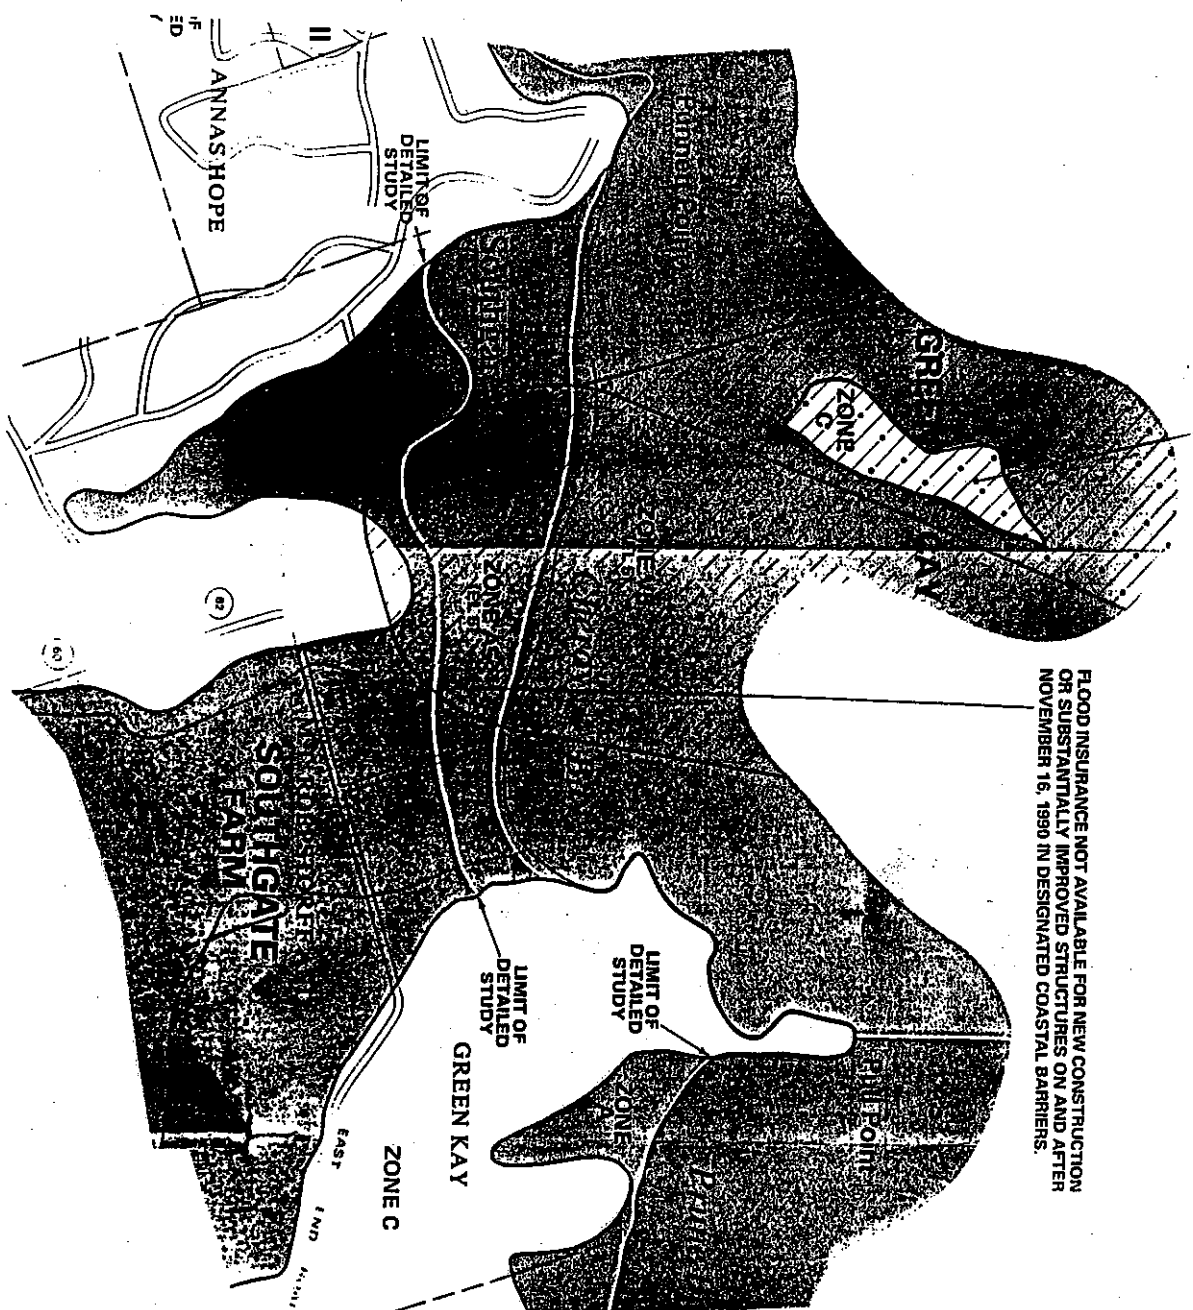
Figure 6  
100-Year Floodplain  
Adapted from: FEMA, 1992  
Island Resources Foundation, 1993

- ZONE**      **EXPLANATION**
- A** Area of 100-year flood; base flood elevations and flood hazard factors not determined.
  - AQ** Areas of 100-year shallow flooding where depths are between one (1) and three (3) feet; average depth of inundation are shown; but no flood hazard factors are determined.

The Federal Emergency Management Agency (FEMA) Flood Insurance Rate Maps (FIRMs) for the Virgin Islands identify and classify areas subject to flooding and denote the boundary limits for projected 100-year and 500-year floods (Figure 6). Flooding may be caused by both inundation of the sea and/or by concentrated runoff from the surrounding watershed during storm periods. The flood hazard designations shown on the map relate to the frequency and severity of the flooding that can be expected to affect any one area. The maps are used to determine base flood elevations, or how high above ground level new structures must be built.

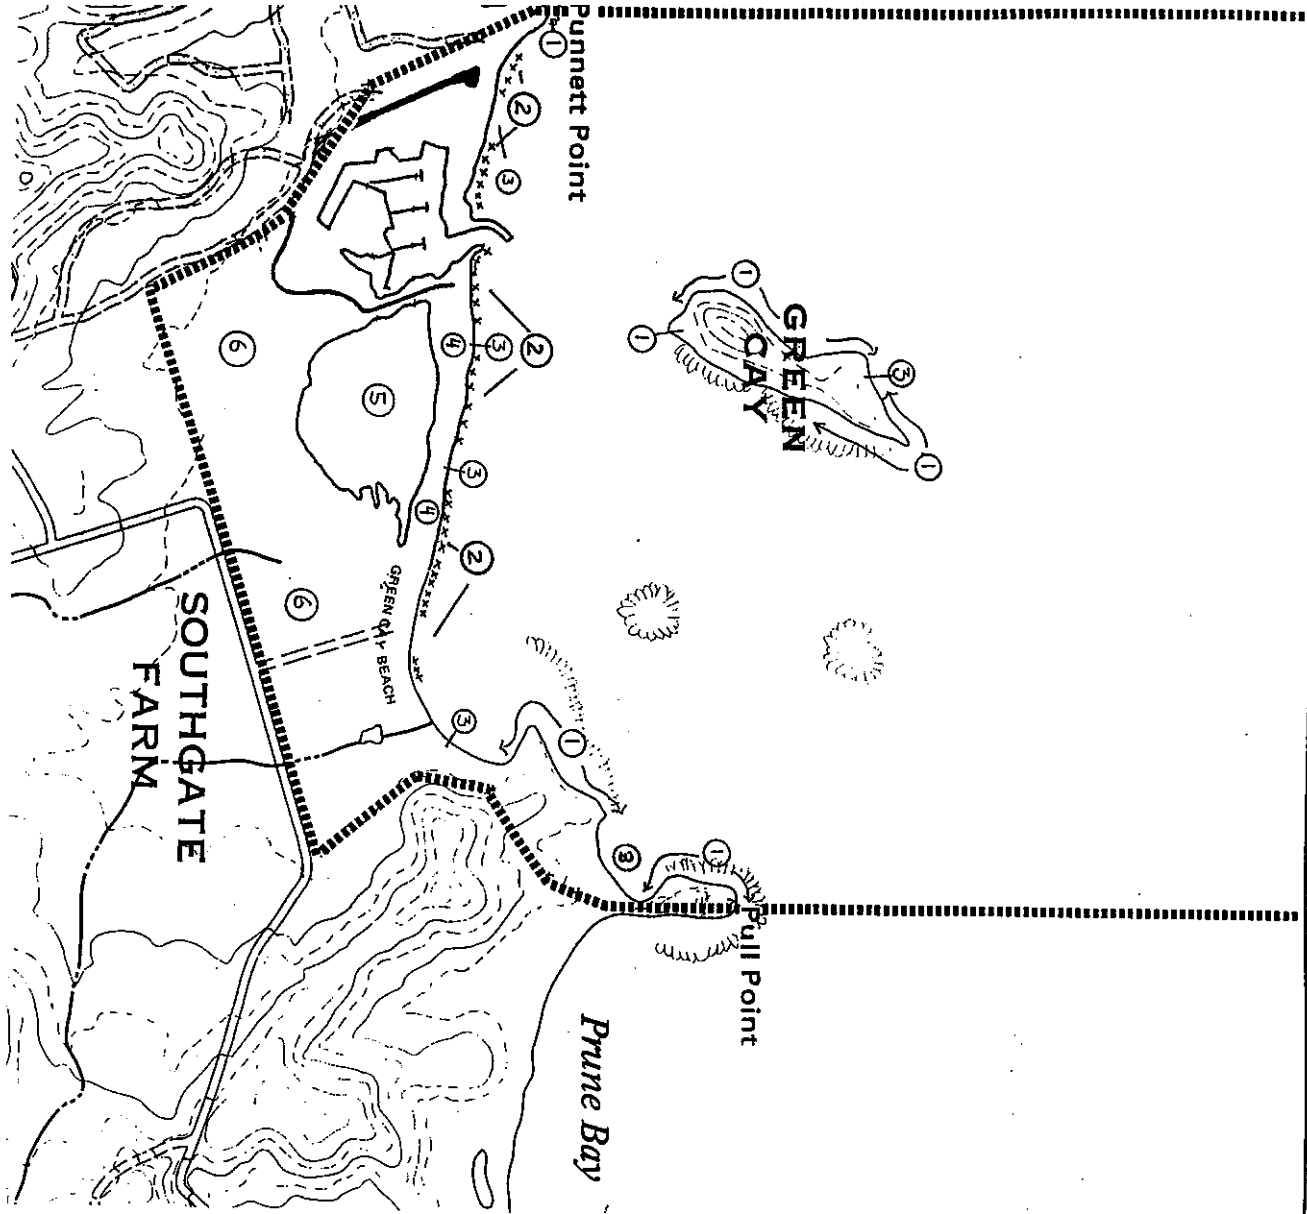
Figure 8  
Physical Features  
Base map adapted from: BC&E, 1979  
Island Resources Foundation, 1993

- 1 Rocky Shoreline/Rock Ledge
- 2 Beach Rock xxxx
- 3 Beach Sand
- 4 Bay-mouth Bar/Sand dune complex
- 5 Silt/Clay Substrate
- 6 Alluvial Plain

The mainland shore is largely sandy beach fronted by beach rock which is often exposed (Figure 8). Beach rock is also found in scattered areas offshore of the site. Chenay Bay is an embayment formed by a northeast point of land (unnamed) and Pull Point which is further northeast. A coral reef extends seaward from this unnamed point; a couple of patch reefs also extend just north of the Chenay Beach Resort. Green Cay island with its fringing reefs lies to the northwest.

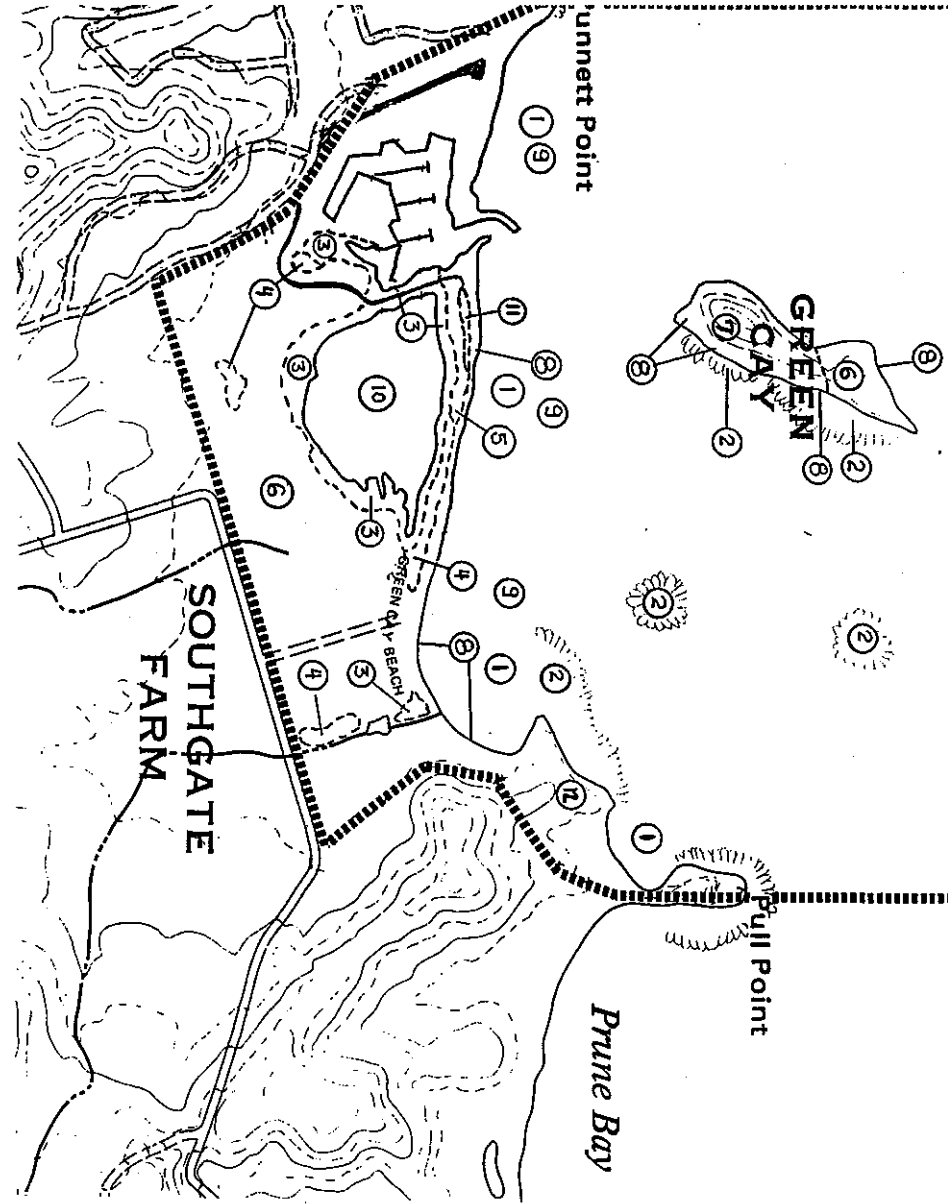
Figure 9  
 Biological Features  
 Base map adapted from: BGEF, 1979  
 Island Resources Foundation, 1993

- 1 Seagrass Beds
- 2 Coral Reefs
- 3 Mangrove
- 4 Manchineel Forest
- 5 Genip Forest
- 6 Savanna Grassland / Scrub Grassland
- 7 Dry Woodland / Dry Forest
- 8 Turtle Nesting Area
- 9 Turtle Feeding Area
- 10 Major Wildlife Habitat
- 11 Coconut Grove
- 12 Disturbed Vegetation

Unmanaged vegetation of the APC includes that surrounding the salt pond, vegetation found on Green Cay NWR, and along the Chenay Bay beach area. The beach ecosystem includes areas of no vegetation, low beach grass, succulents, shrubs, and trees. Three terrestrial ecotypes are found in the area: mixed scrub woodland and savanna grasslands, baymouth bar vegetation, and a salt pond/mangrove system (Figure 9).

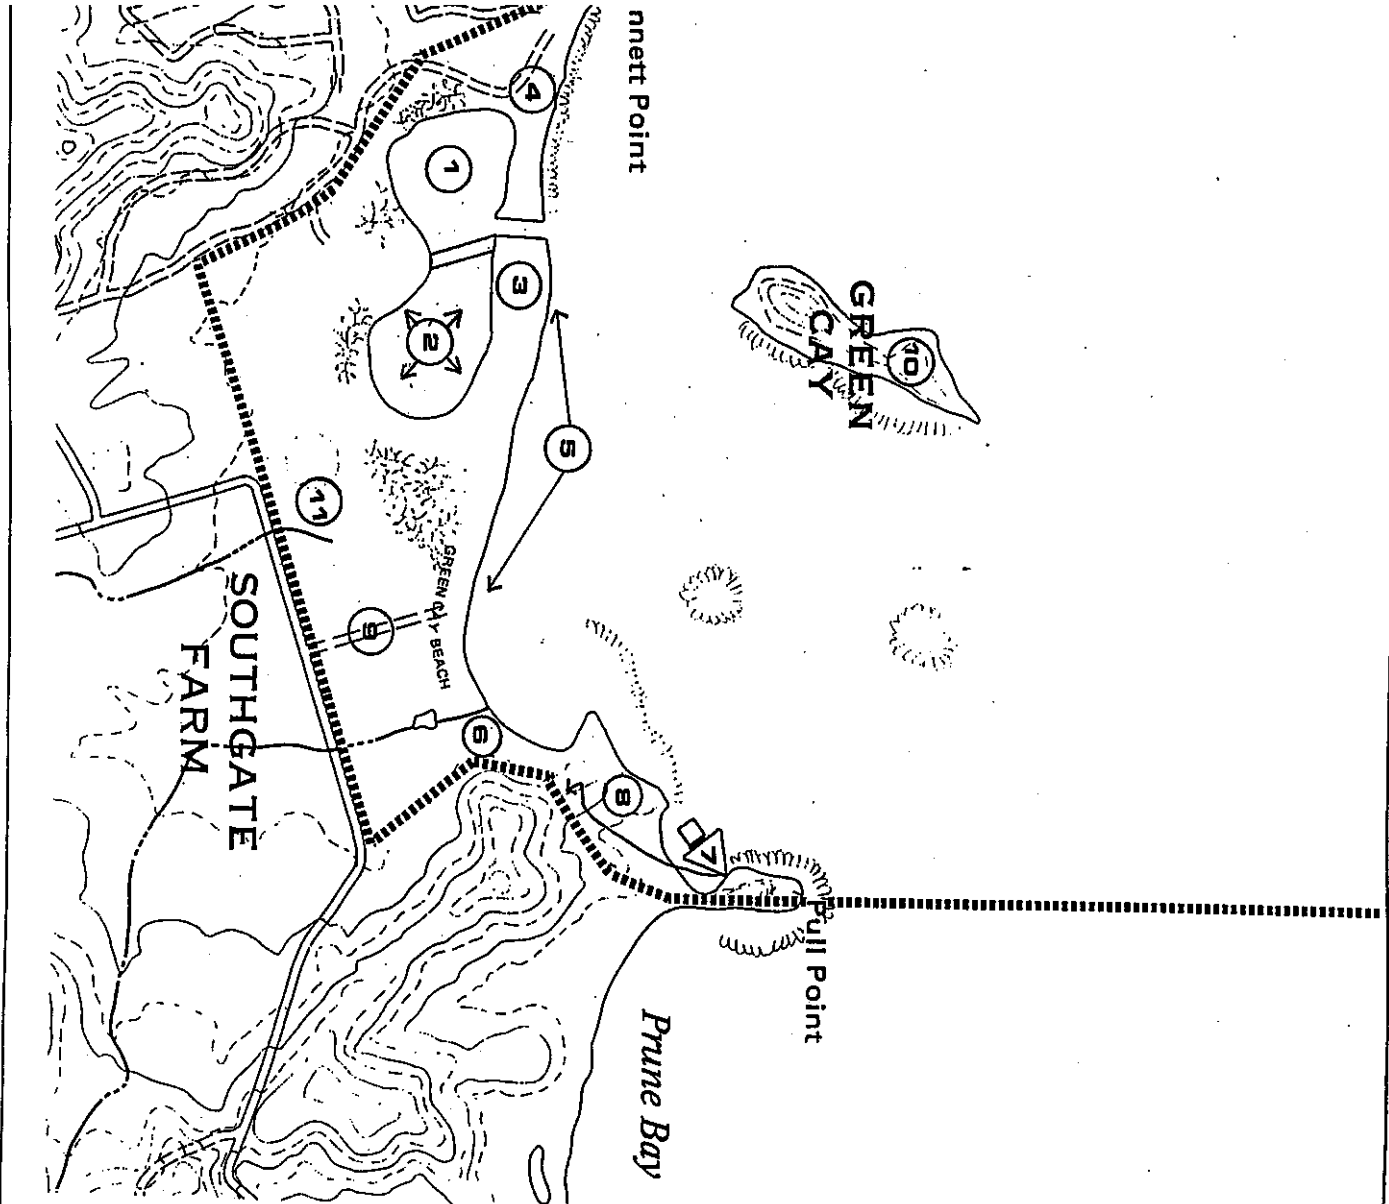
7. Cheney Bay Beach Resort Hotel
8. Construction in text as "Permit No. 4".
9. Construction on Plots Nos. 10, 10-B, 10-D, and 12 of Estate Green Cay.
10. Beach access road. Some junk cars on road.

11. Green Cay National Wildlife Refuge. One of the last remaining habitats for the St. Croix Ground Lizard. Described in text as "Permit No. 3".
12. Construction on Plots Nos. 84, 84A, 84B, 8, 48, and 32 of Estate Green Cay.
